Rehabilitation Alternatives Analysis - DRAFT

Hesperia Dam

Oceana County, Michigan
Dam I.D. No. 678

June 16, 2025
Project No. 2403886

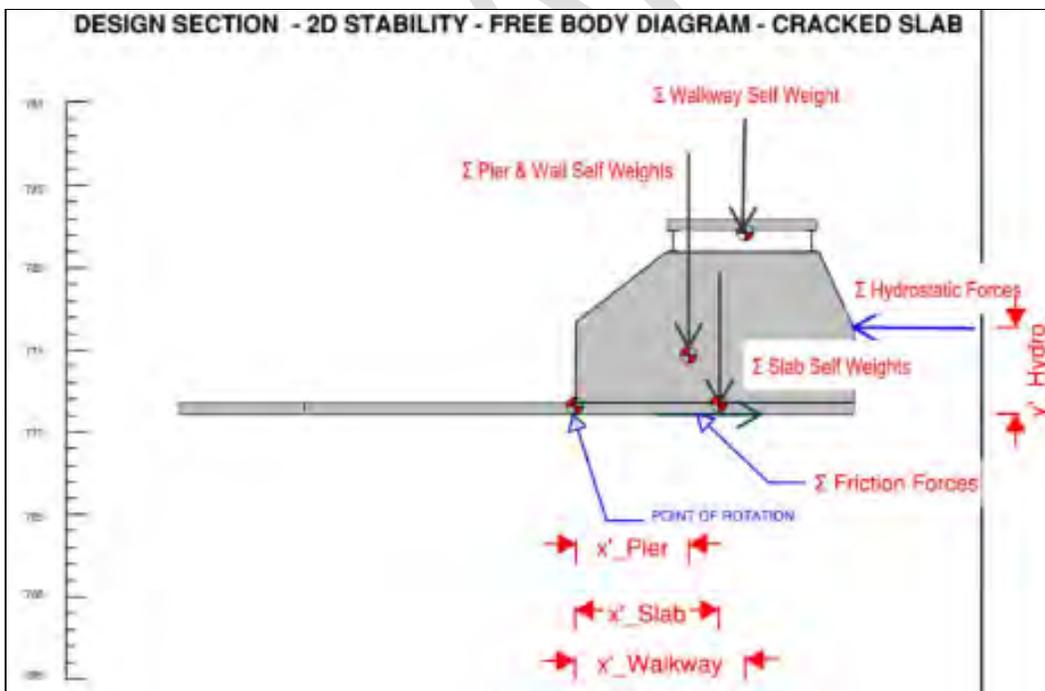
Figure 16. Spillway Structure Free Body Diagram – Cracked Slab

The results show the primary spillway inlet structure at normal pool conditions with stop logs does meet the minimum stability criteria based on current industry standard for sliding. However, the structure was found to be at risk of sliding during the condition of a cracked apron slab.

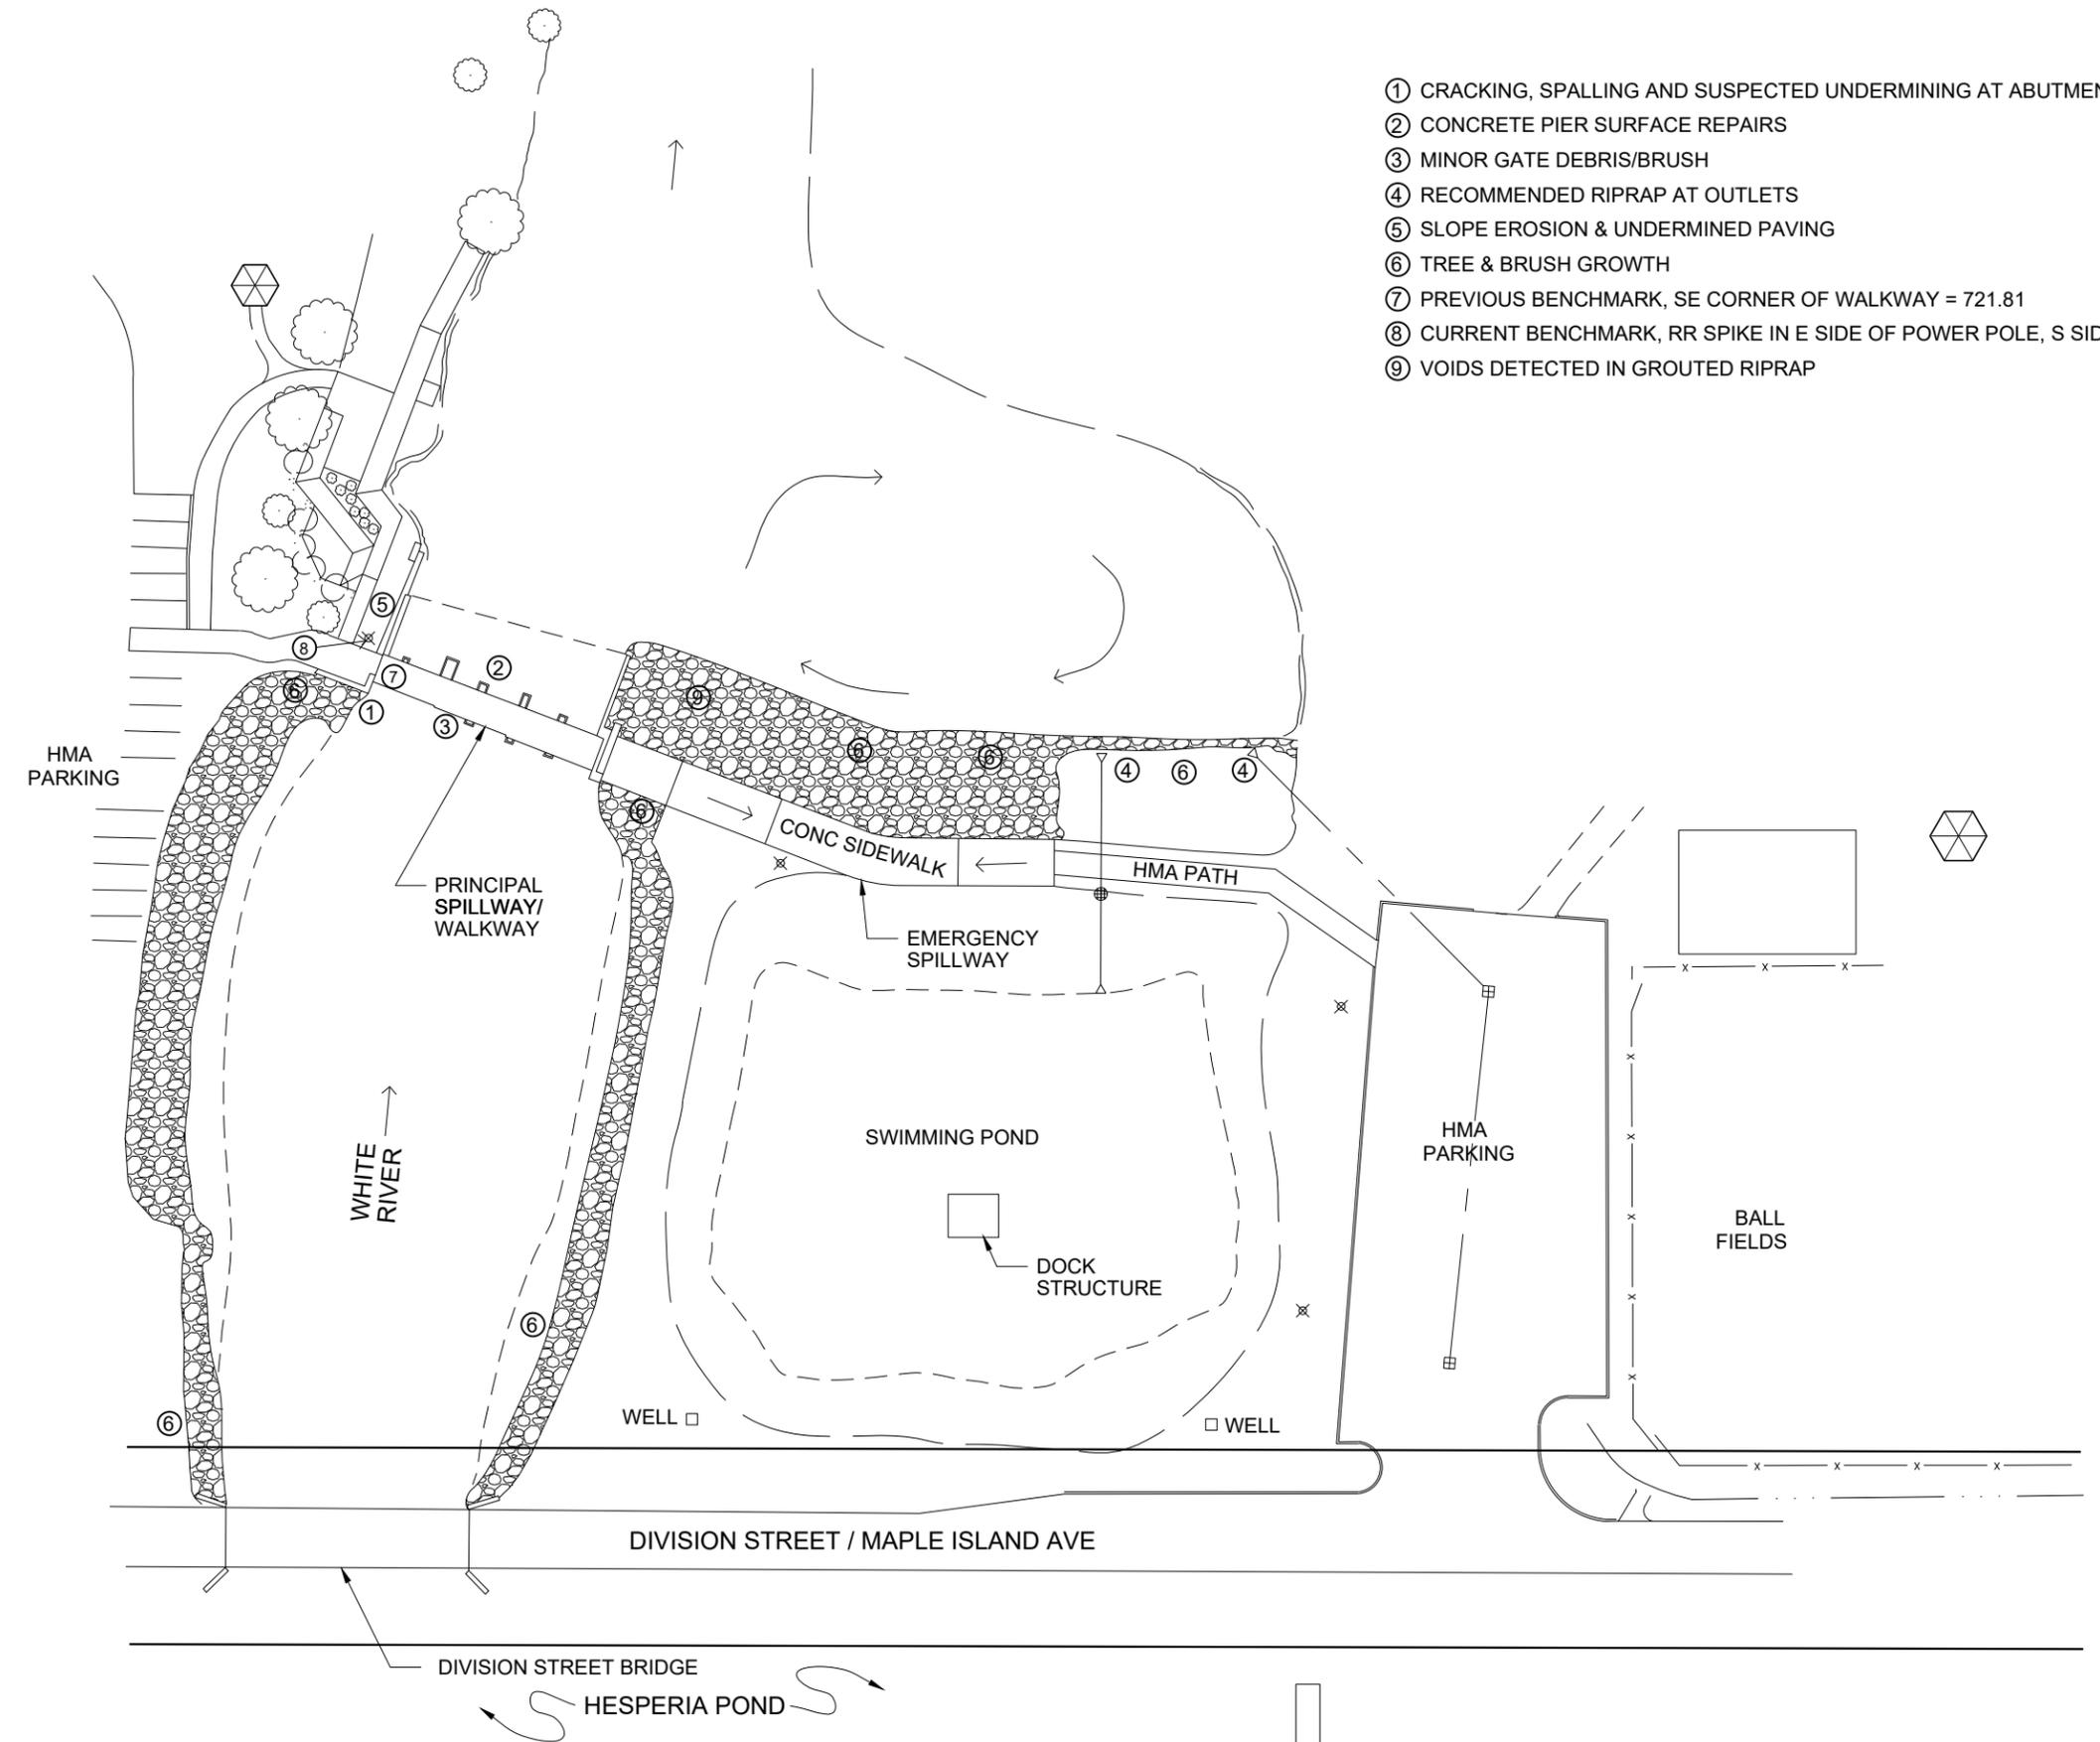
HESPERIA DAM
SCHEMATIC PLAN

- ① CRACKING, SPALLING AND SUSPECTED UNDERMINING AT ABUTMENT
- ② CONCRETE PIER SURFACE REPAIRS
- ③ MINOR GATE DEBRIS/BRUSH
- ④ RECOMMENDED RIPRAP AT OUTLETS
- ⑤ SLOPE EROSION & UNDERMINED PAVING
- ⑥ TREE & BRUSH GROWTH
- ⑦ PREVIOUS BENCHMARK, SE CORNER OF WALKWAY = 721.81
- ⑧ CURRENT BENCHMARK, RR SPIKE IN E SIDE OF POWER POLE, S SIDE OF DAM = 723.96
- ⑨ VOIDS DETECTED IN GROUTED RIPRAP

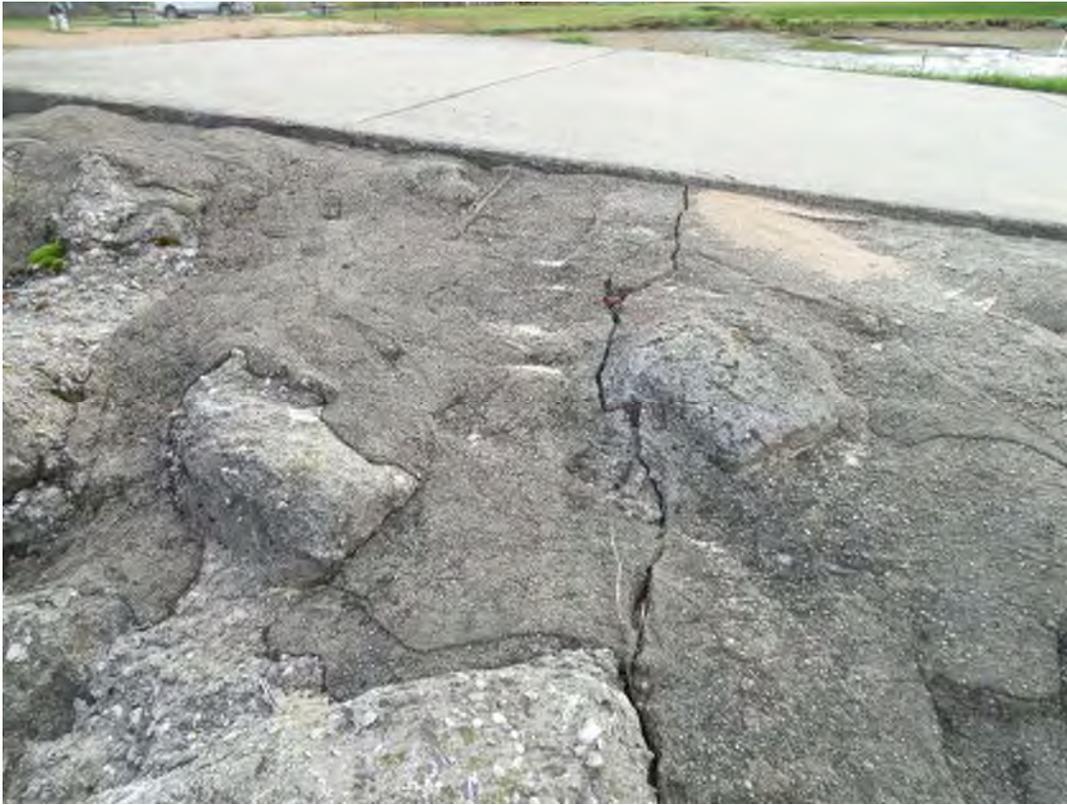
Cracking in grouted concrete on downstream slope of emergency spillway

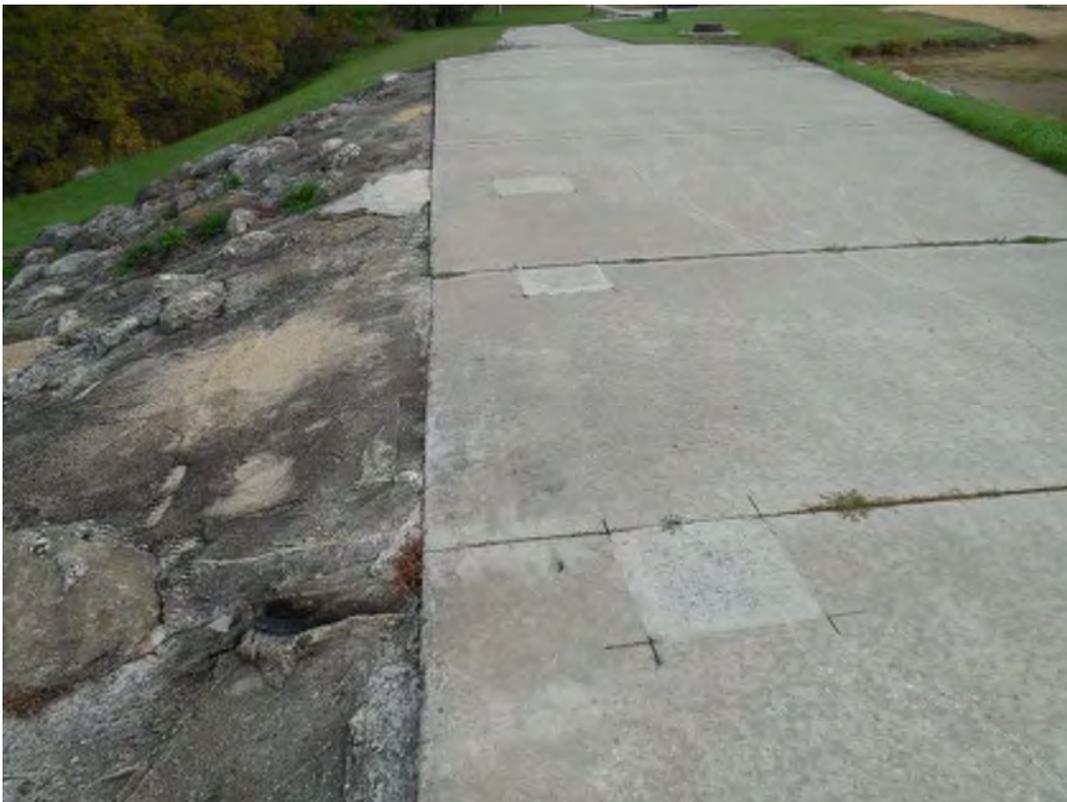
Cracking in grouted concrete on downstream slope of emergency spillway

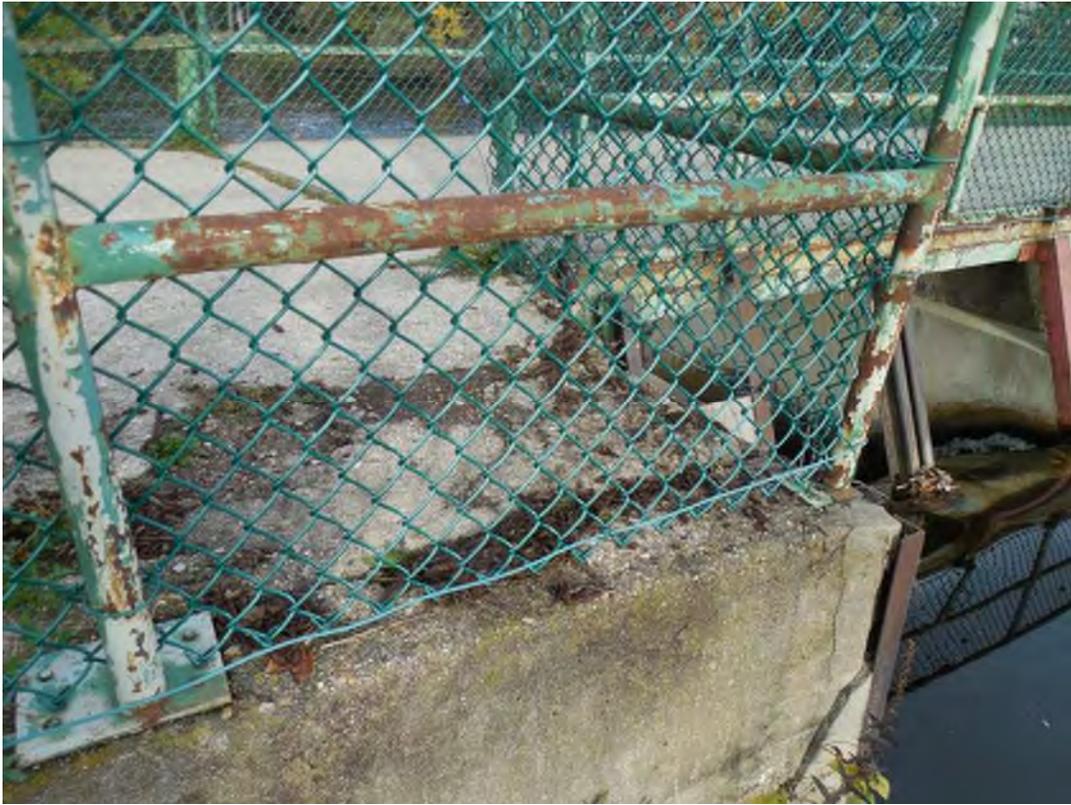
Cracking and delamination on southeast abutment

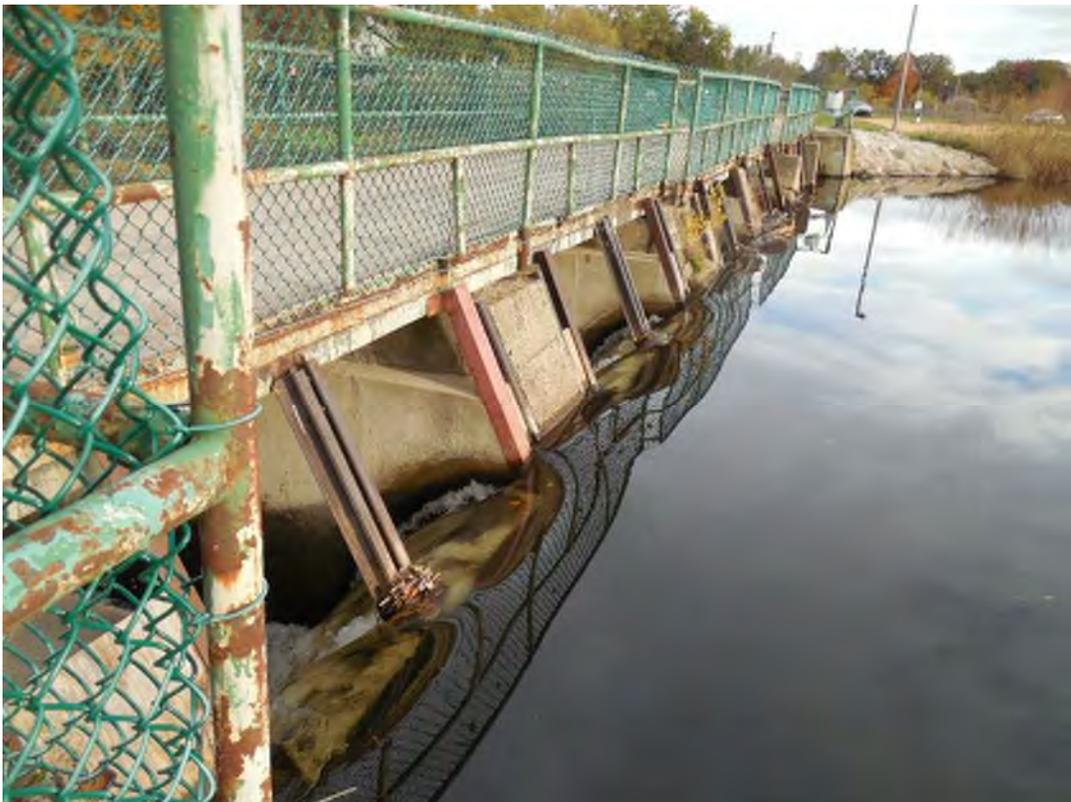
Deterioration of southeast abutment area

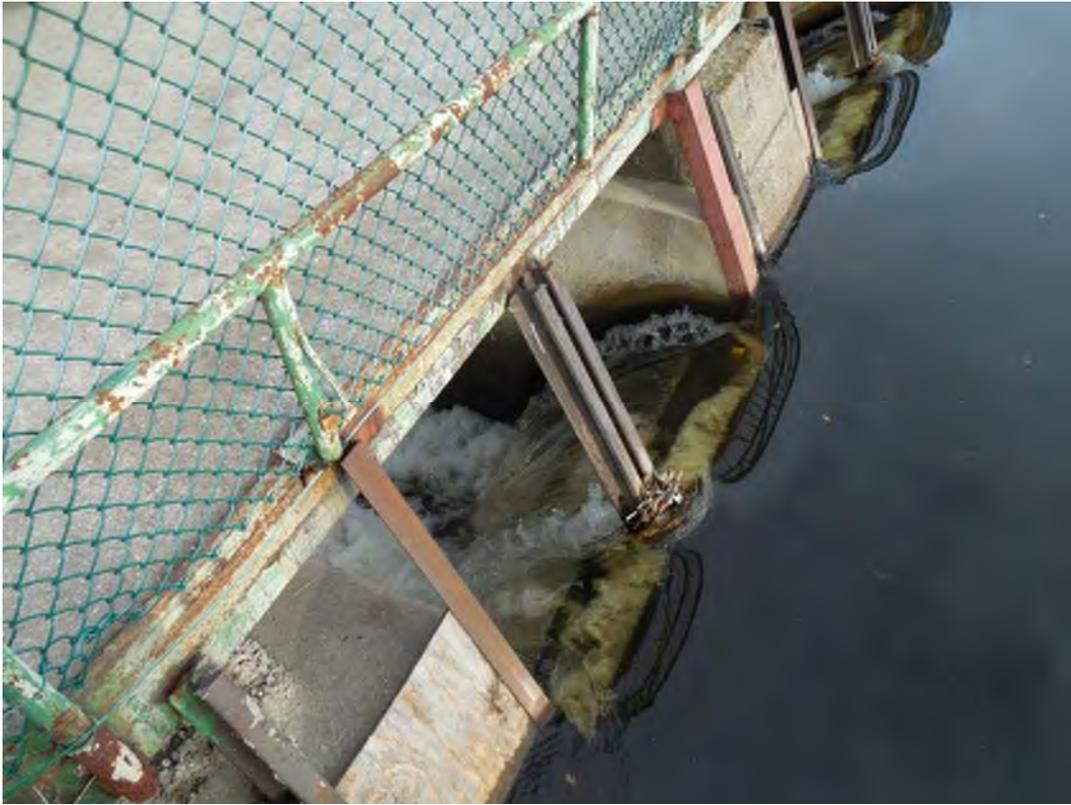
Deterioration of southeast abutment area

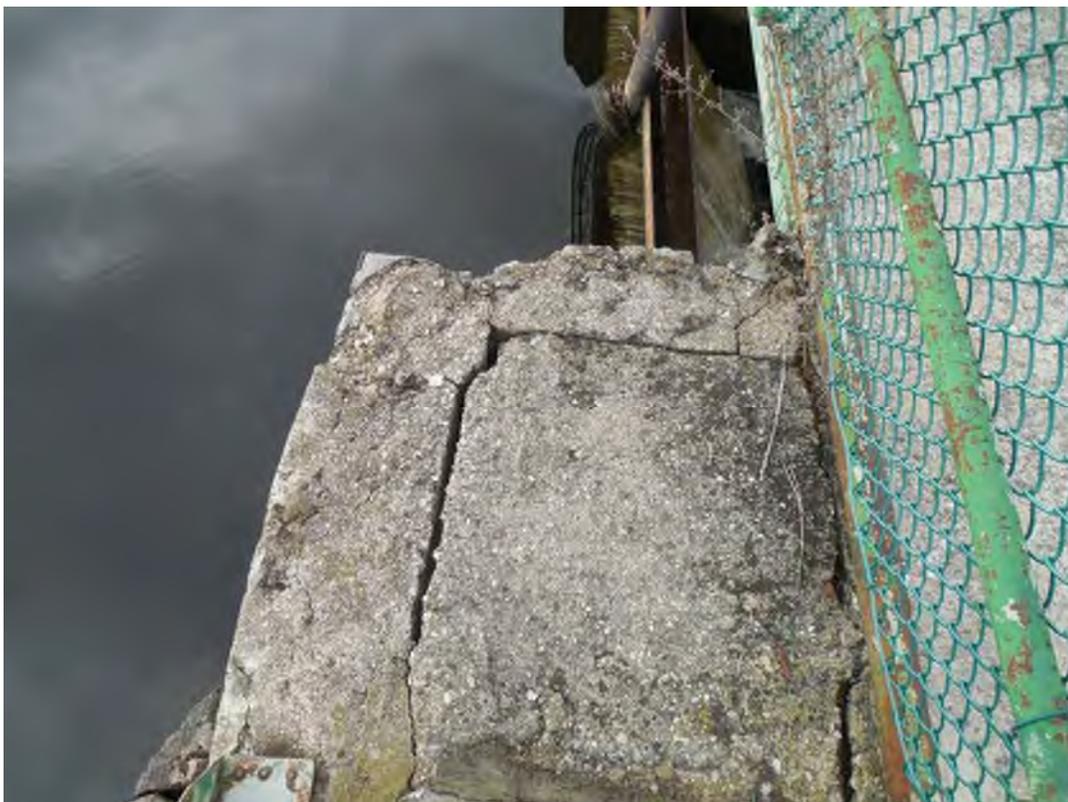
Deterioration of northeast abutment area

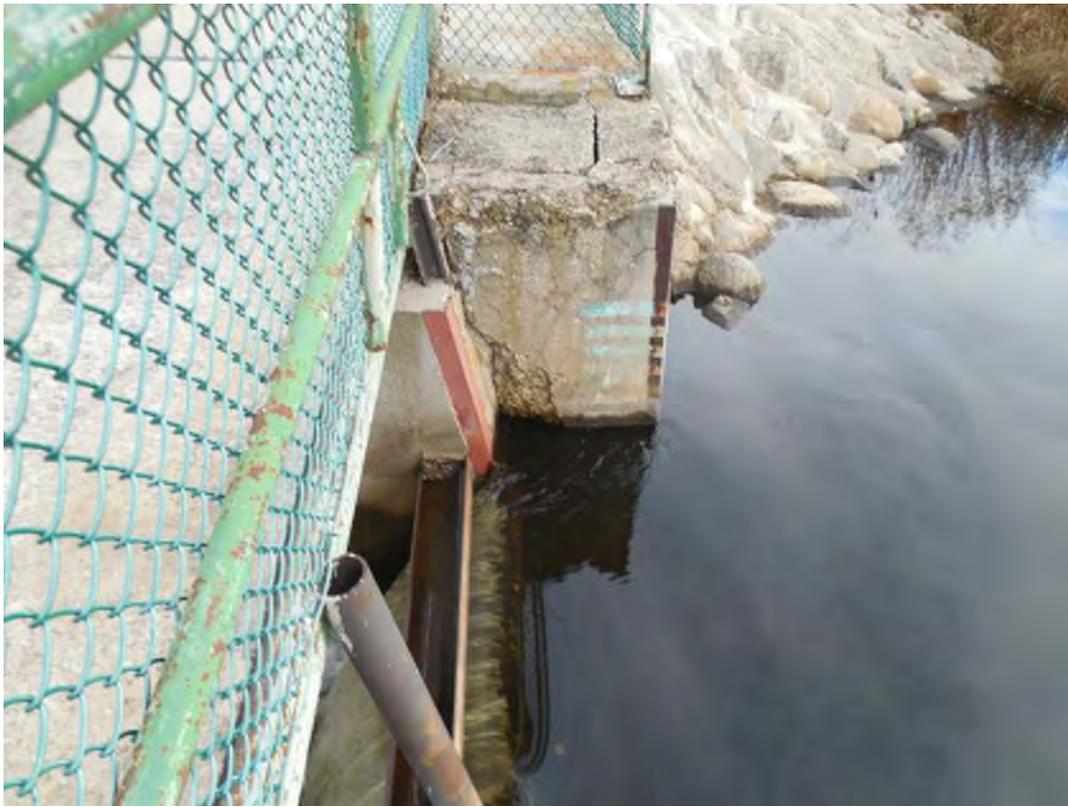
Deterioration of northeast abutment area

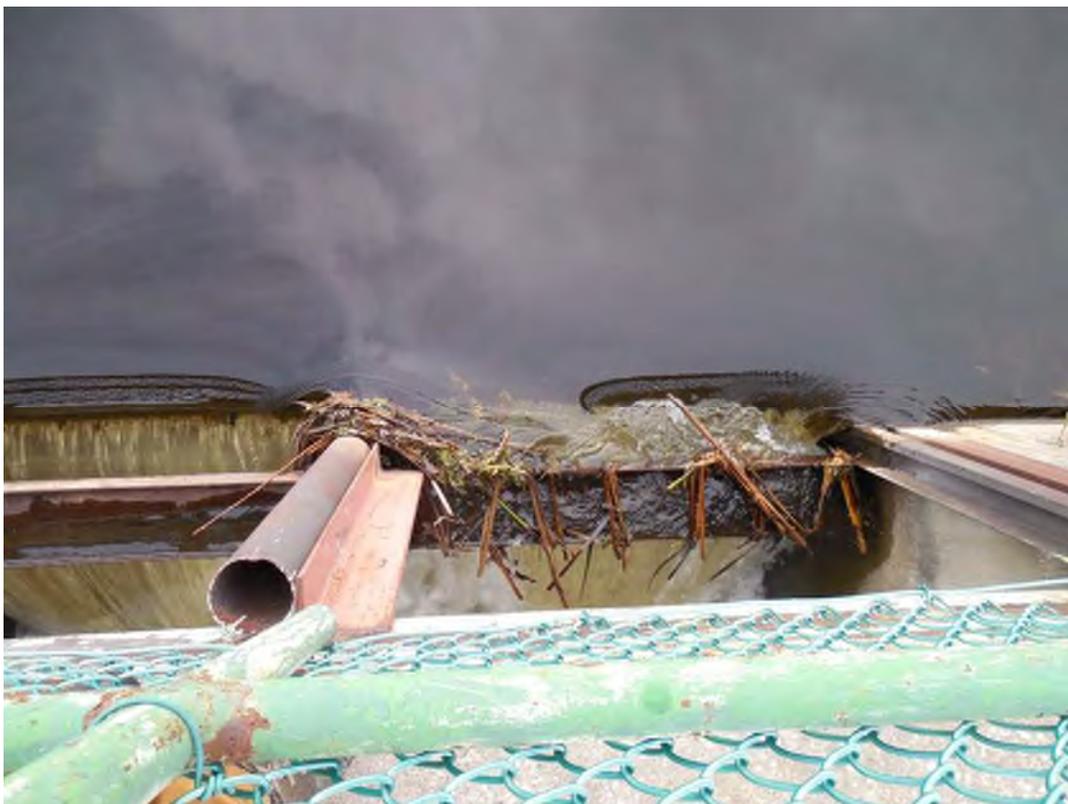
Deterioration of northeast abutment area looking north

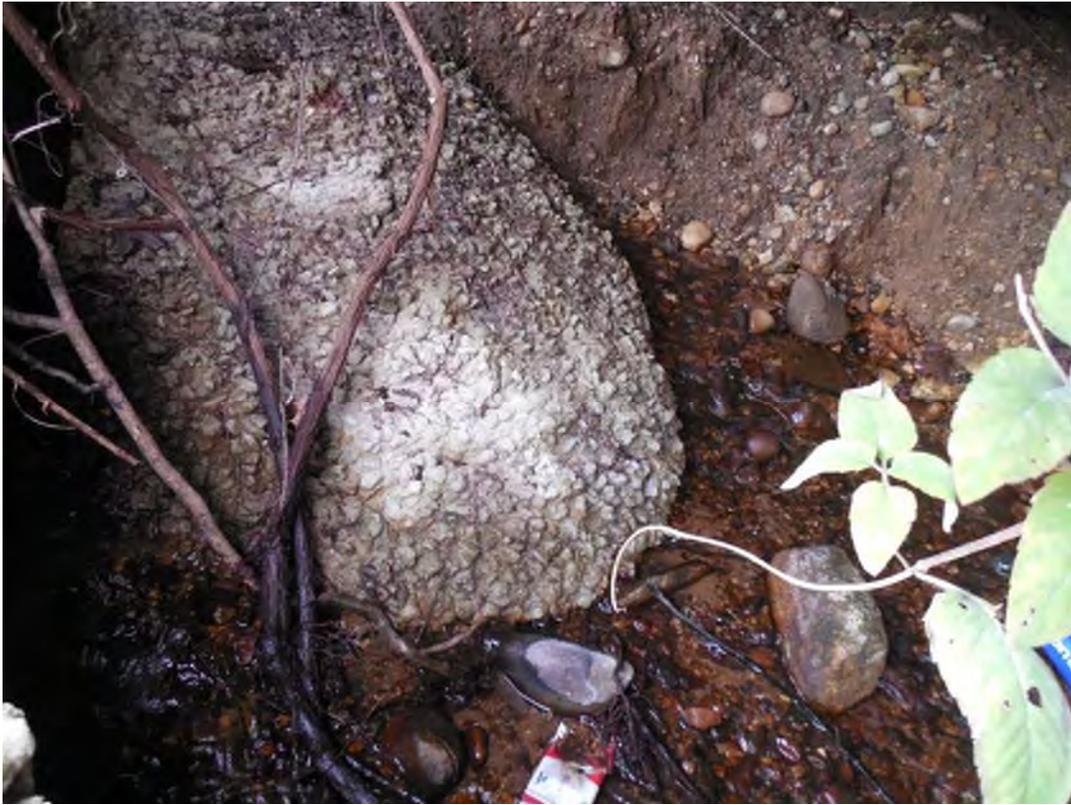
Eroding slope and exposed roots beneath boardwalk structure along concrete slope paving

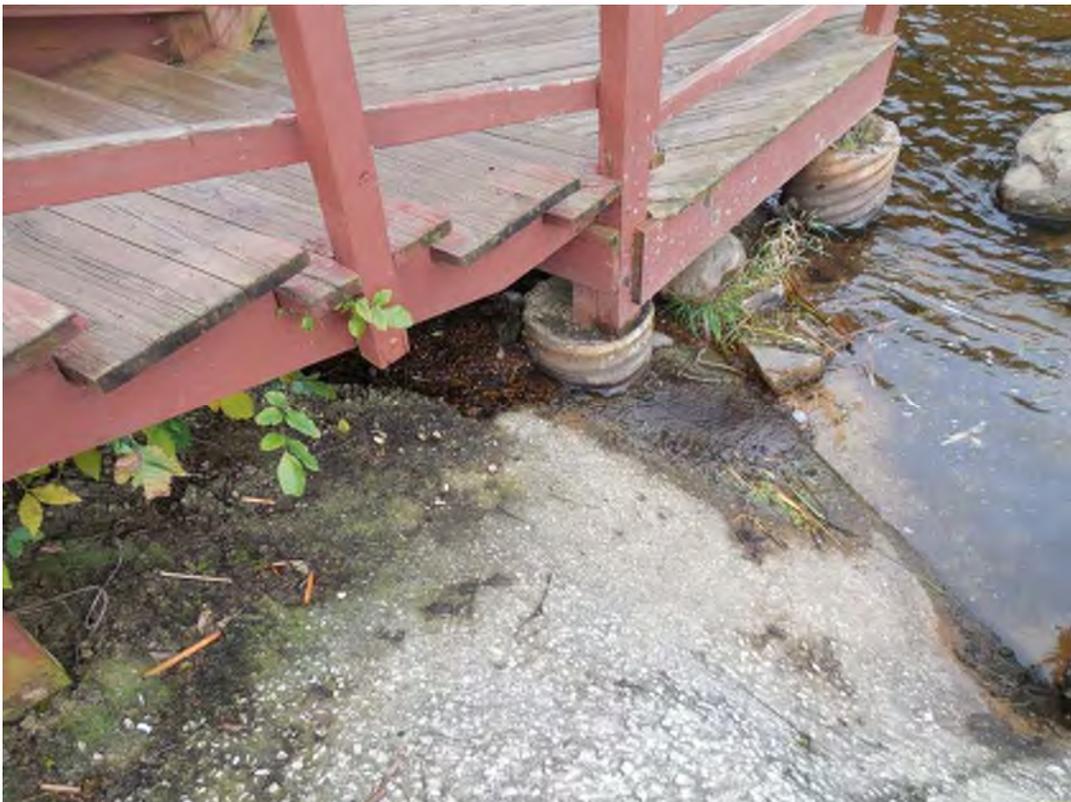
Section of concrete slope paving settled from erosion and flow of seepage/leakage water

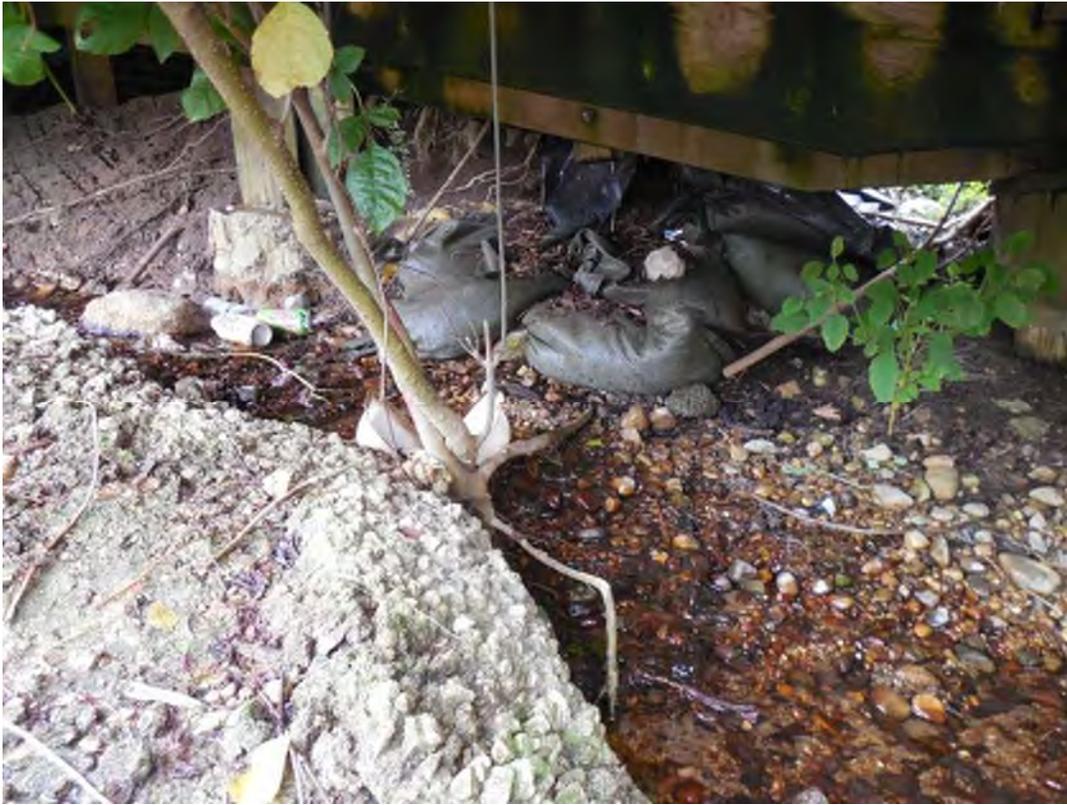
Flow of seepage/leakage water through left berm re-entering downstream channel

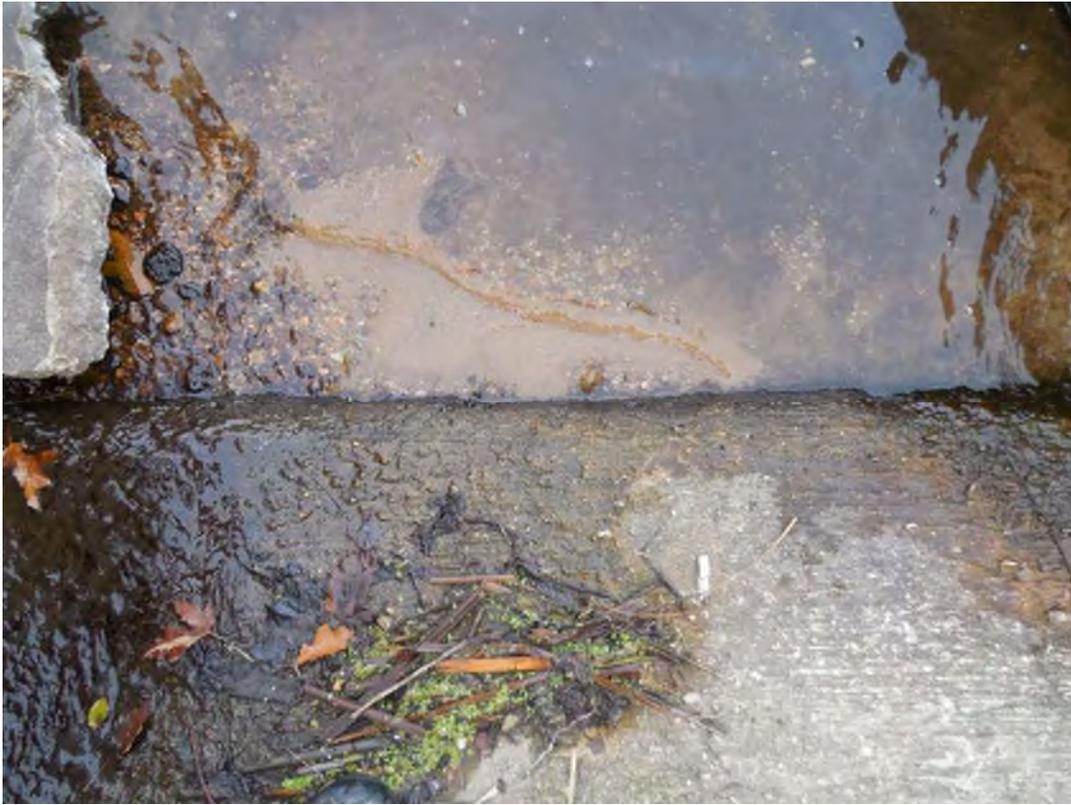
Cracking in concrete repairs on piers

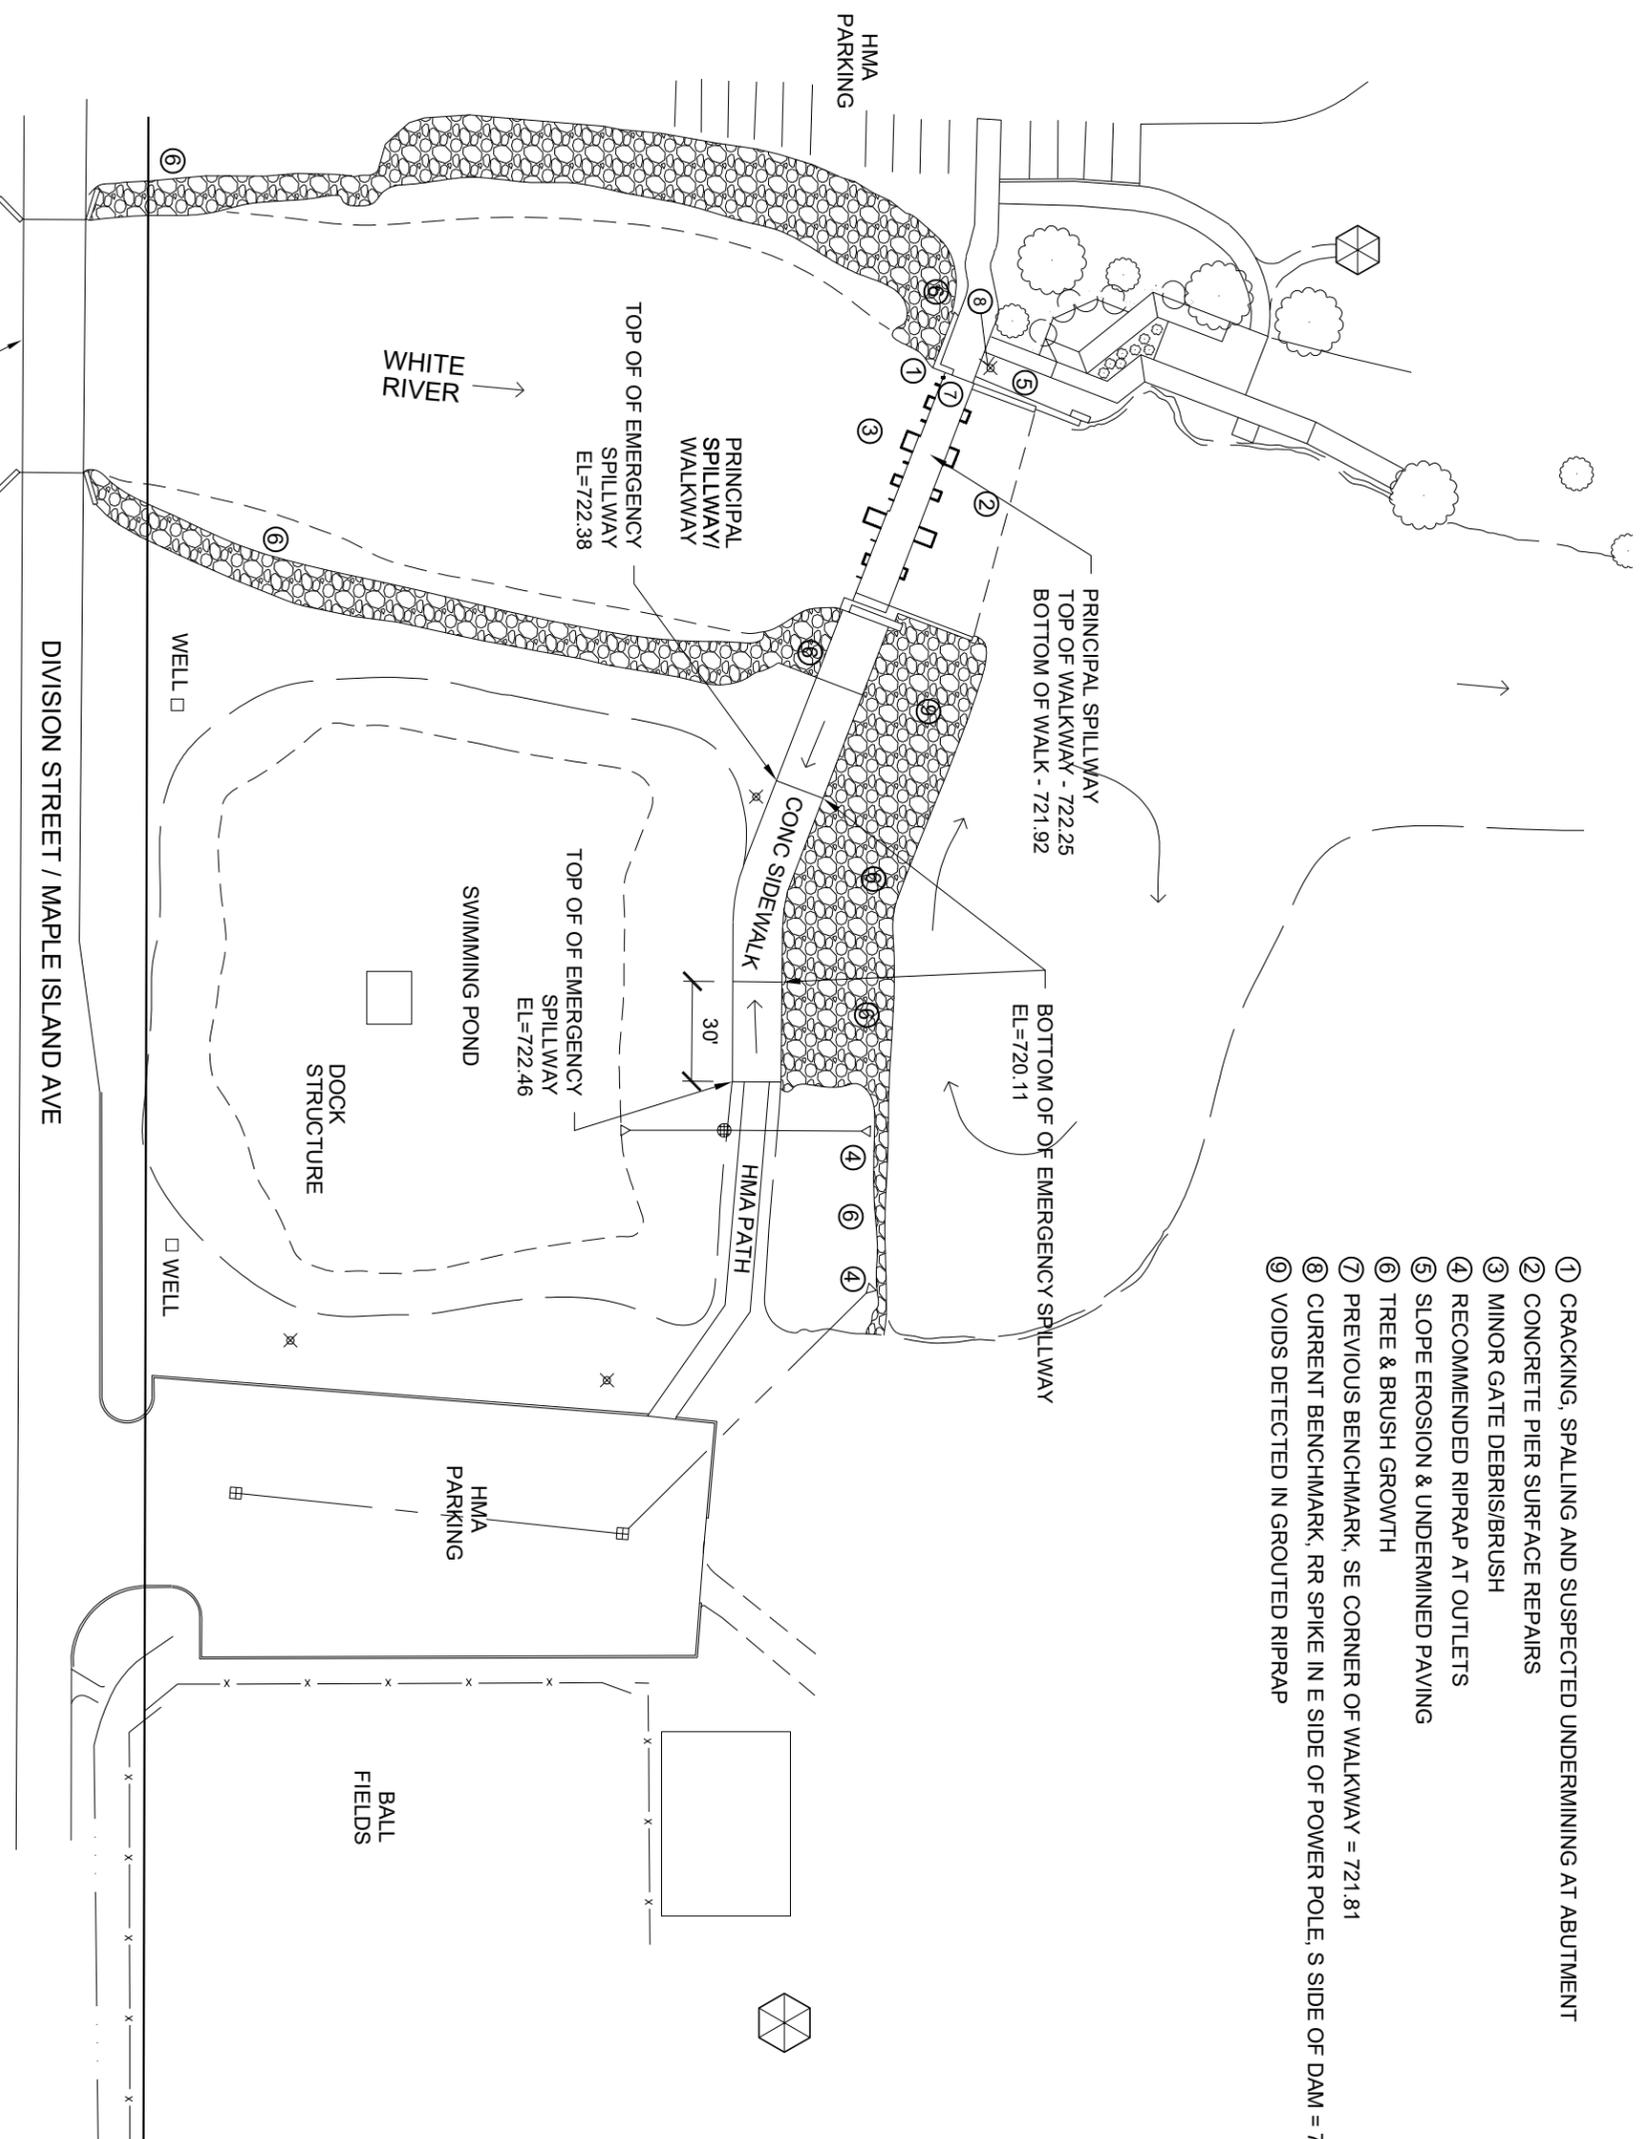
- ① CRACKING, SPALLING AND SUSPECTED UNDERMINING AT ABUTMENT
- ② CONCRETE PIER SURFACE REPAIRS
- ③ MINOR GATE DEBRIS/BRUSH
- ④ RECOMMENDED RIPRAP AT OUTLETS
- ⑤ SLOPE EROSION & UNDERMINED PAVING
- ⑥ TREE & BRUSH GROWTH
- ⑦ PREVIOUS BENCHMARK, SE CORNER OF WALKWAY = 721.81
- ⑧ CURRENT BENCHMARK, RR SPIKE IN E SIDE OF POWER POLE, S SIDE OF DAM = 723.96
- ⑨ VOIDS DETECTED IN GROUTED RIPRAP
