Rehabilitation Alternatives Analysis - DRAFT

Hesperia Dam

Oceana County, Michigan
Dam I.D. No. 678

June 16, 2025
Project No. 2403886

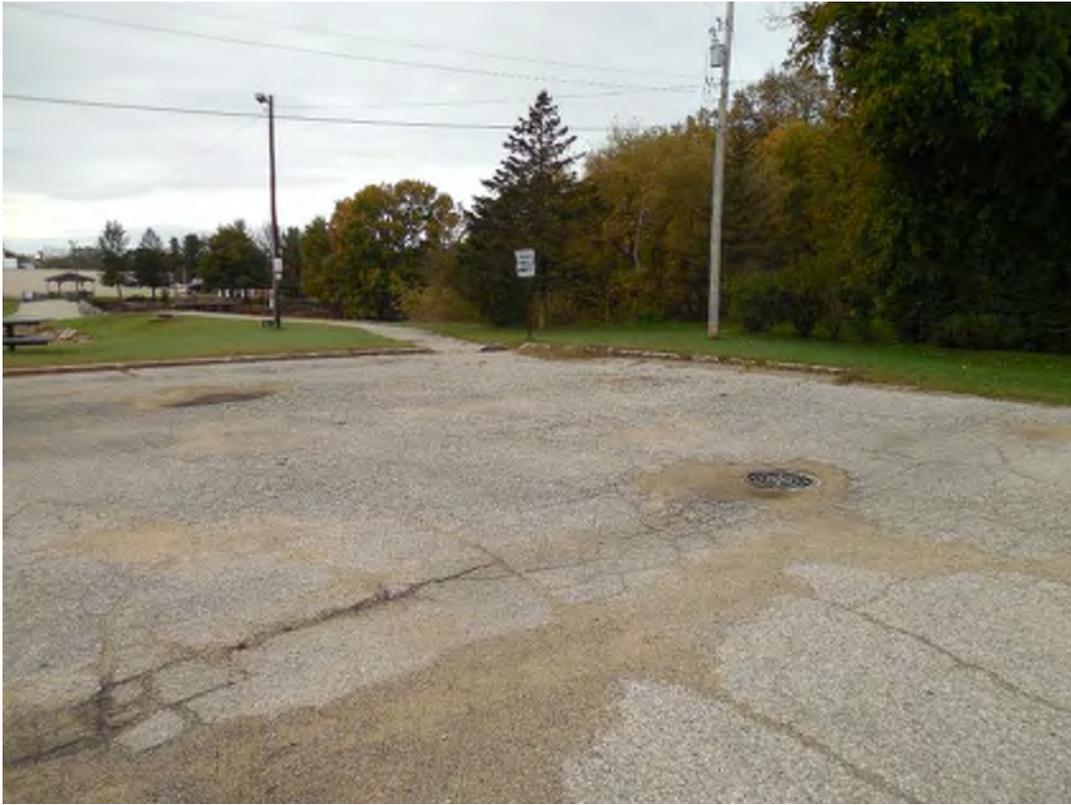
View of parking lot catch basin at end of right berm

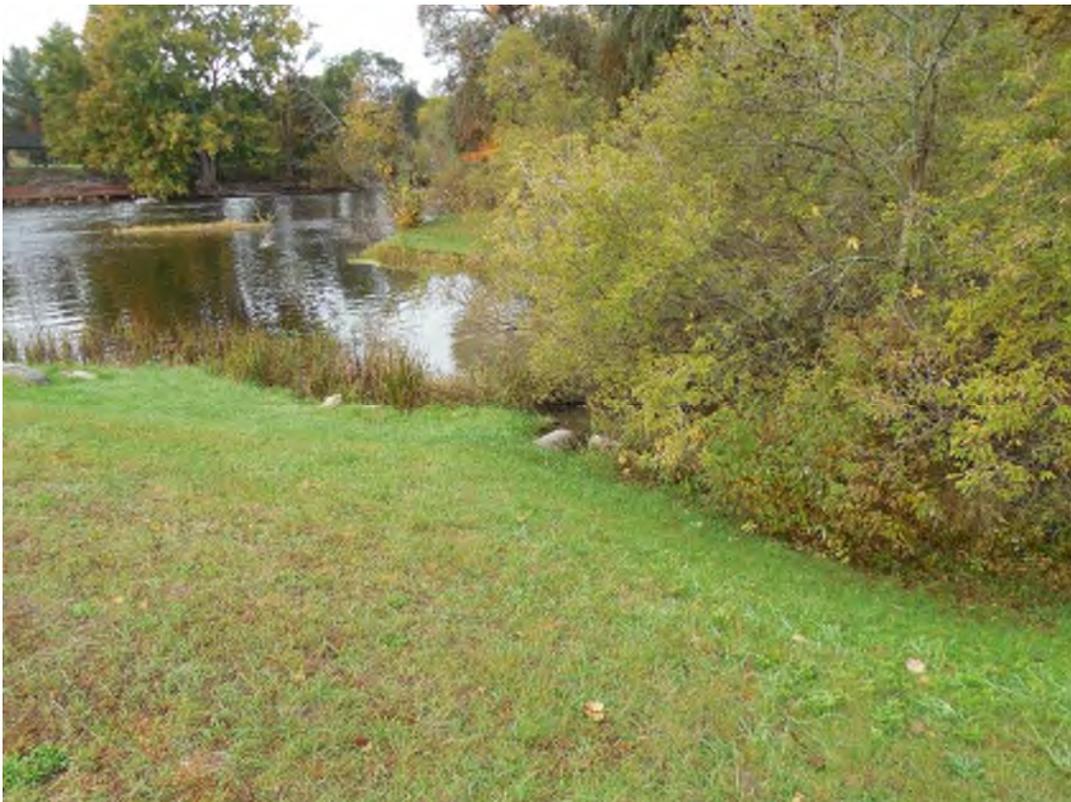
Minor scouring in the downstream berm slope was noted at the outlets from the swimming pond and parking lot storm sewer. The area of the upstream slope below the normal water level of the swimming pond has been reinforced with riprap.

View of downstream right berm at swimming pond outlet pipe looking west

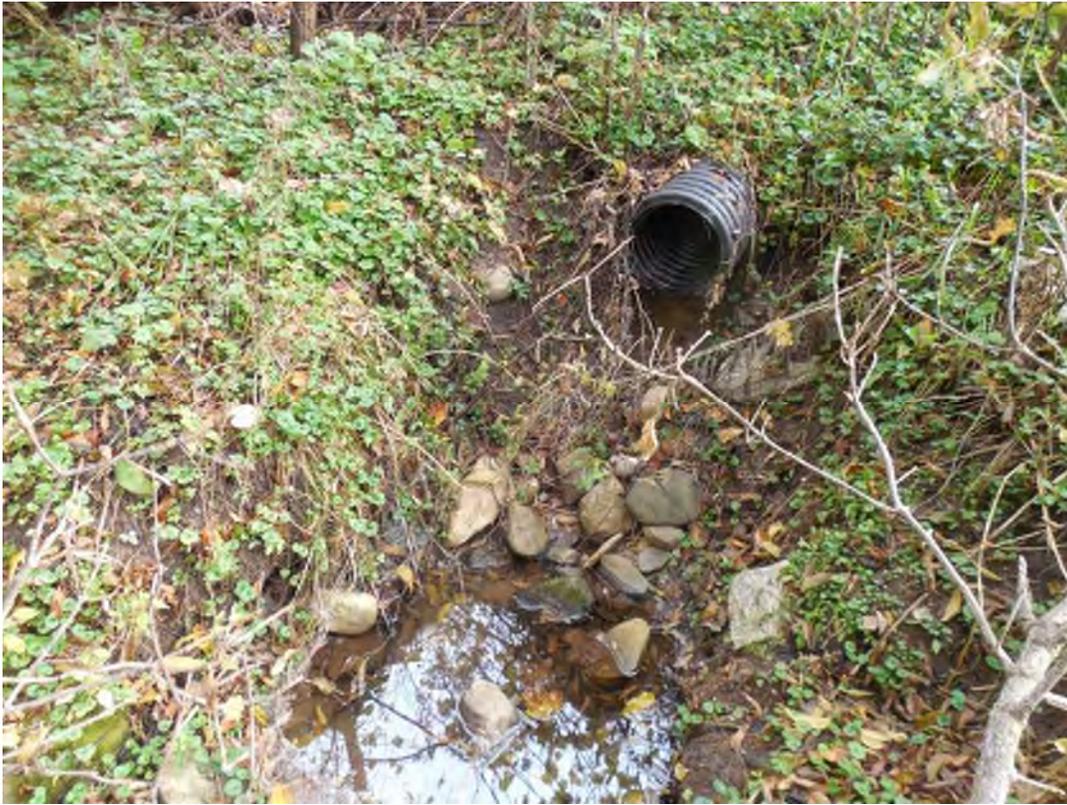
Erosion around end of catch basin outlet pipe

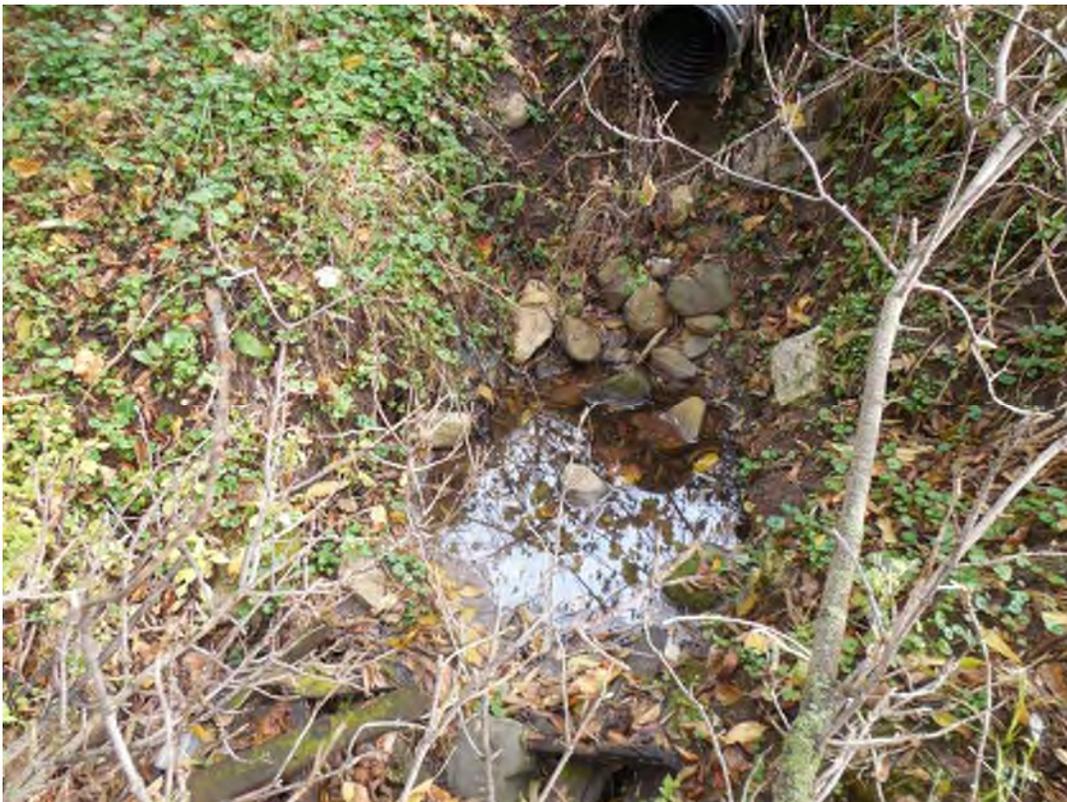
Erosion around end of catch basin outlet pipe

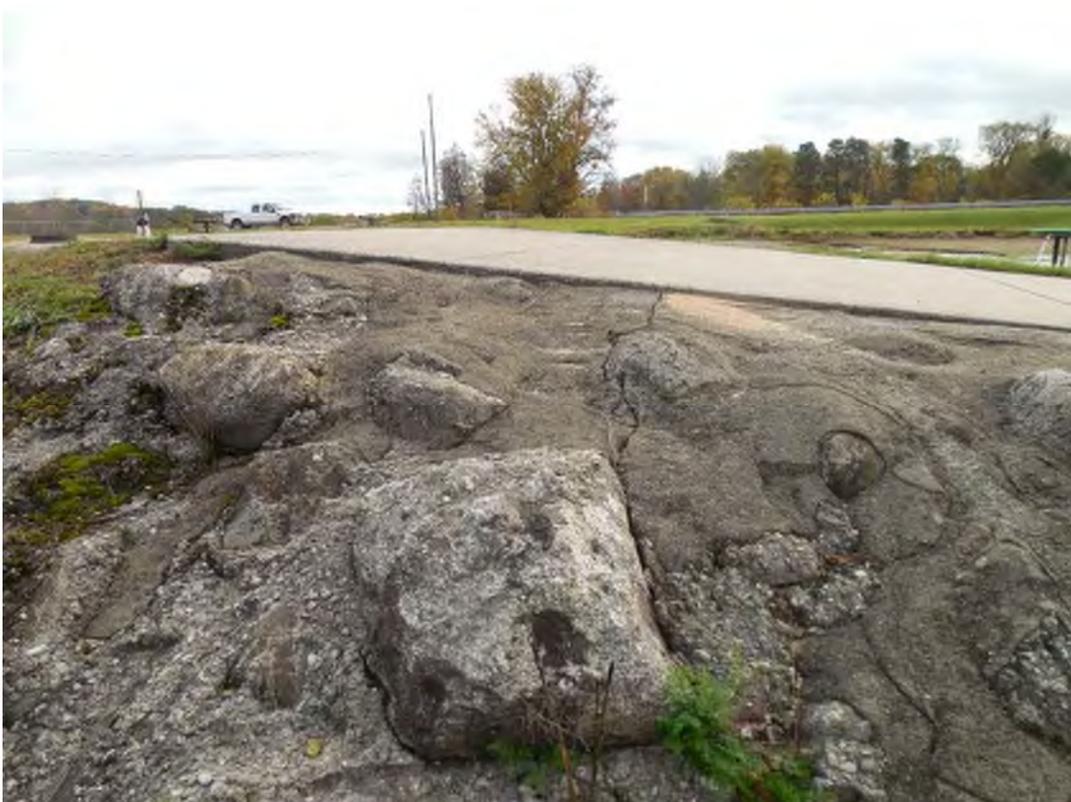
Cracking in grouted concrete on downstream slope of emergency spillway

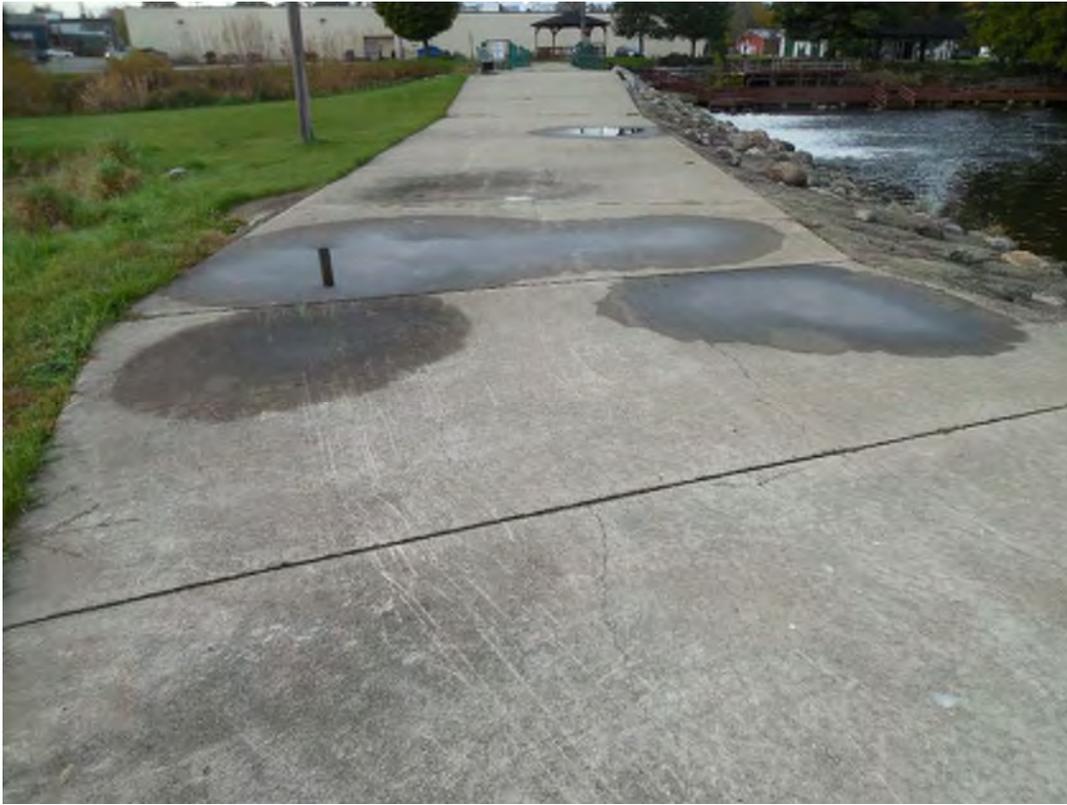
Ponding on emergency spillway sidewalk, looking south

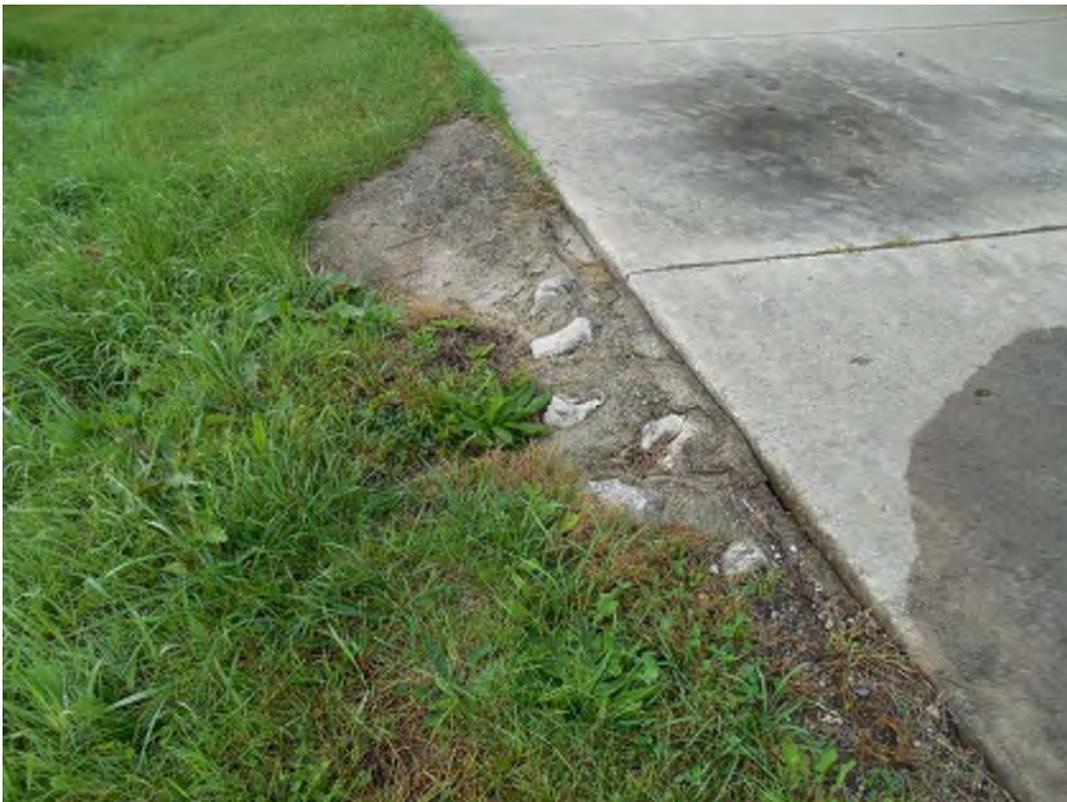
Settlement of grouted riprap on upstream side of emergency spillway sidewalk

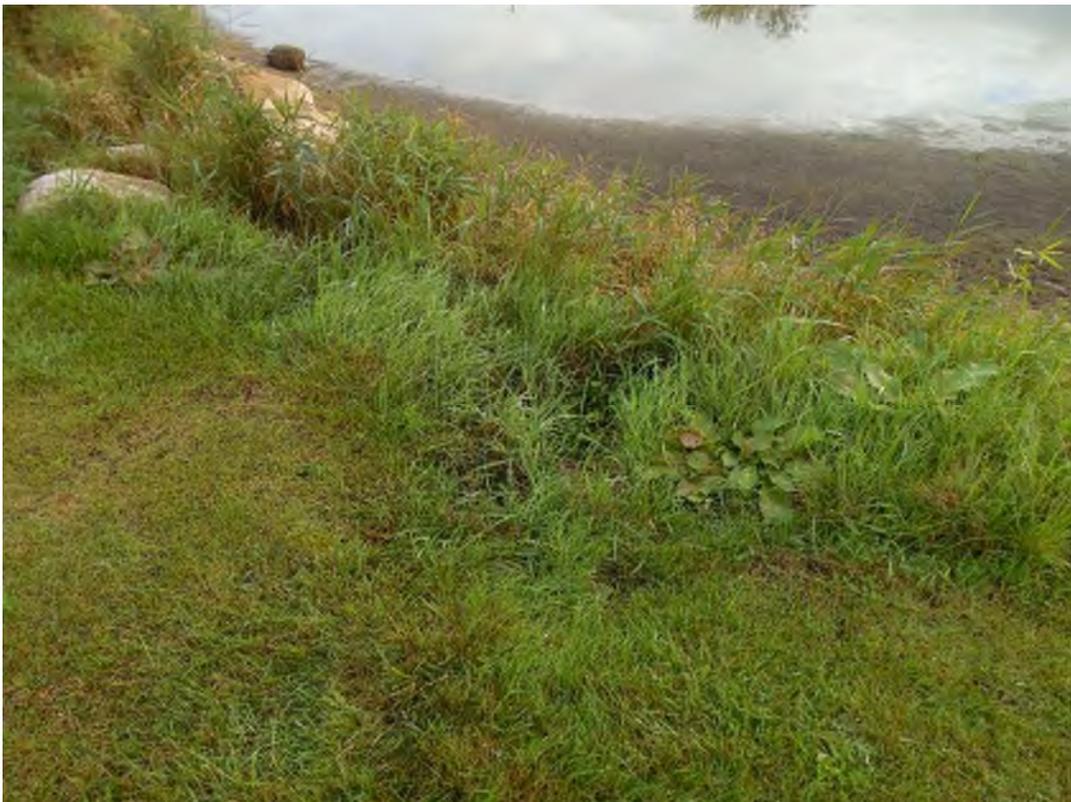
Minor bank erosion in southwest corner of swimming pond

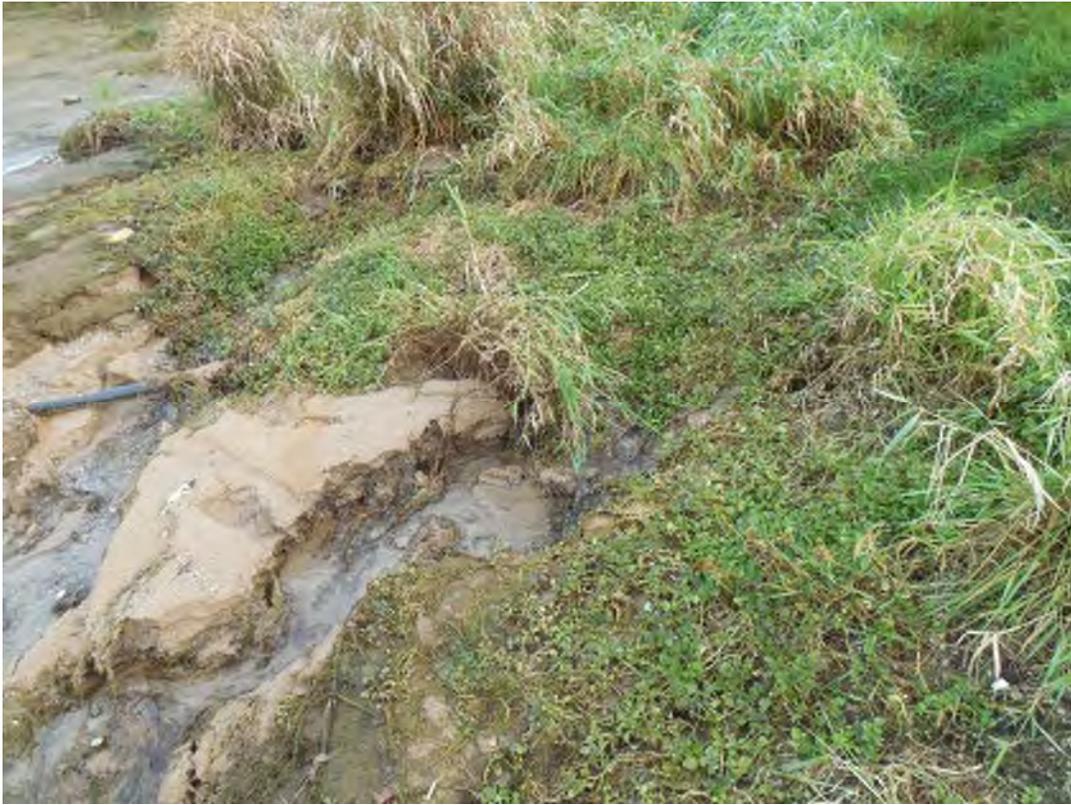
Bank erosion at artesian well structure in northeast corner of swimming pond

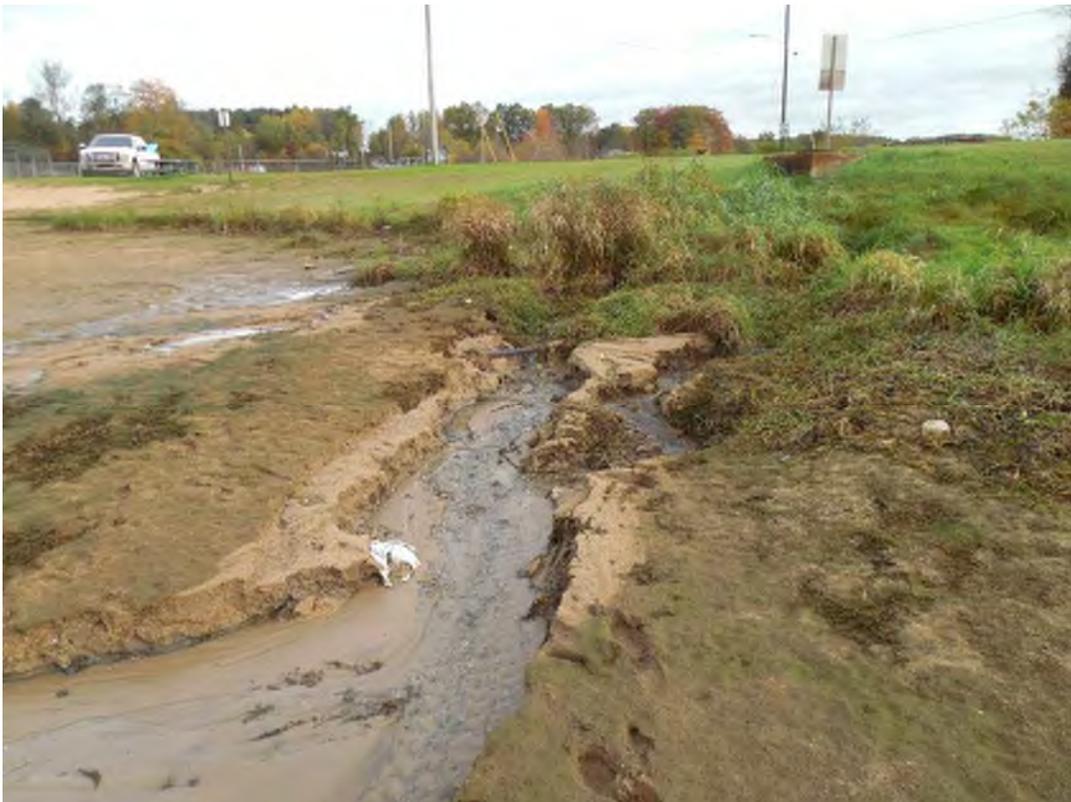
Bank erosion at artesian well structure in northeast corner of swimming pond

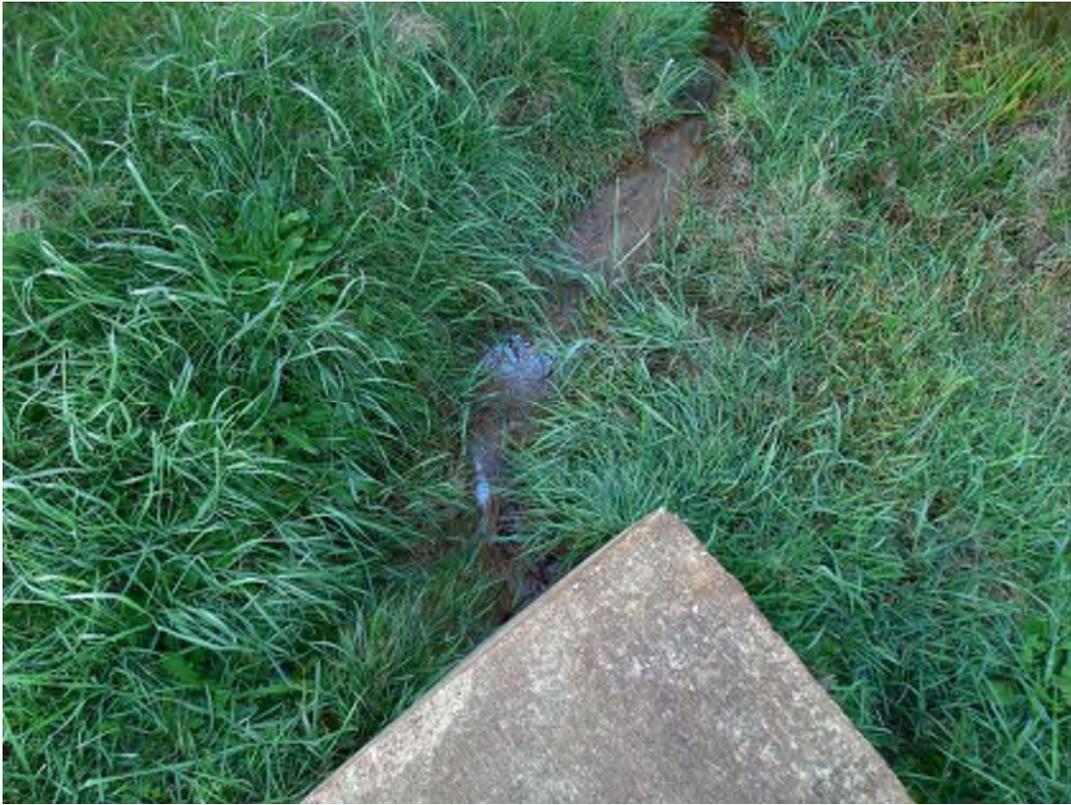
Bank erosion at artesian well structure in northeast corner of swimming pond

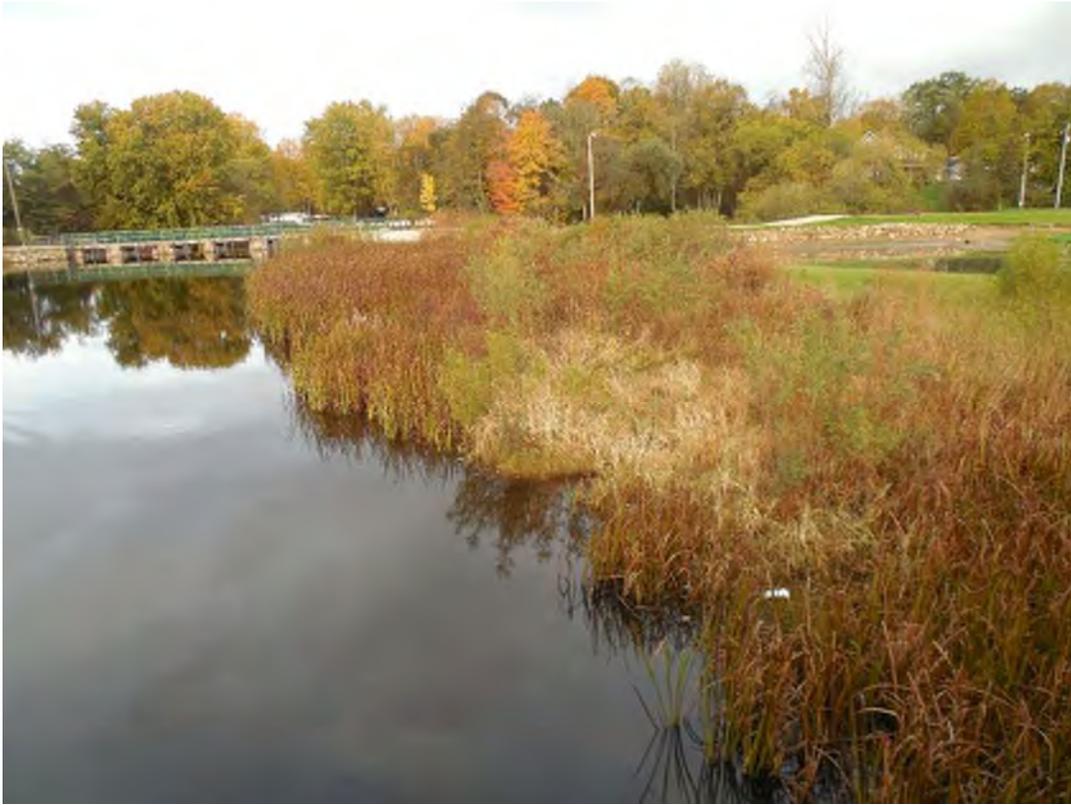
Brush growth along upstream right bank of White River

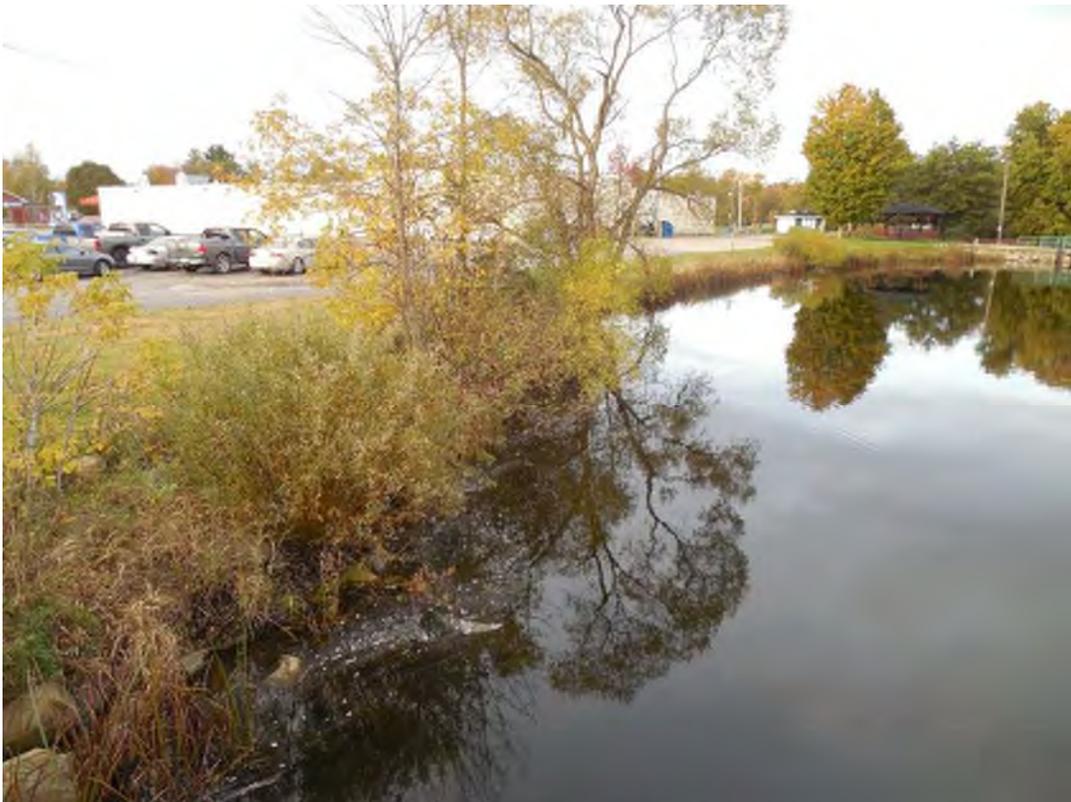
Tree and brush growth along upstream left bank of White River

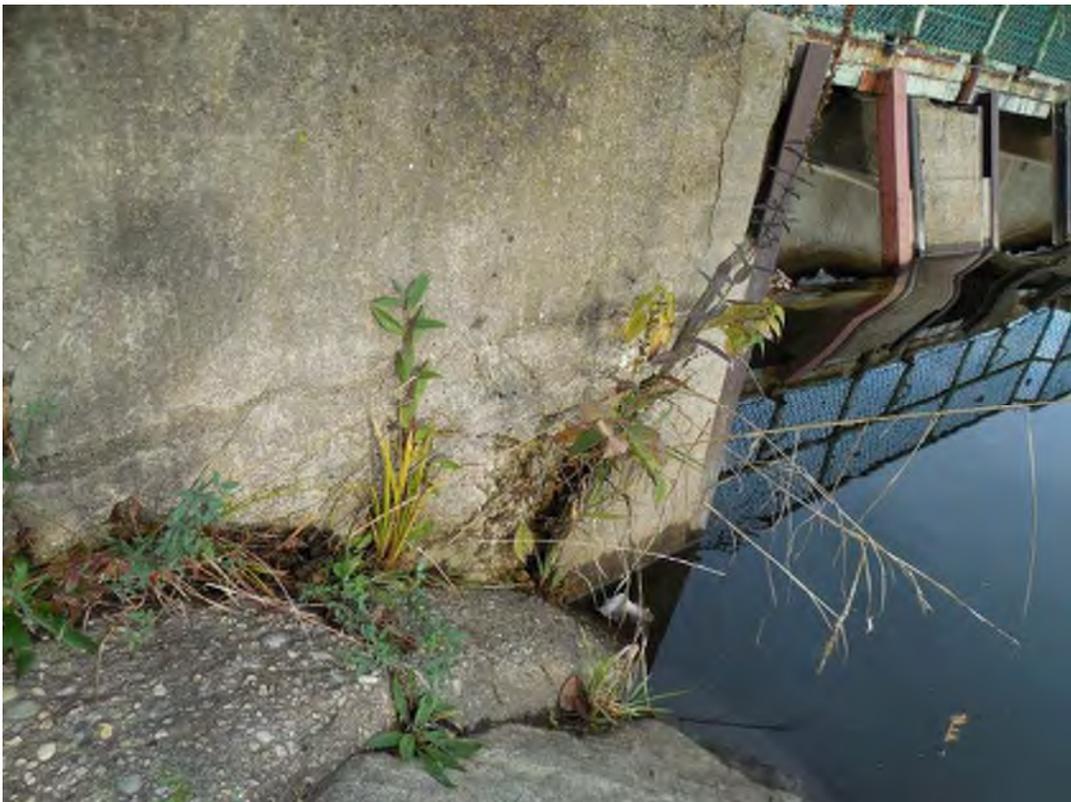
The deterioration of the southeastern corner section of the south abutment is approximately 3 feet high by 2 feet long with a spall depth of about 8 to 12 inches. The foundation under this section is suspected to have some minor scour and undermining that should be inspected in the dry condition. The steel decking supporting the walkway shows moderate surface corrosion of approximately 75% of the bottom surface. There are a number of areas of concrete surface weathering, cracking and minor spalling throughout the principal spillway structure, which are felt to be consistent with a structure of this age and construction. The steel rails and stop log supports show surface corrosion and section loss was minor in several areas.

Cracking and delamination on southeast abutment

Another stability concern for the structure is the suspected undermining and scour under the abutment and principal spillway. A “dry” (to the extent practical) inspection performed by a professional engineer is highly recommended to determine the severity and amount of loss of the foundation material.

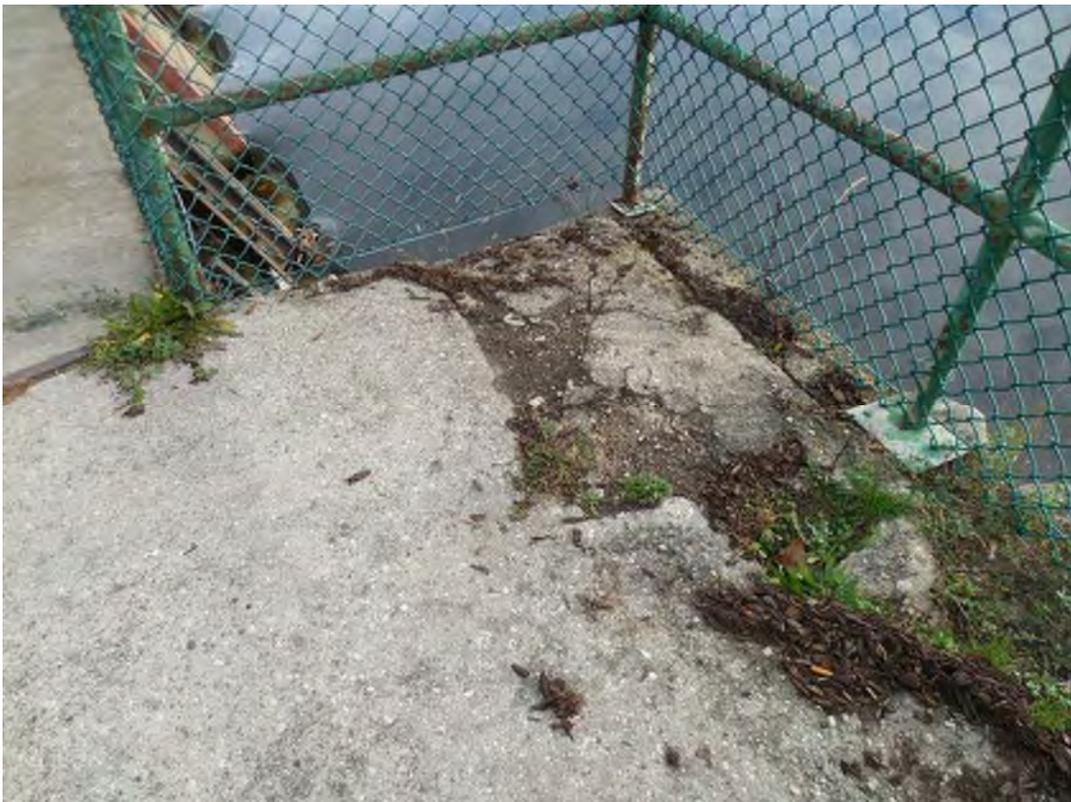
Deterioration of southeast abutment area

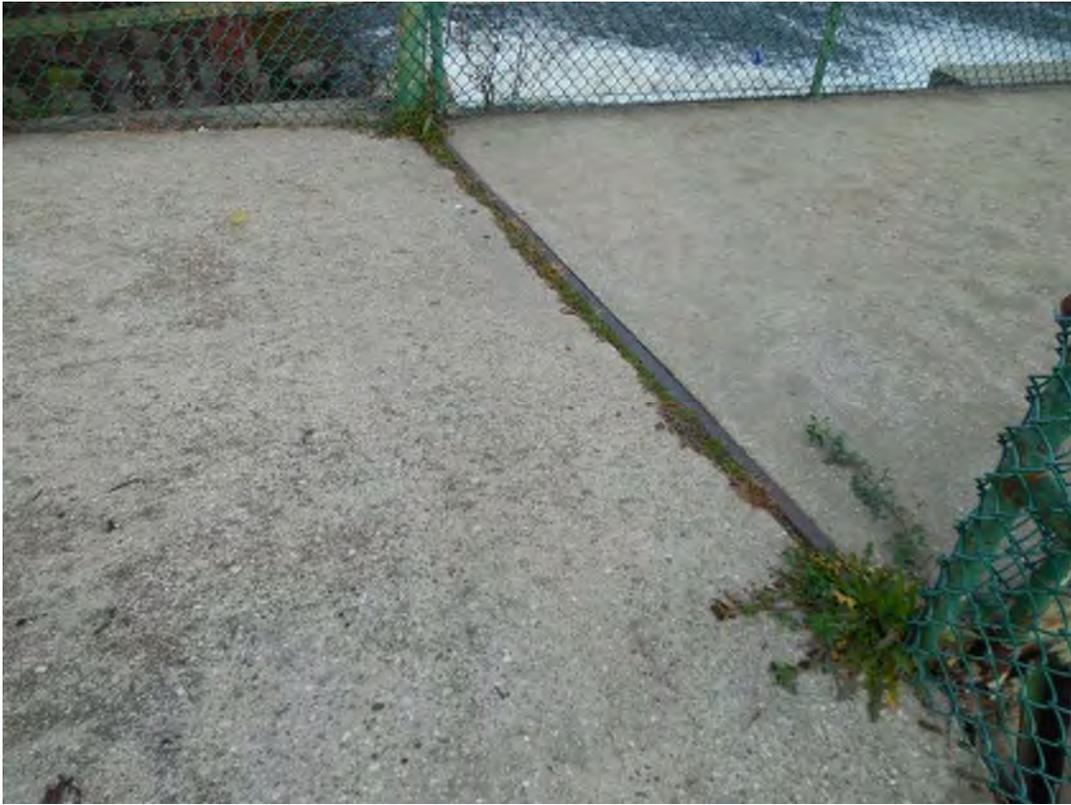
Vegetation growth in joint at end of walkway

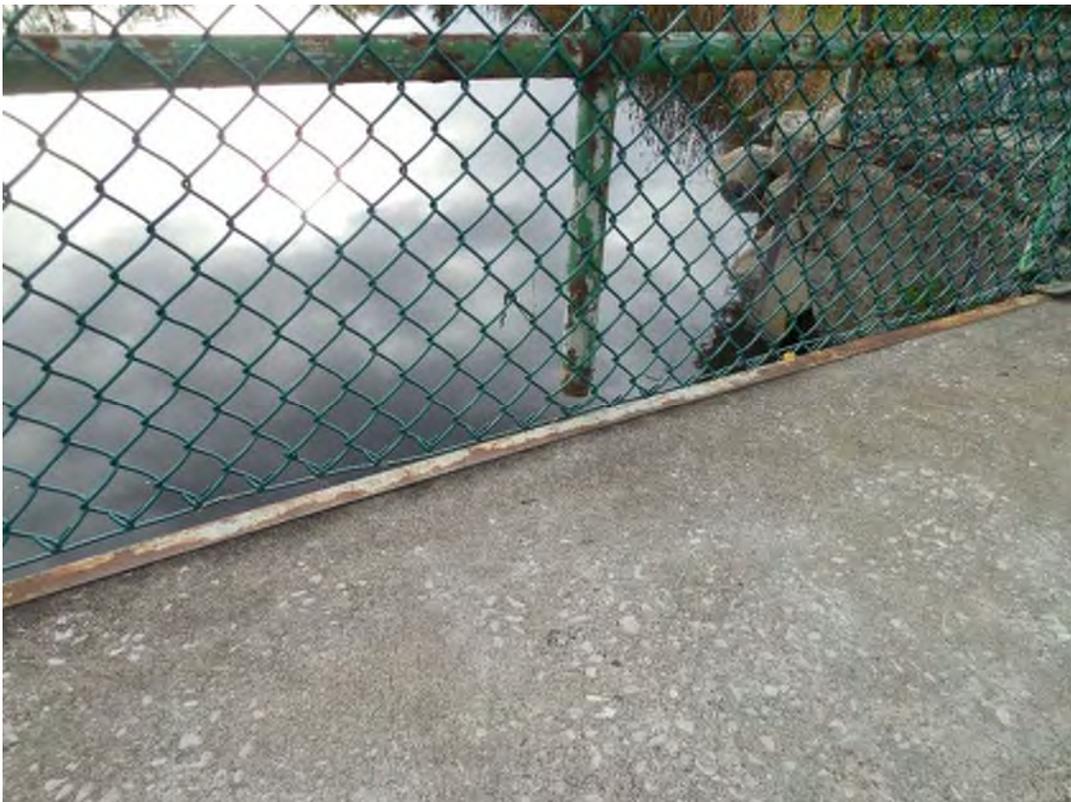
Chain link fence post not connected to walkway

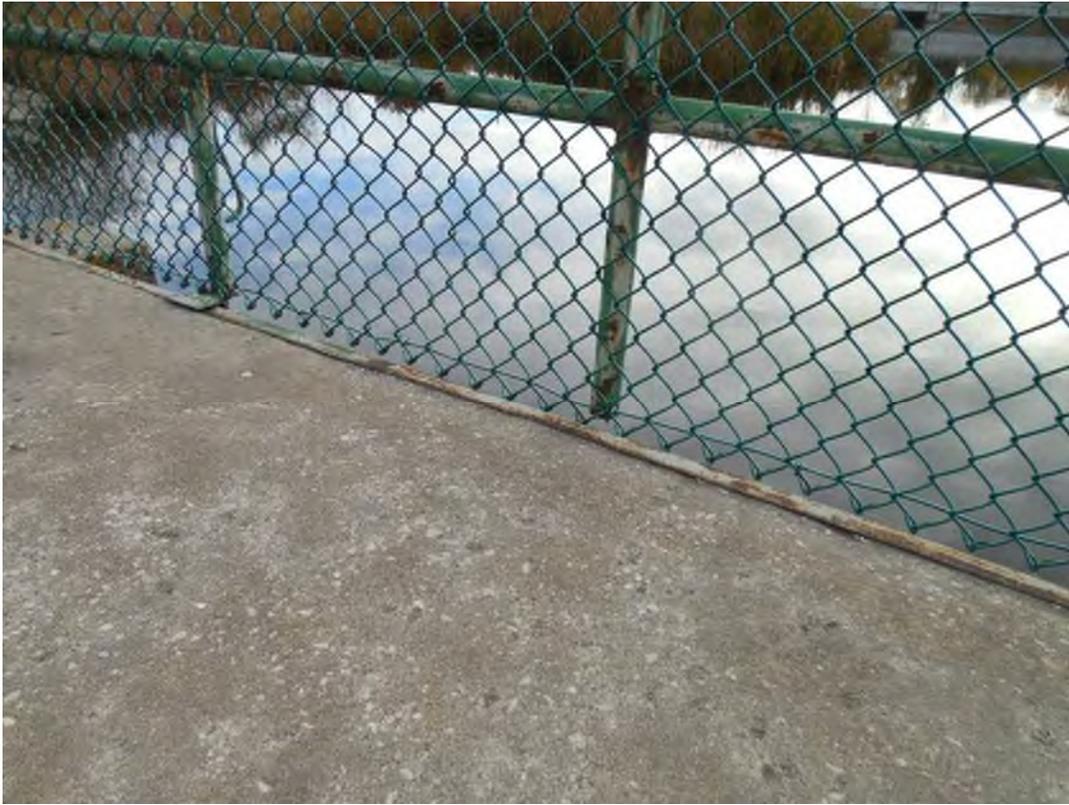
Chain link fence post not connected to walkway

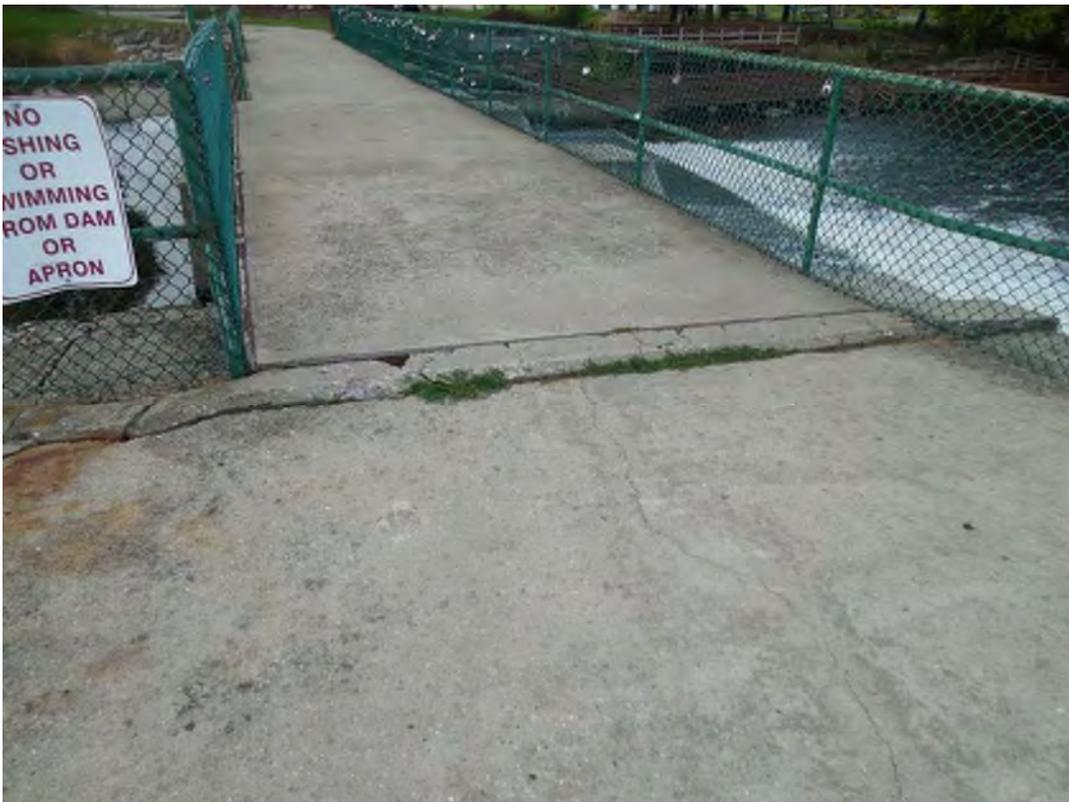
Settlement of north approach sidewalk along north abutment

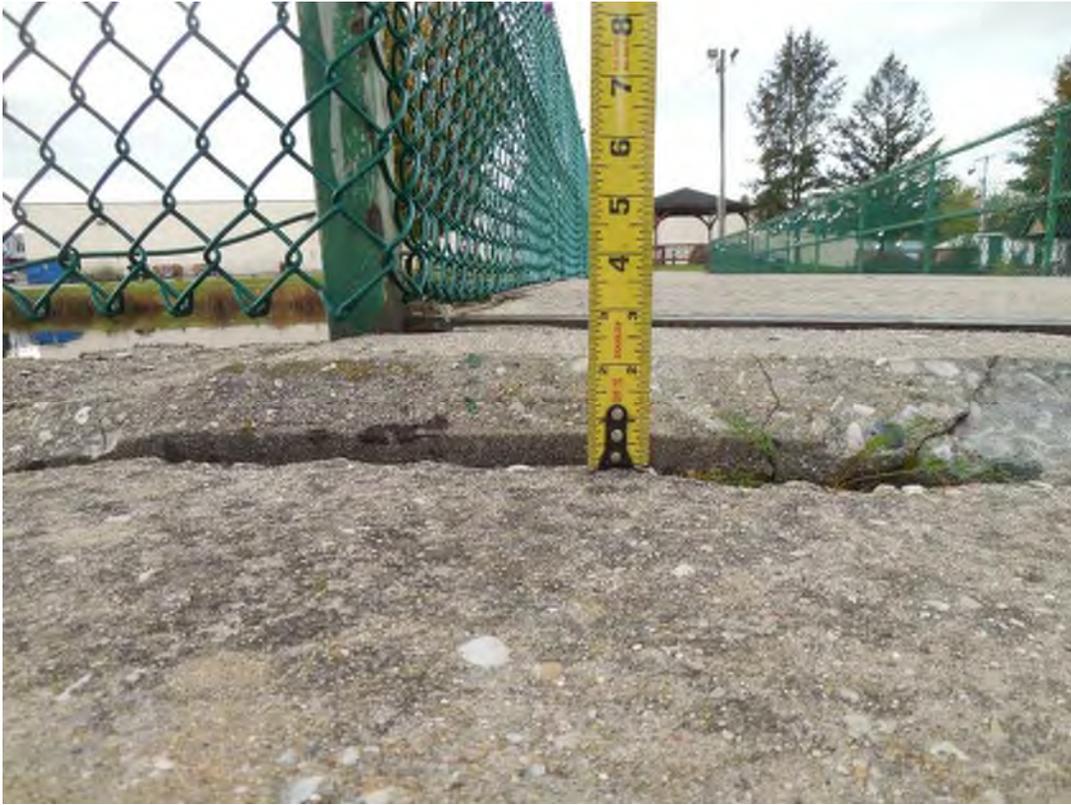
Settlement of north approach sidewalk along northeast abutment

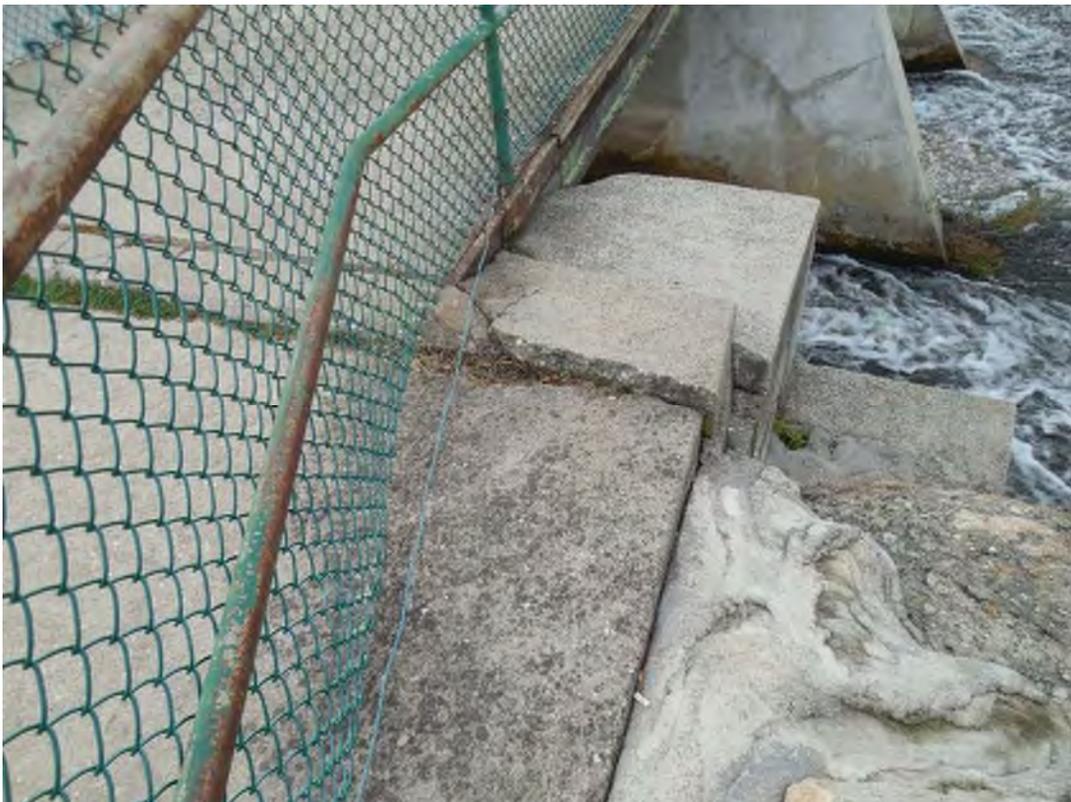
Settlement of north approach sidewalk along northwest abutment

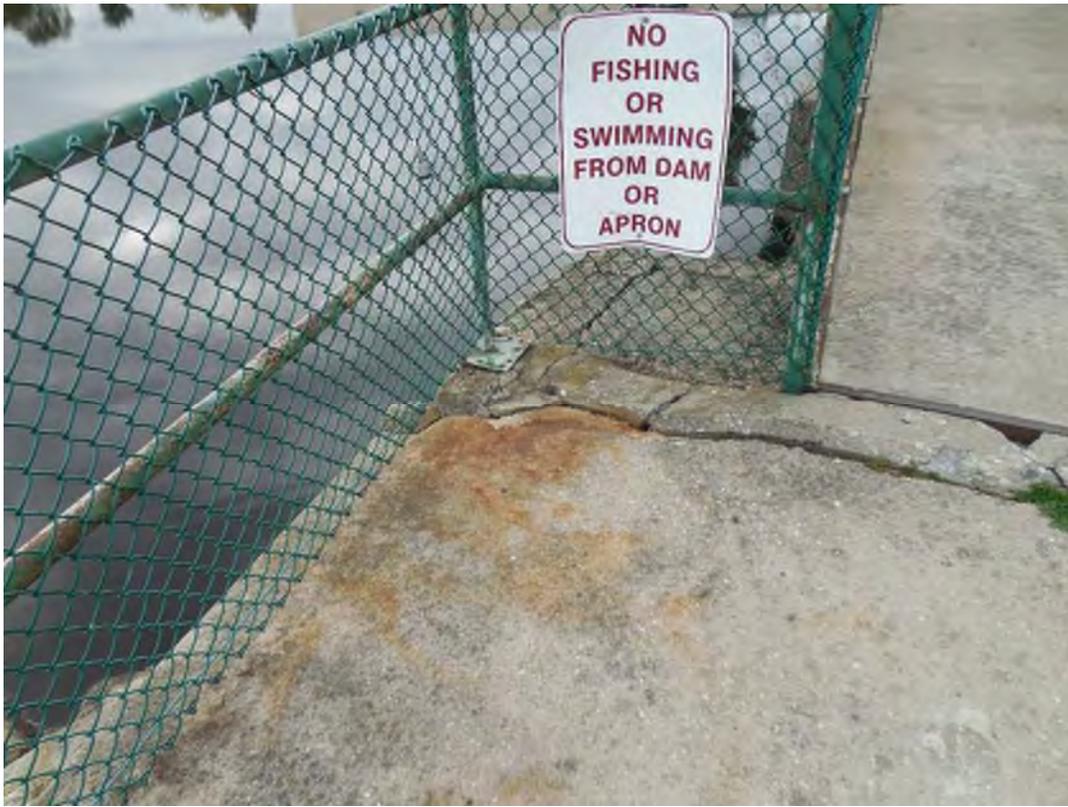
Deterioration of northeast abutment area

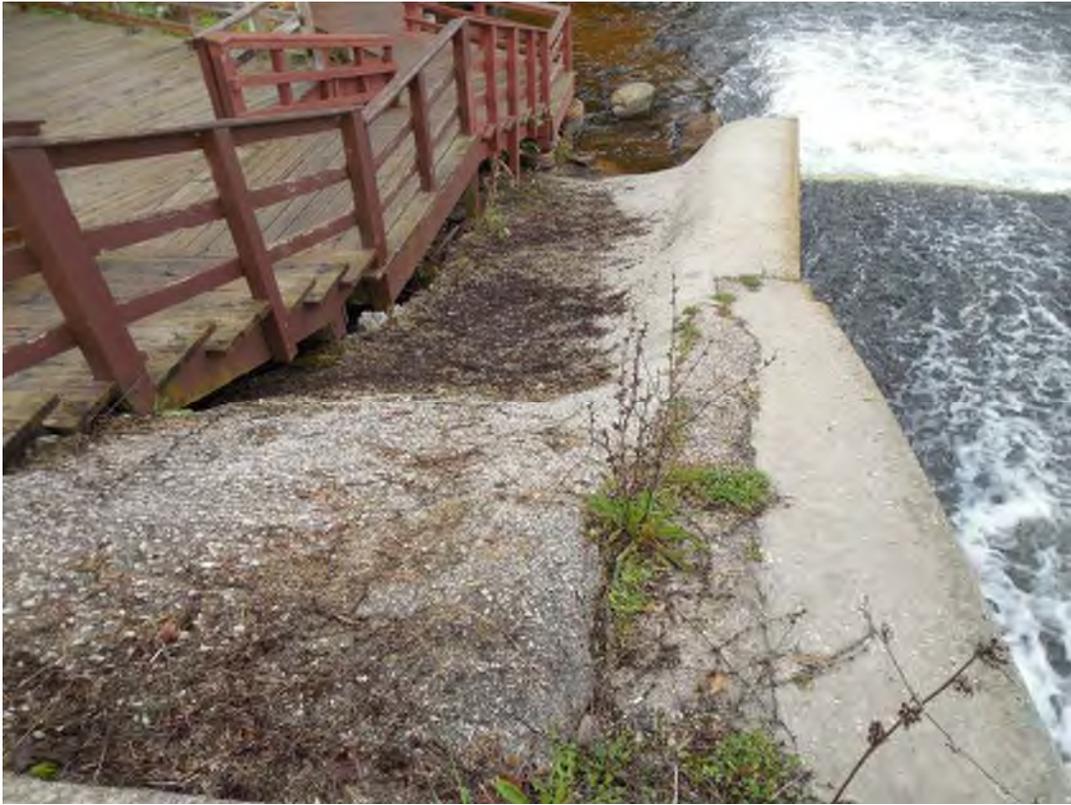
Concrete slope paving behind downstream south abutment

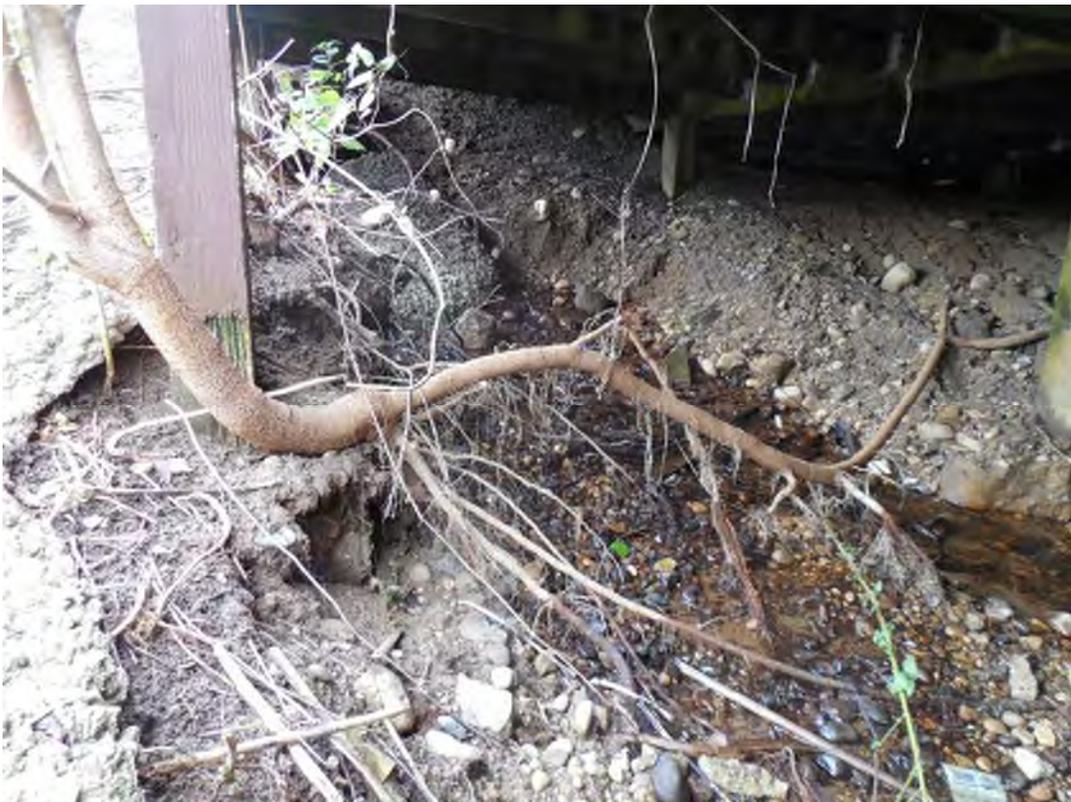
Eroding slope and exposed roots beneath boardwalk structure along concrete slope paving

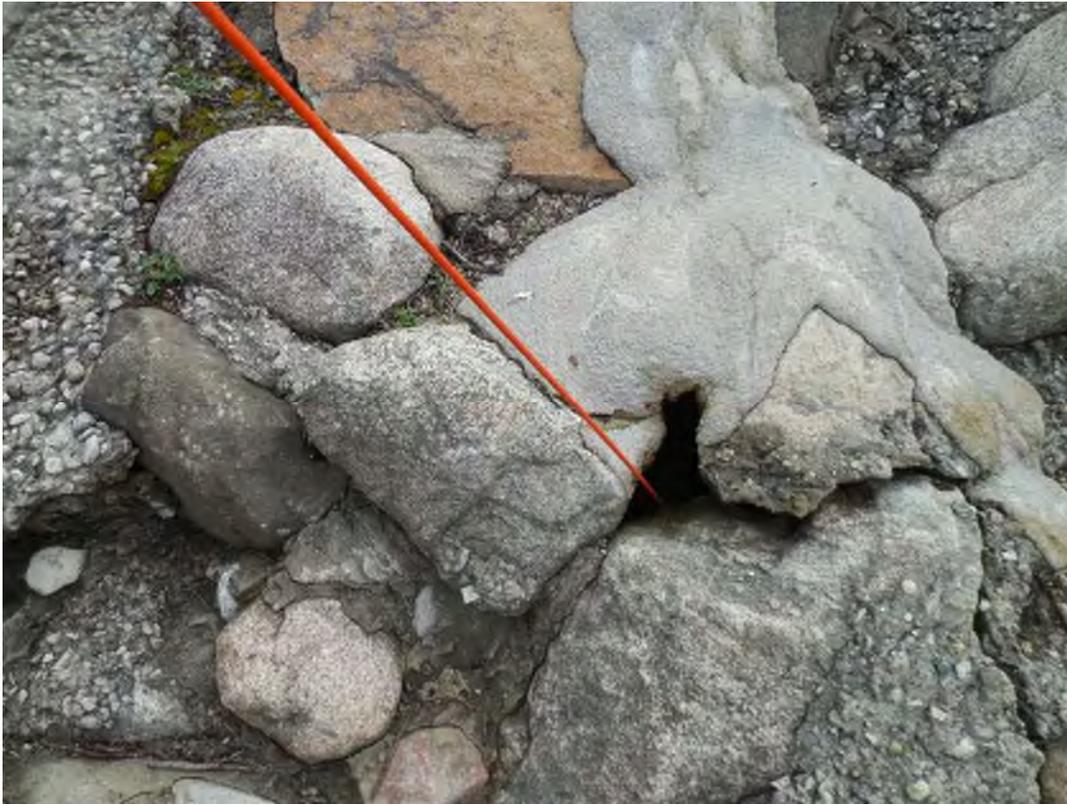
Settlement of grouted riprap looking south

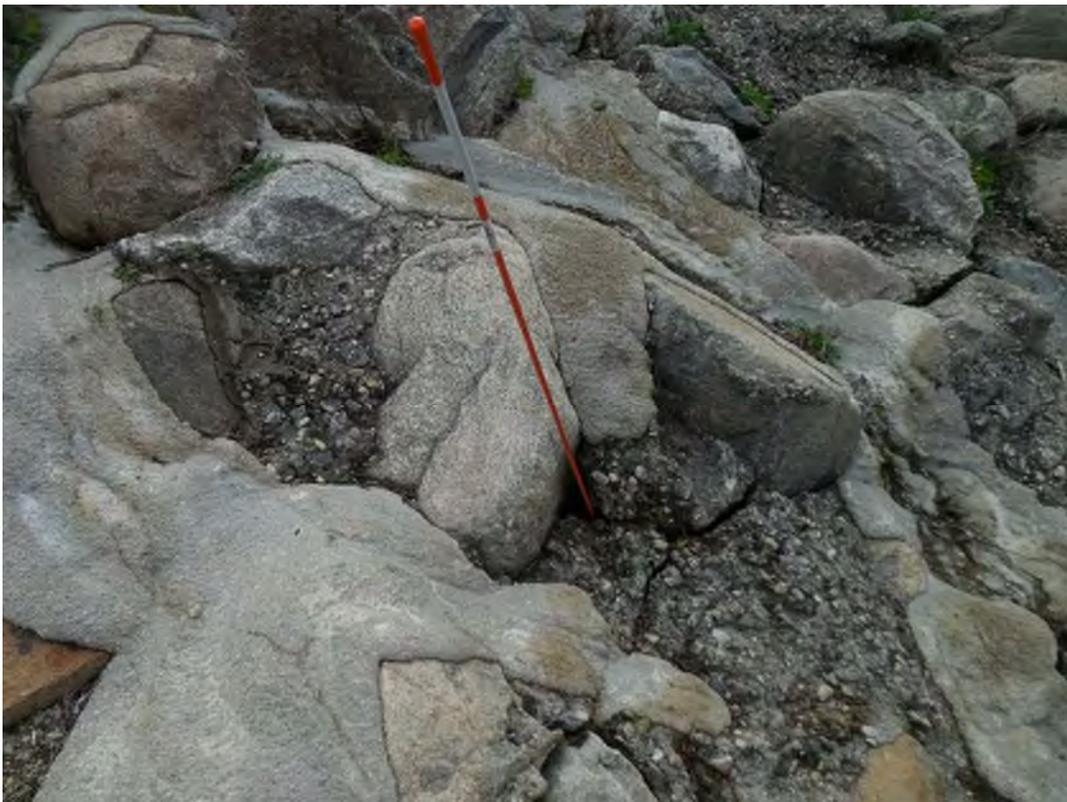
Probe illustrating void in grouted riprap on downstream slope of emergency spillway
