Rehabilitation Alternatives Analysis - DRAFT

Hesperia Dam

Oceana County, Michigan
Dam I.D. No. 678

June 16, 2025
Project No. 2403886

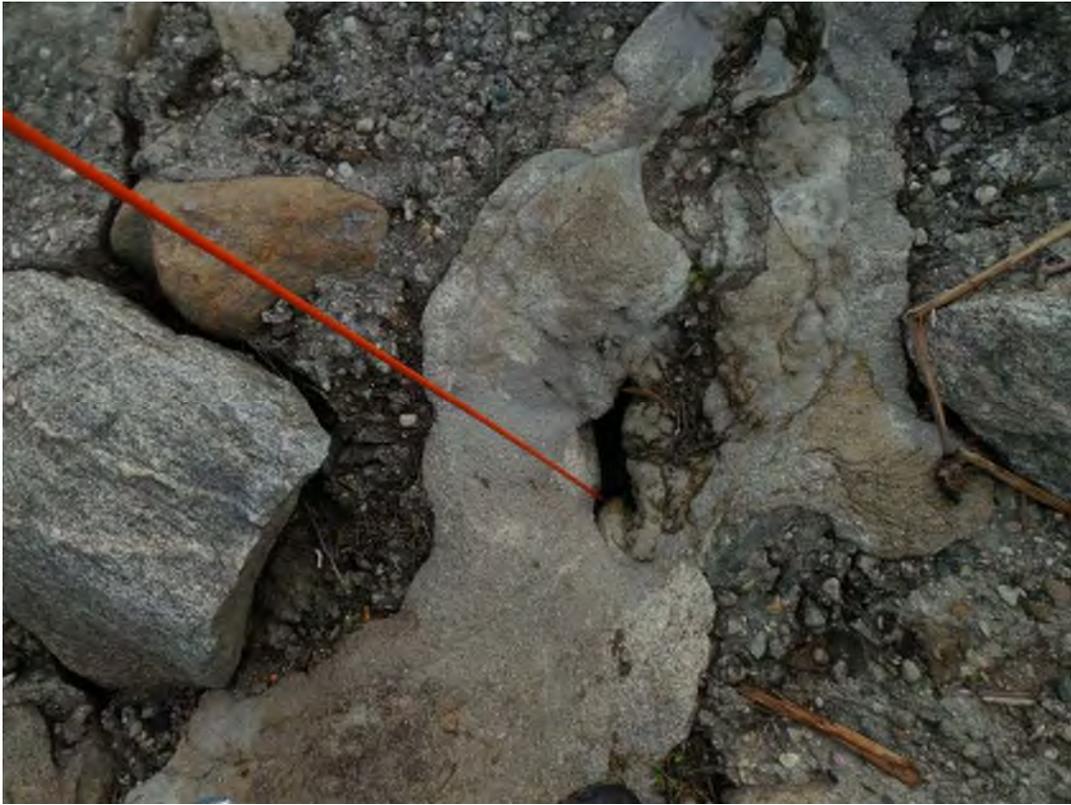
Probe illustrating void in grouted riprap on downstream slope of emergency spillway

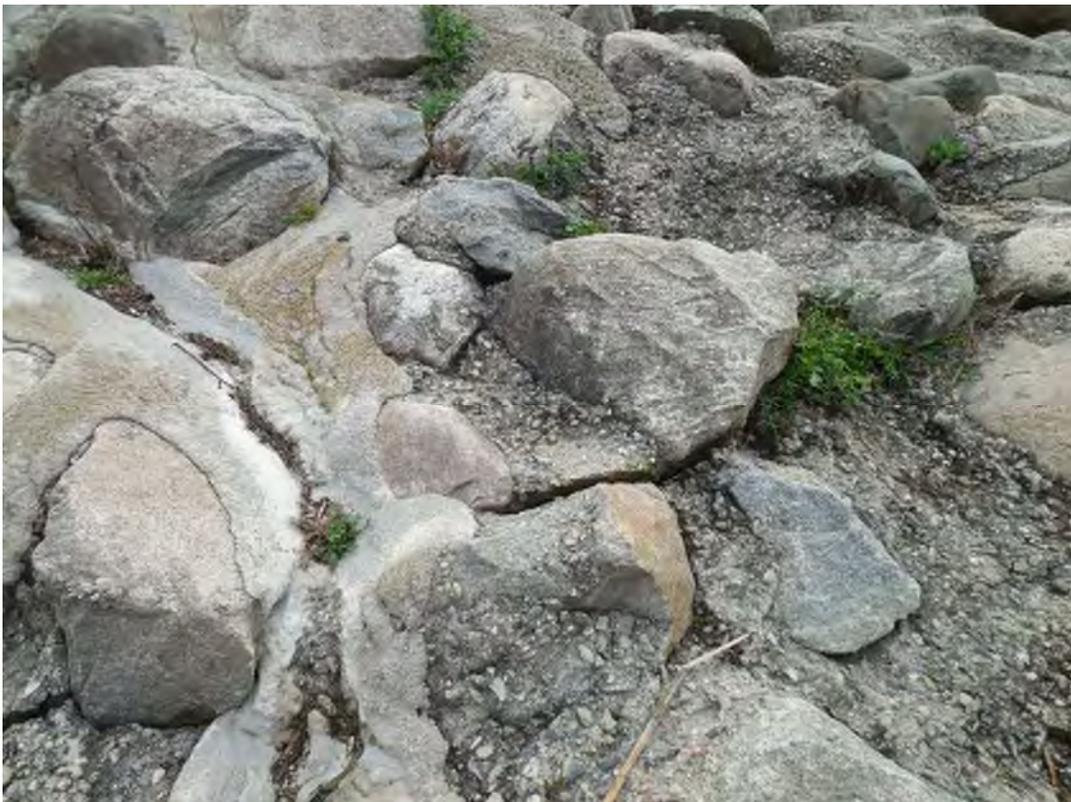
Probe illustrating void in grouted riprap on downstream slope of emergency spillway

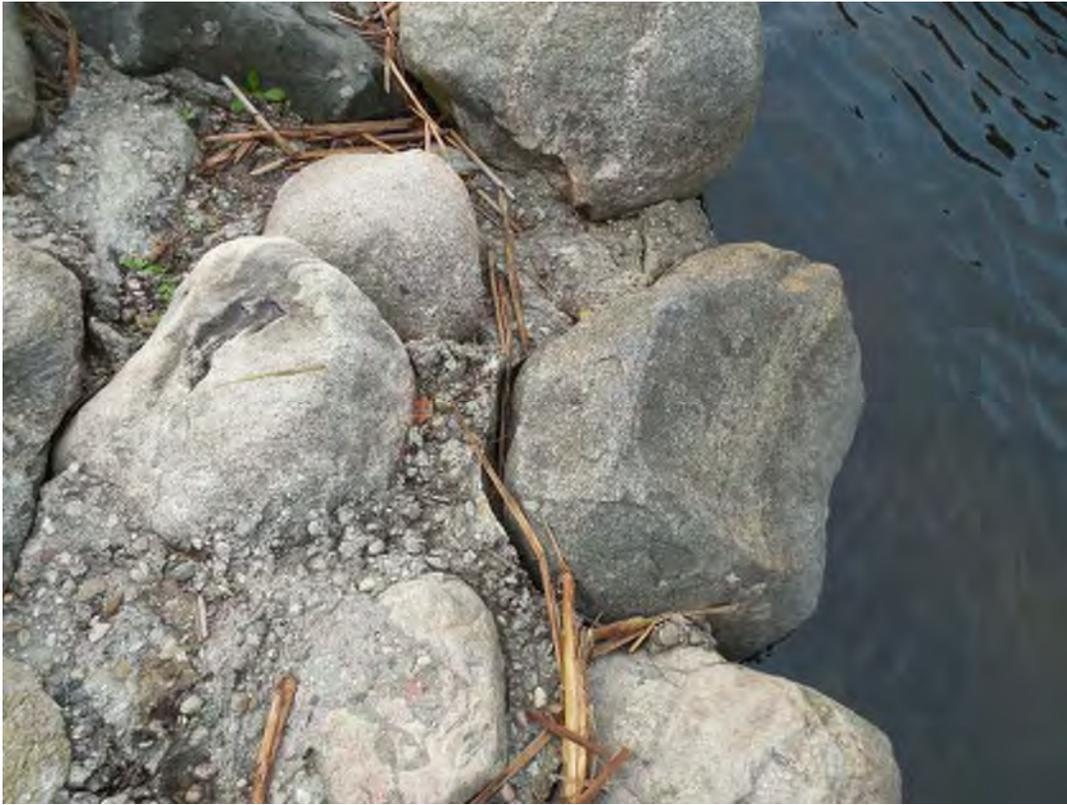
Prior patching of grouted riprap voids

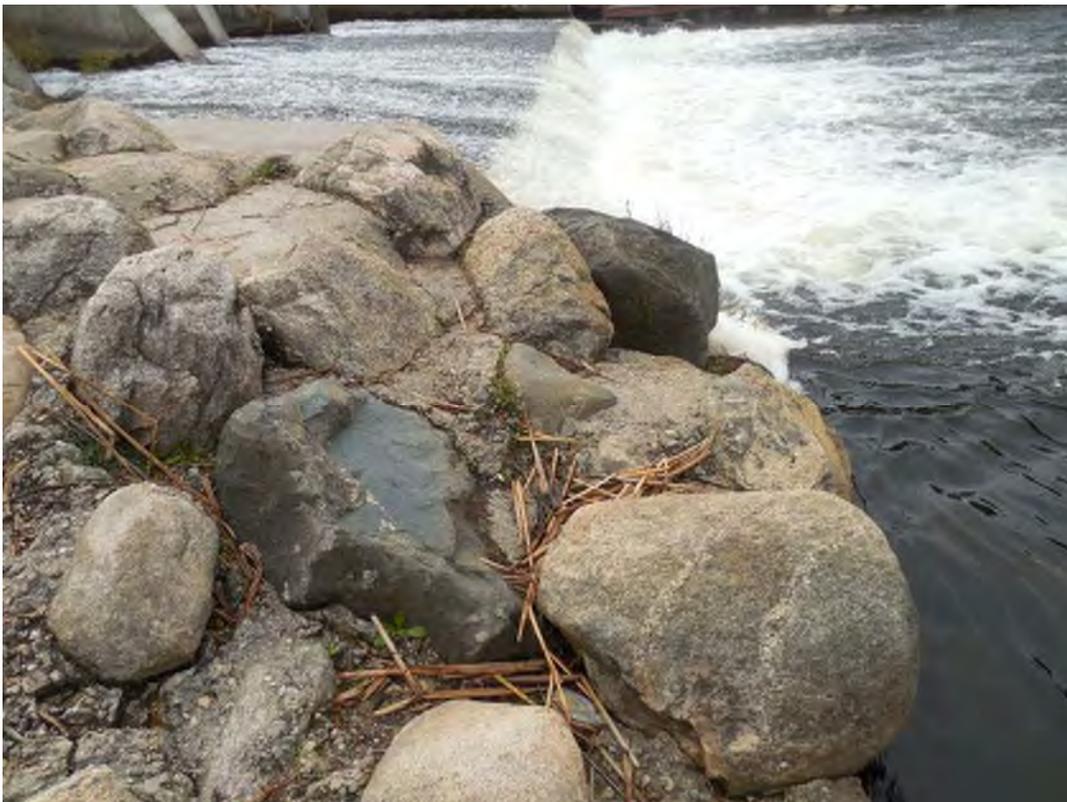
Riprap at bottom of downstream emergency spillway slope settling into the channel

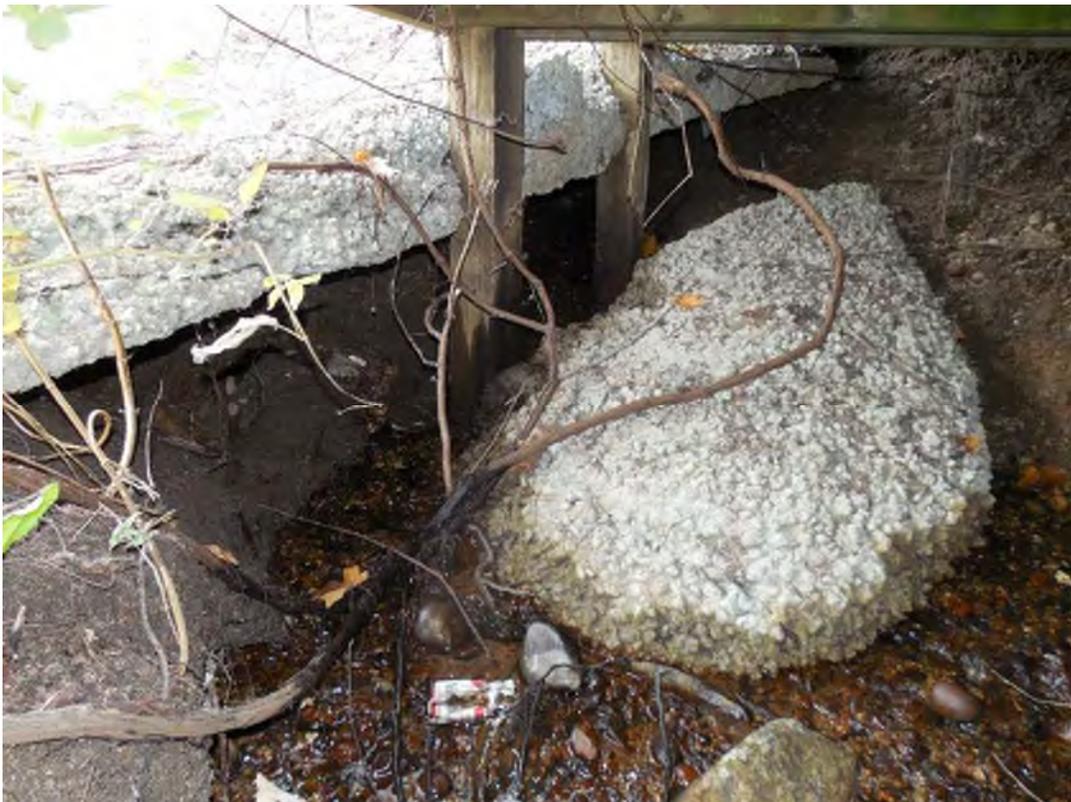
Boiling and sand deposition at bottom of concrete slope paving behind south abutment

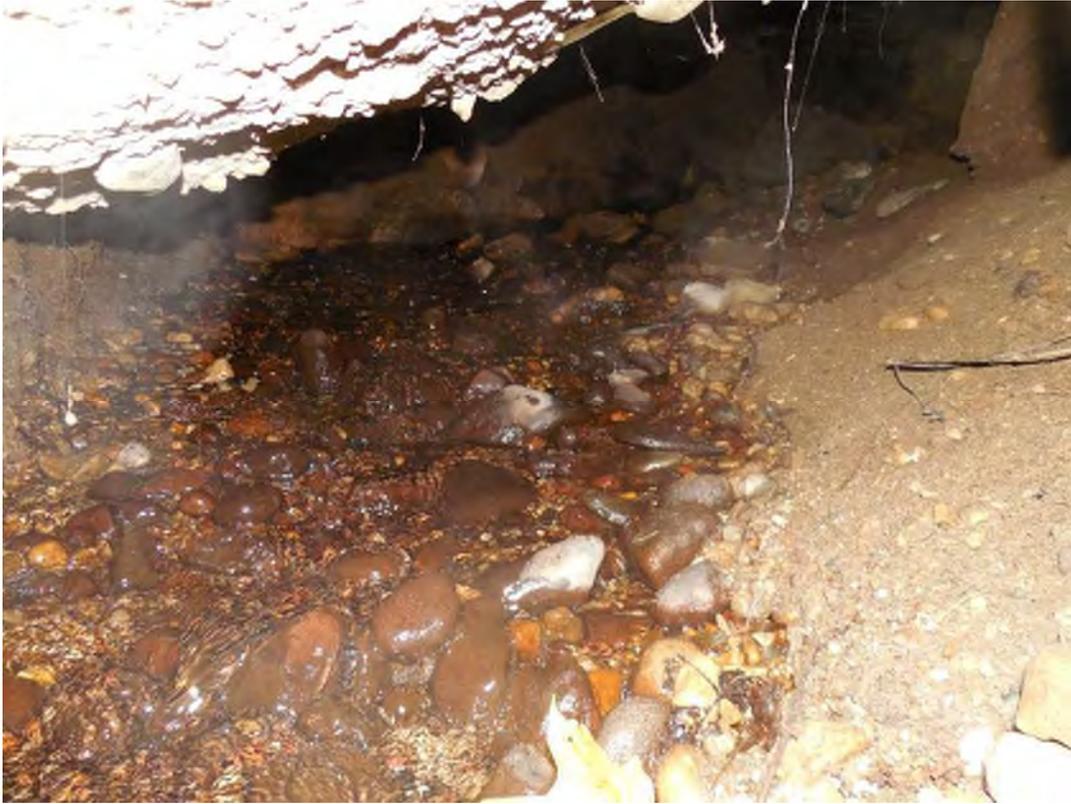
Undermining of concrete slope paving behind south abutment

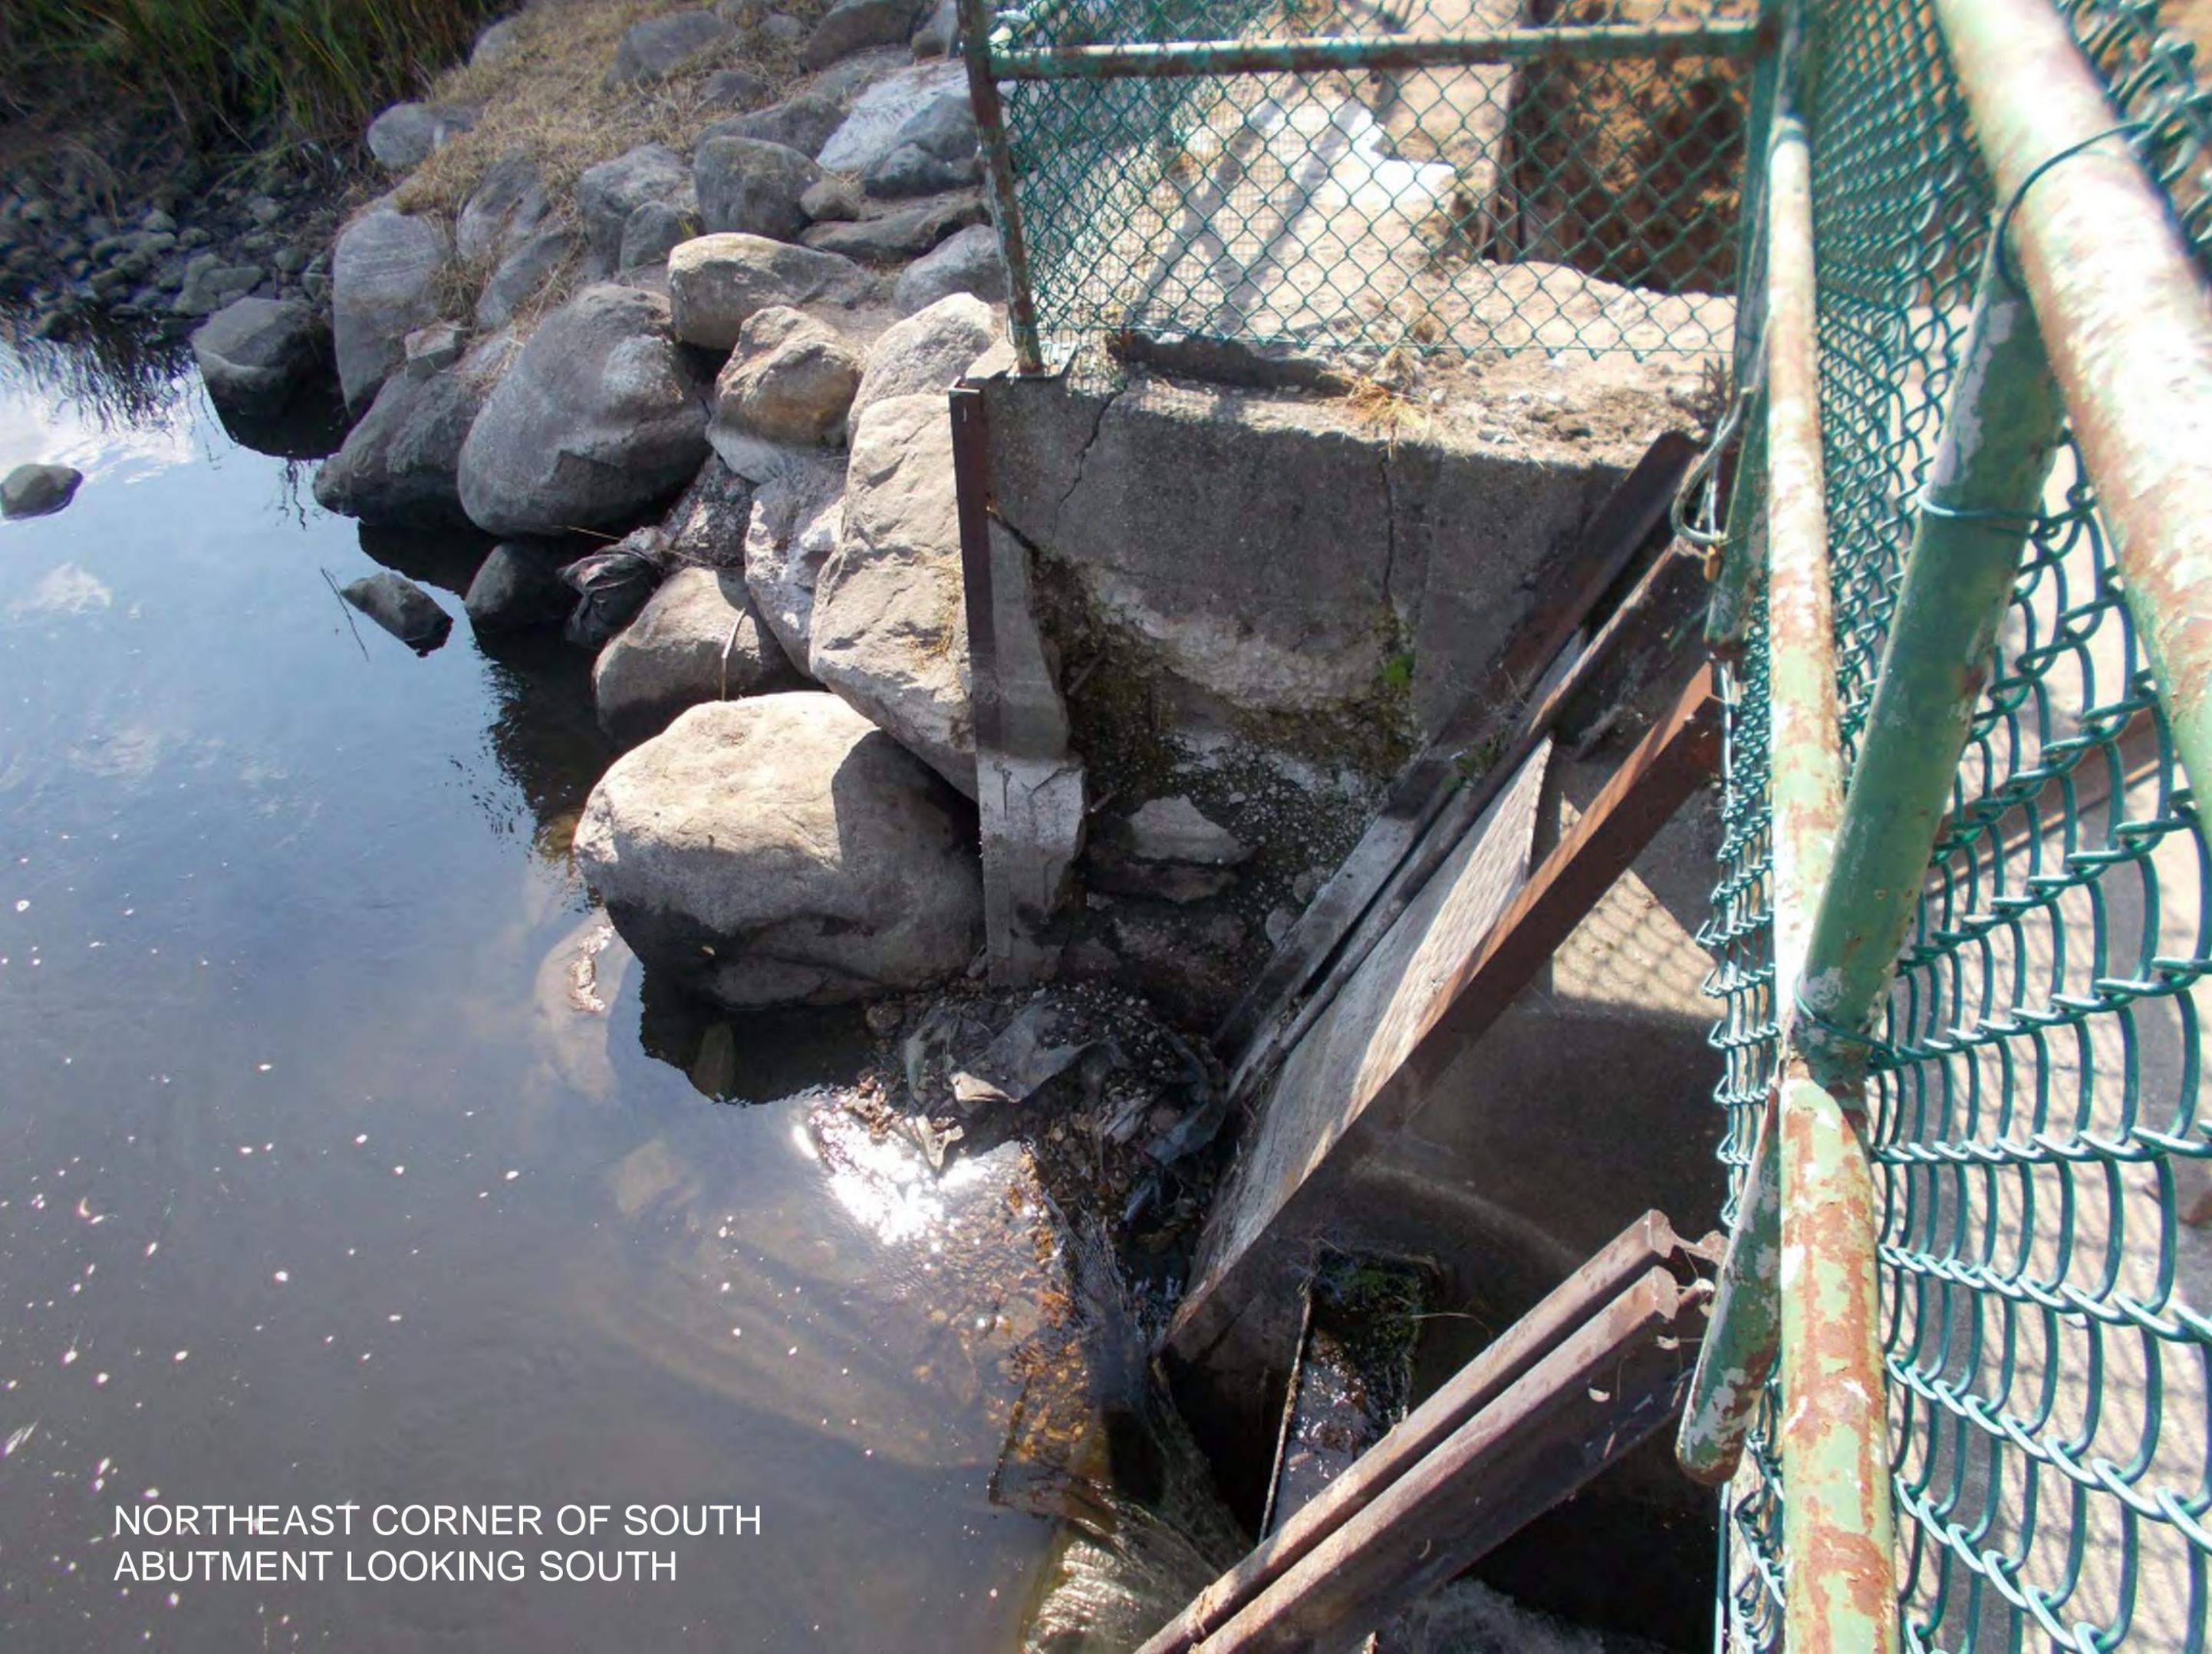
NORTHEAST CORNER OF SOUTH
ABUTMENT LOOKING SOUTH

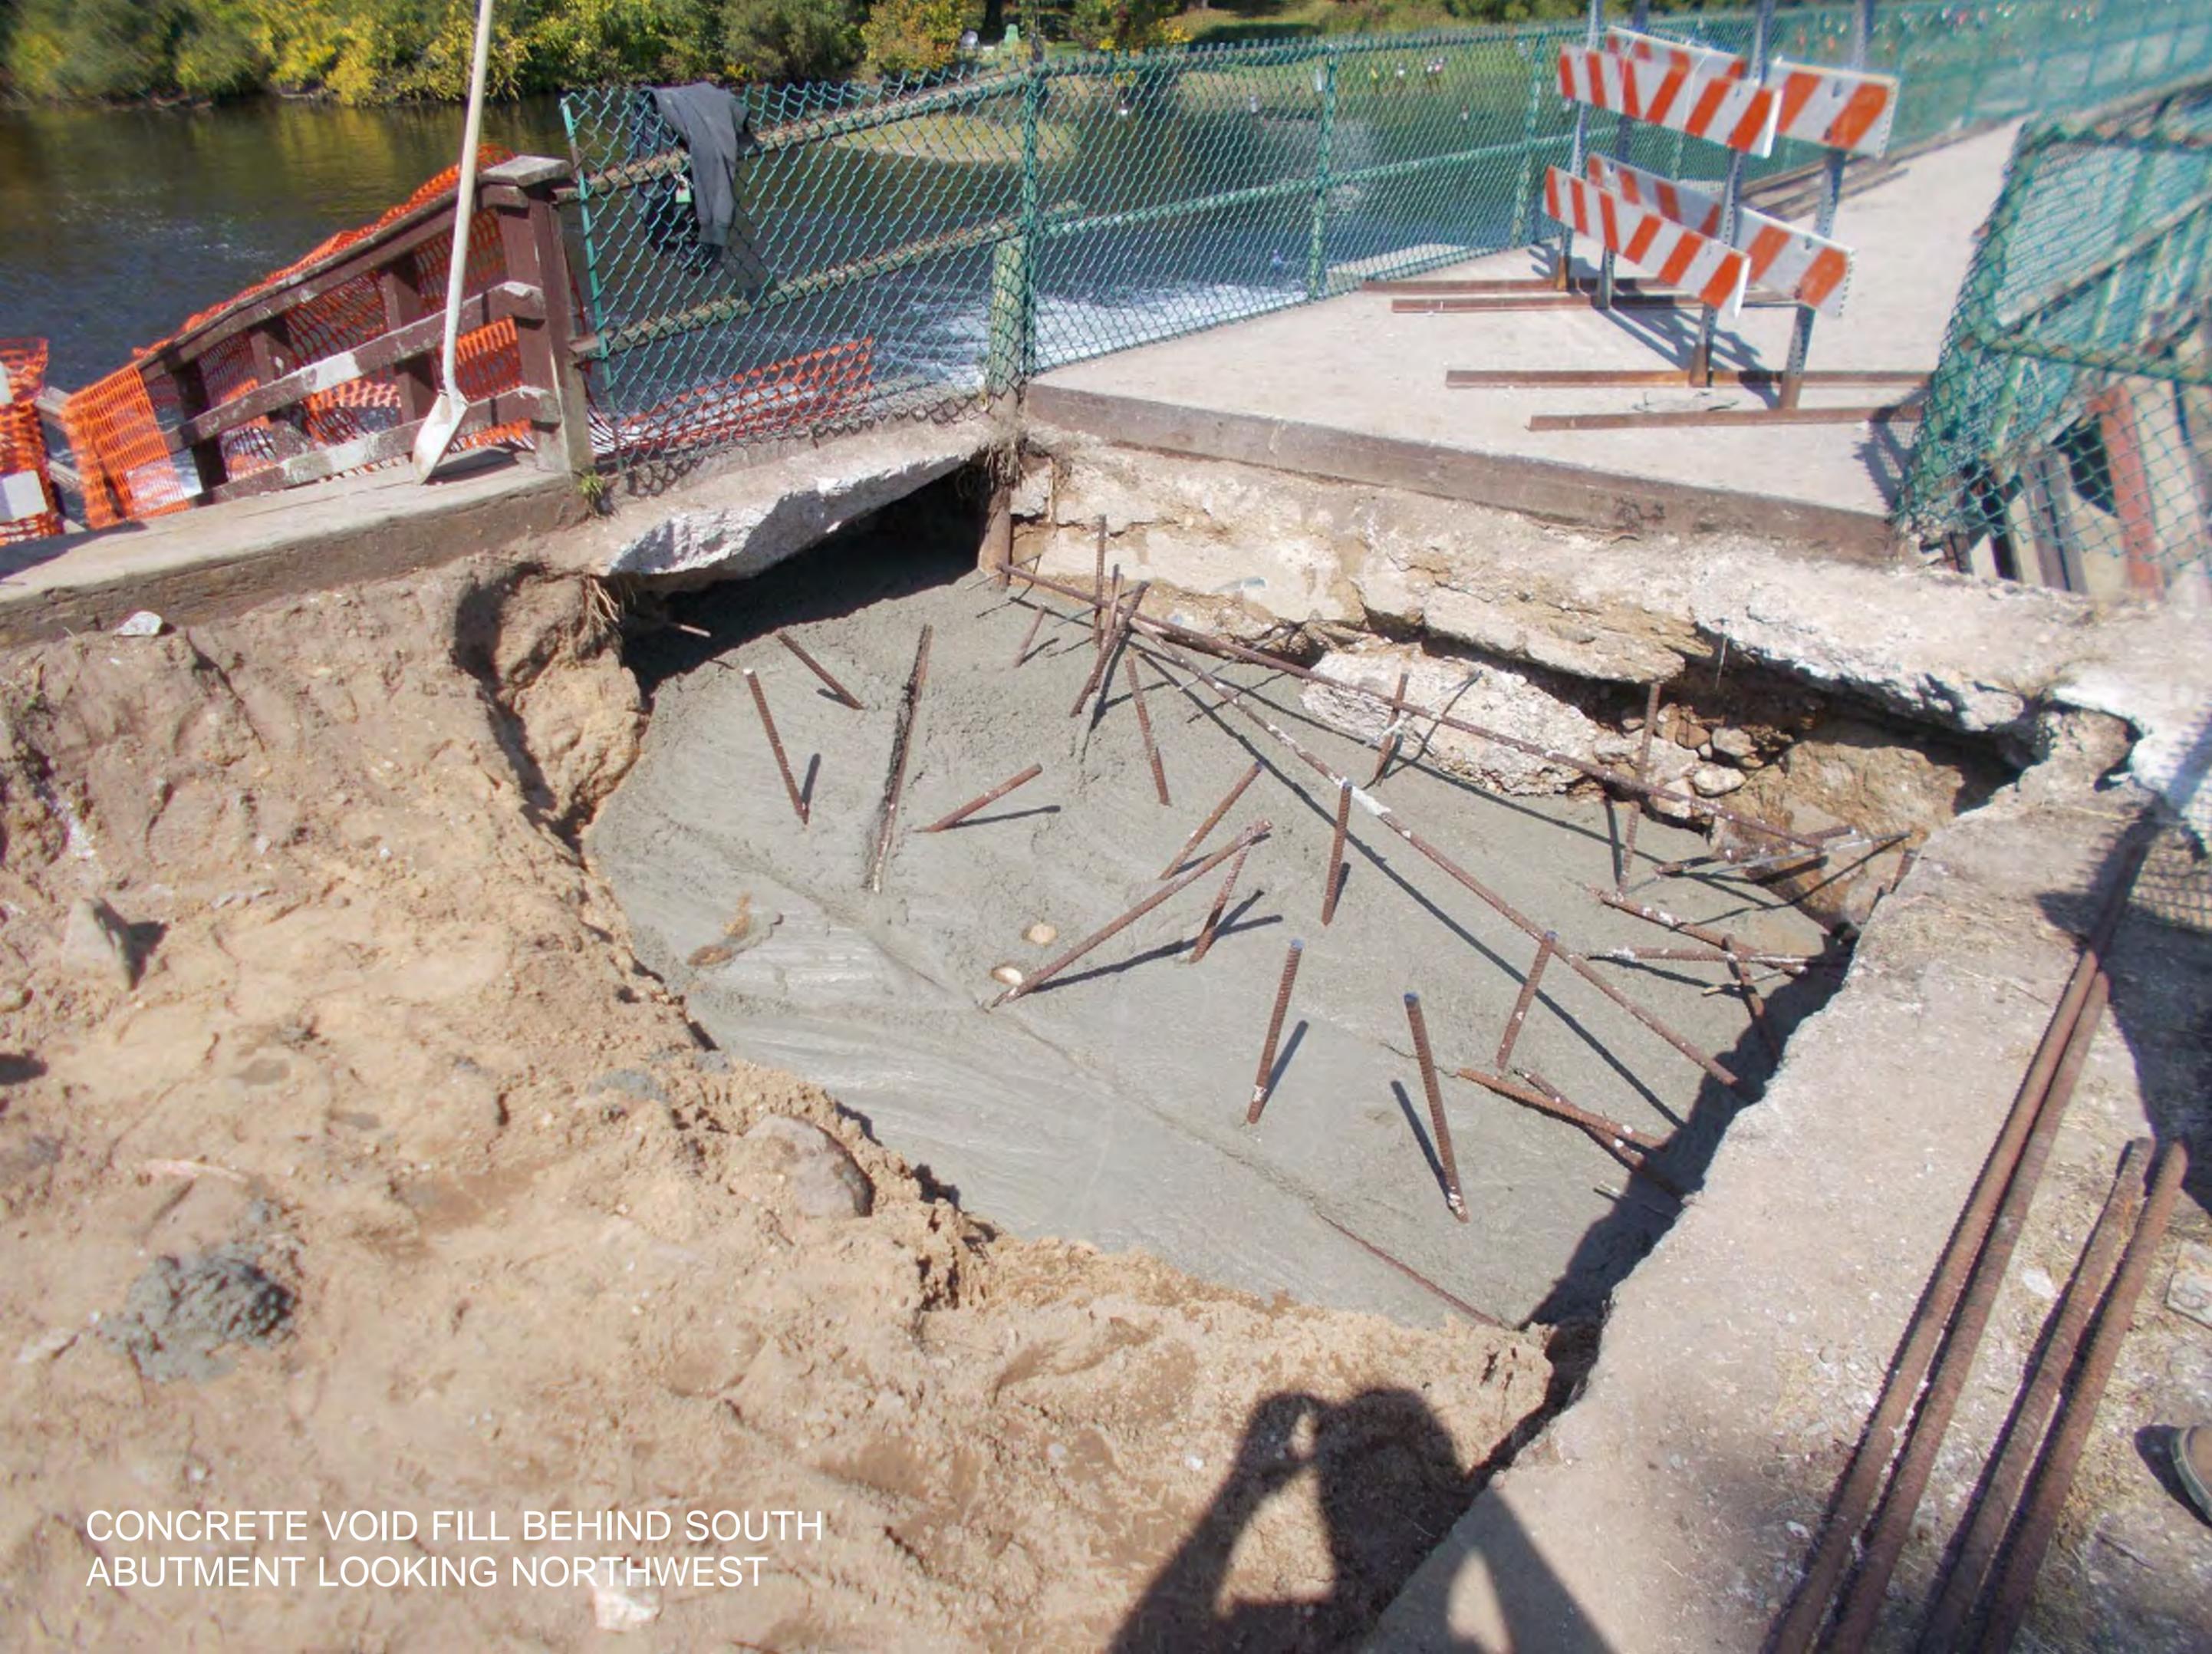
CONCRETE VOID FILL BEHIND SOUTH ABUTMENT LOOKING NORTHWEST

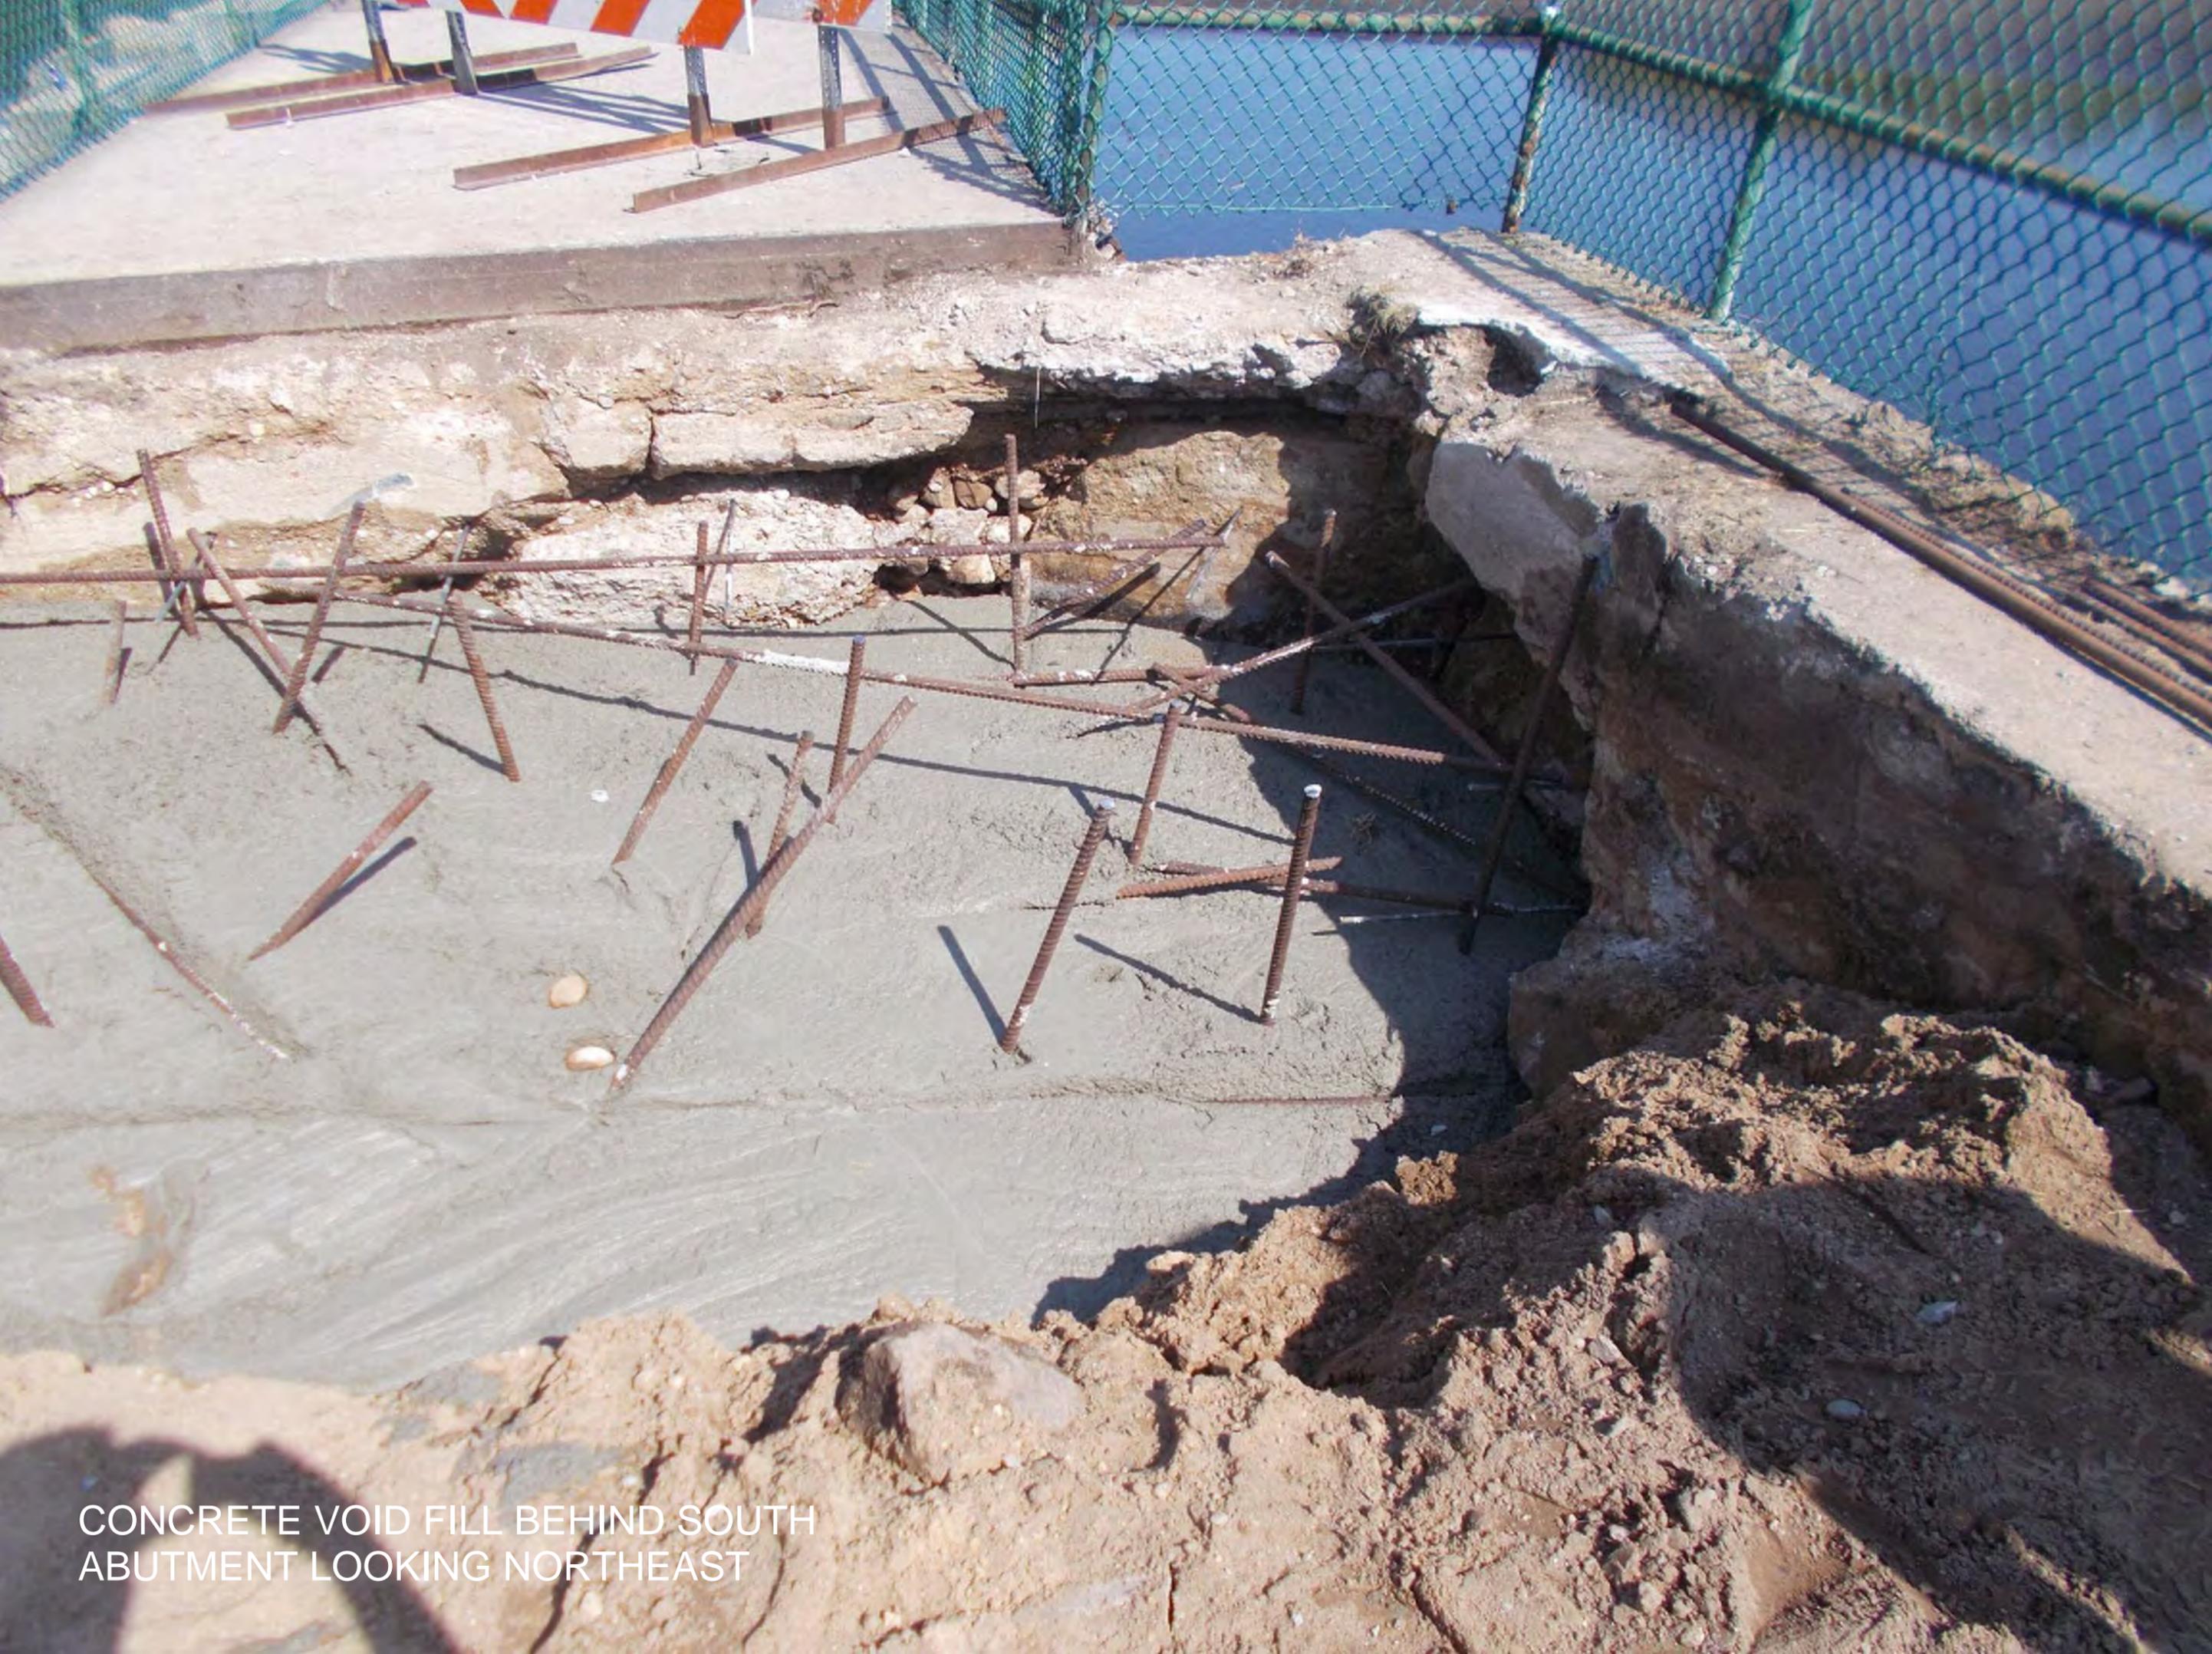
CONCRETE VOID FILL BEHIND SOUTH
ABUTMENT LOOKING NORTHEAST

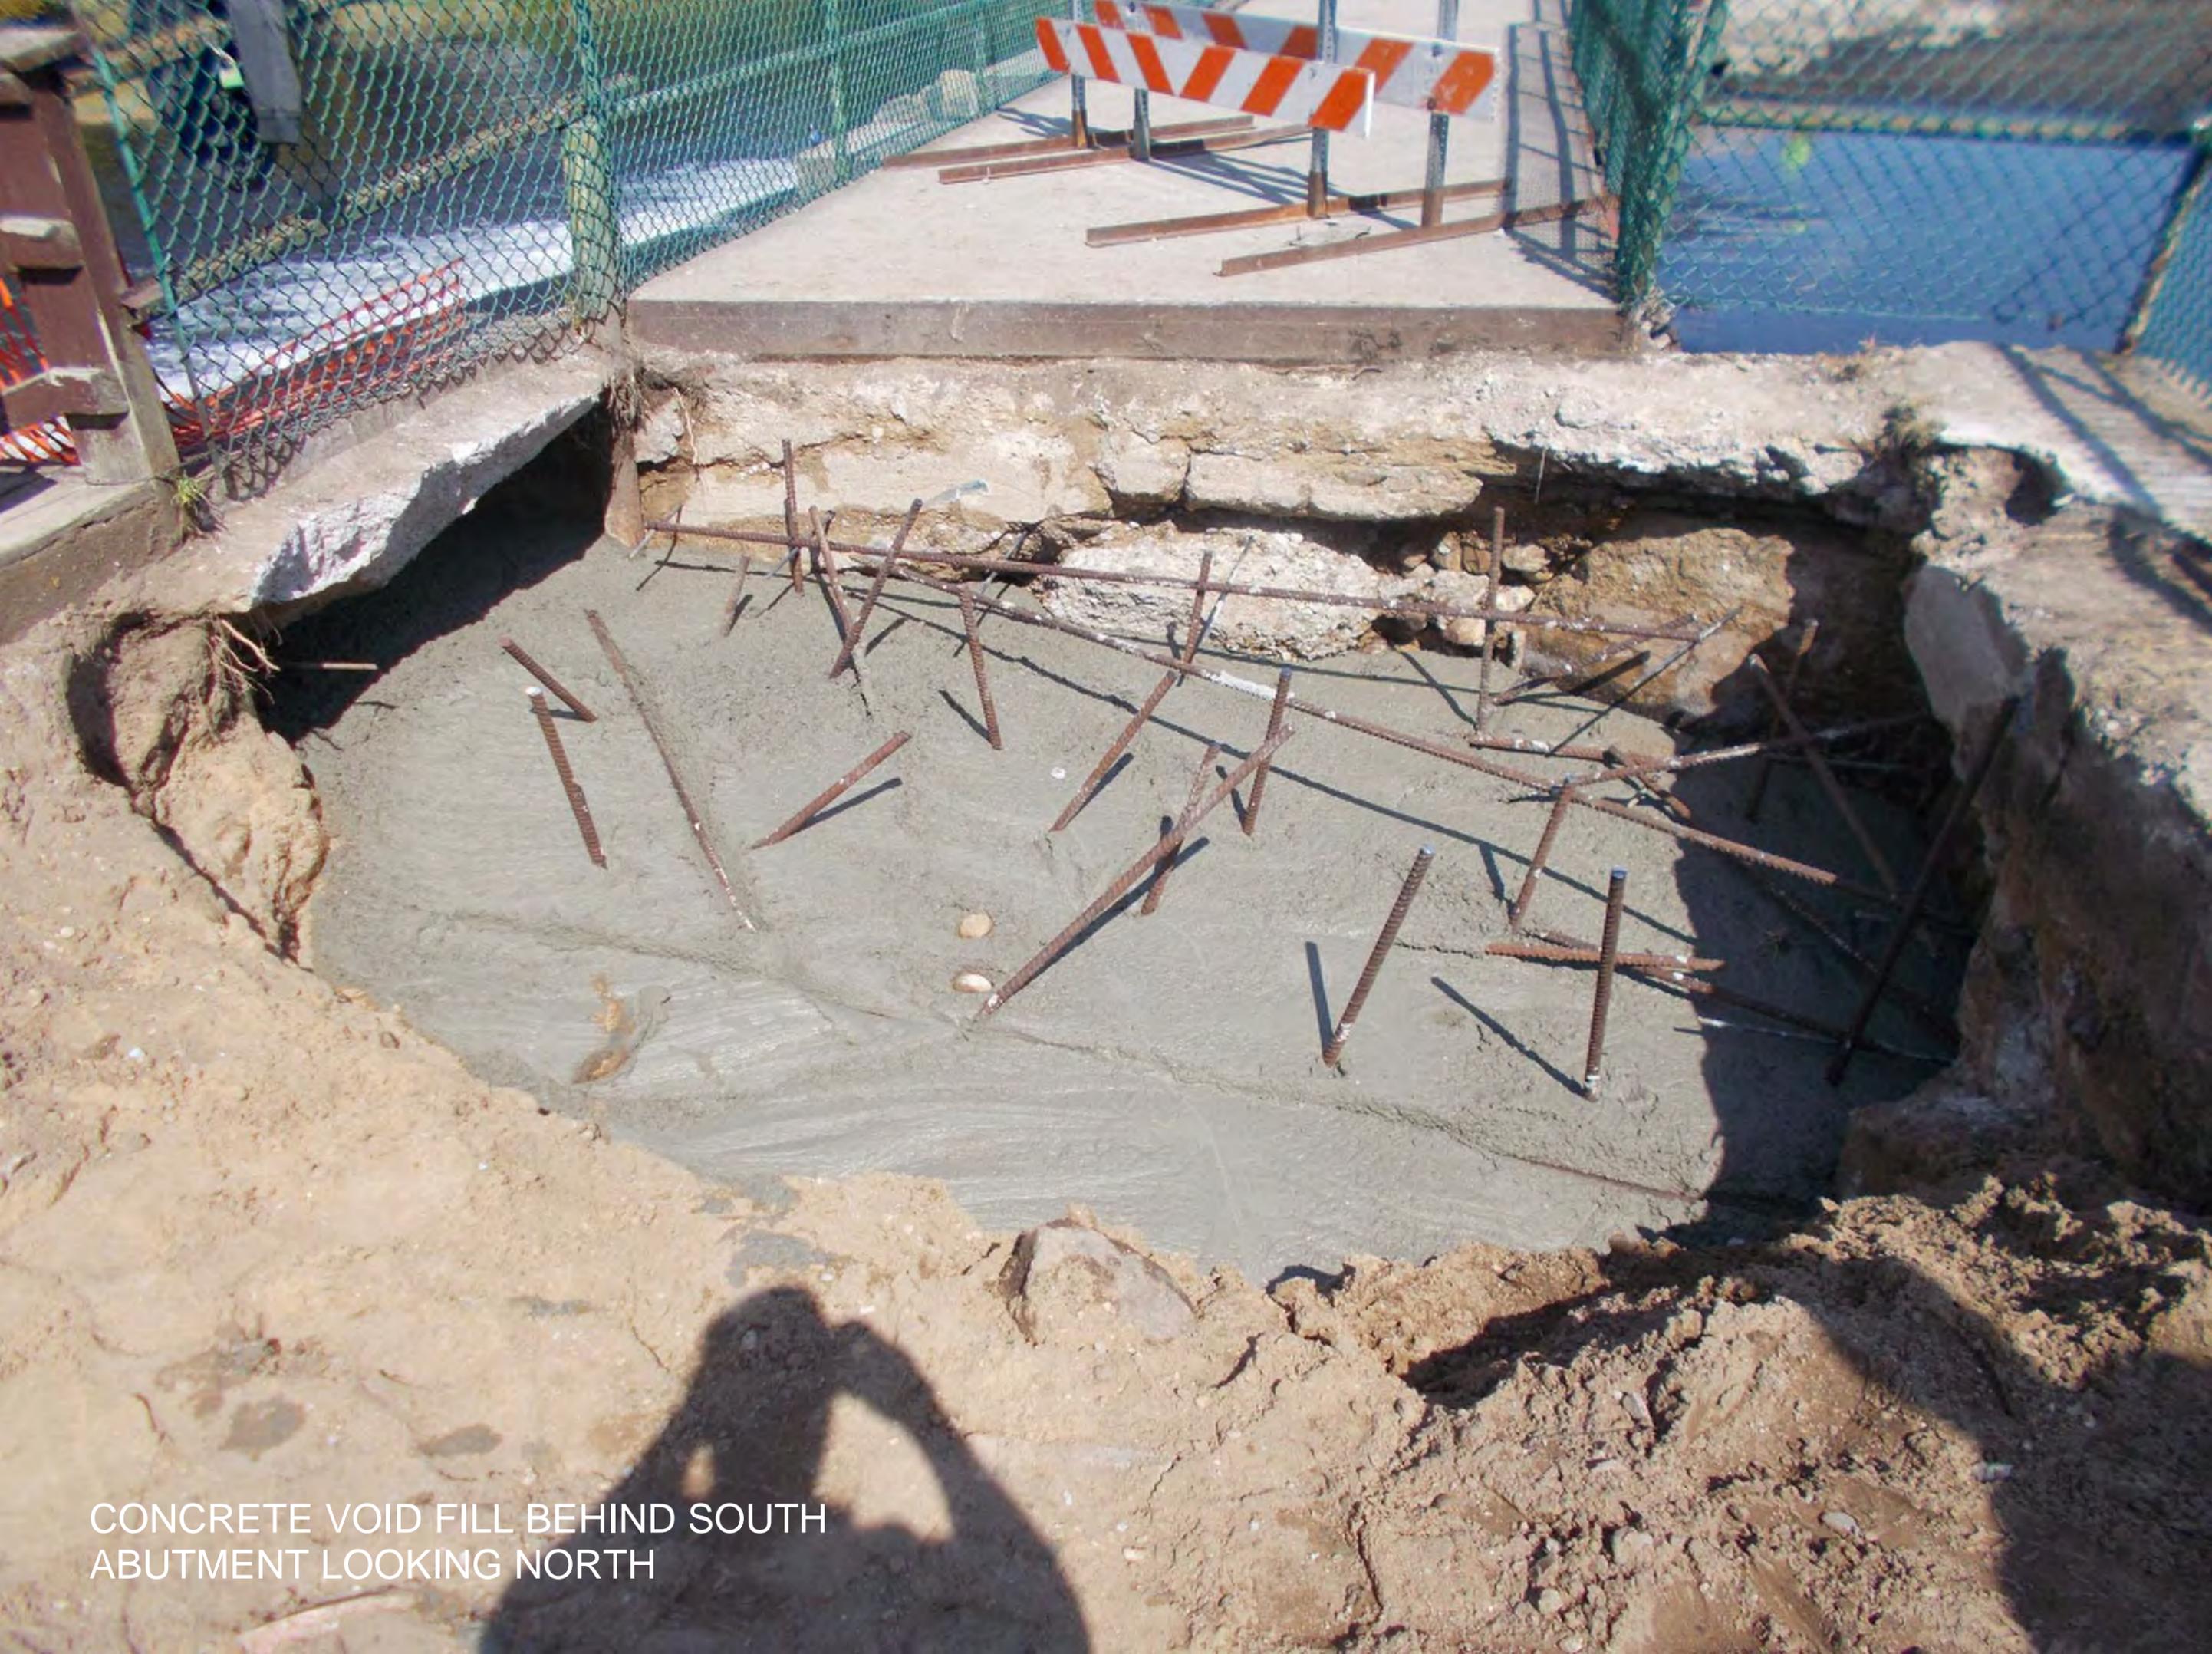
CONCRETE VOID FILL BEHIND SOUTH
ABUTMENT LOOKING NORTH
