Rehabilitation Alternatives Analysis - DRAFT

Hesperia Dam

Oceana County, Michigan
Dam I.D. No. 678

June 16, 2025
Project No. 2403886

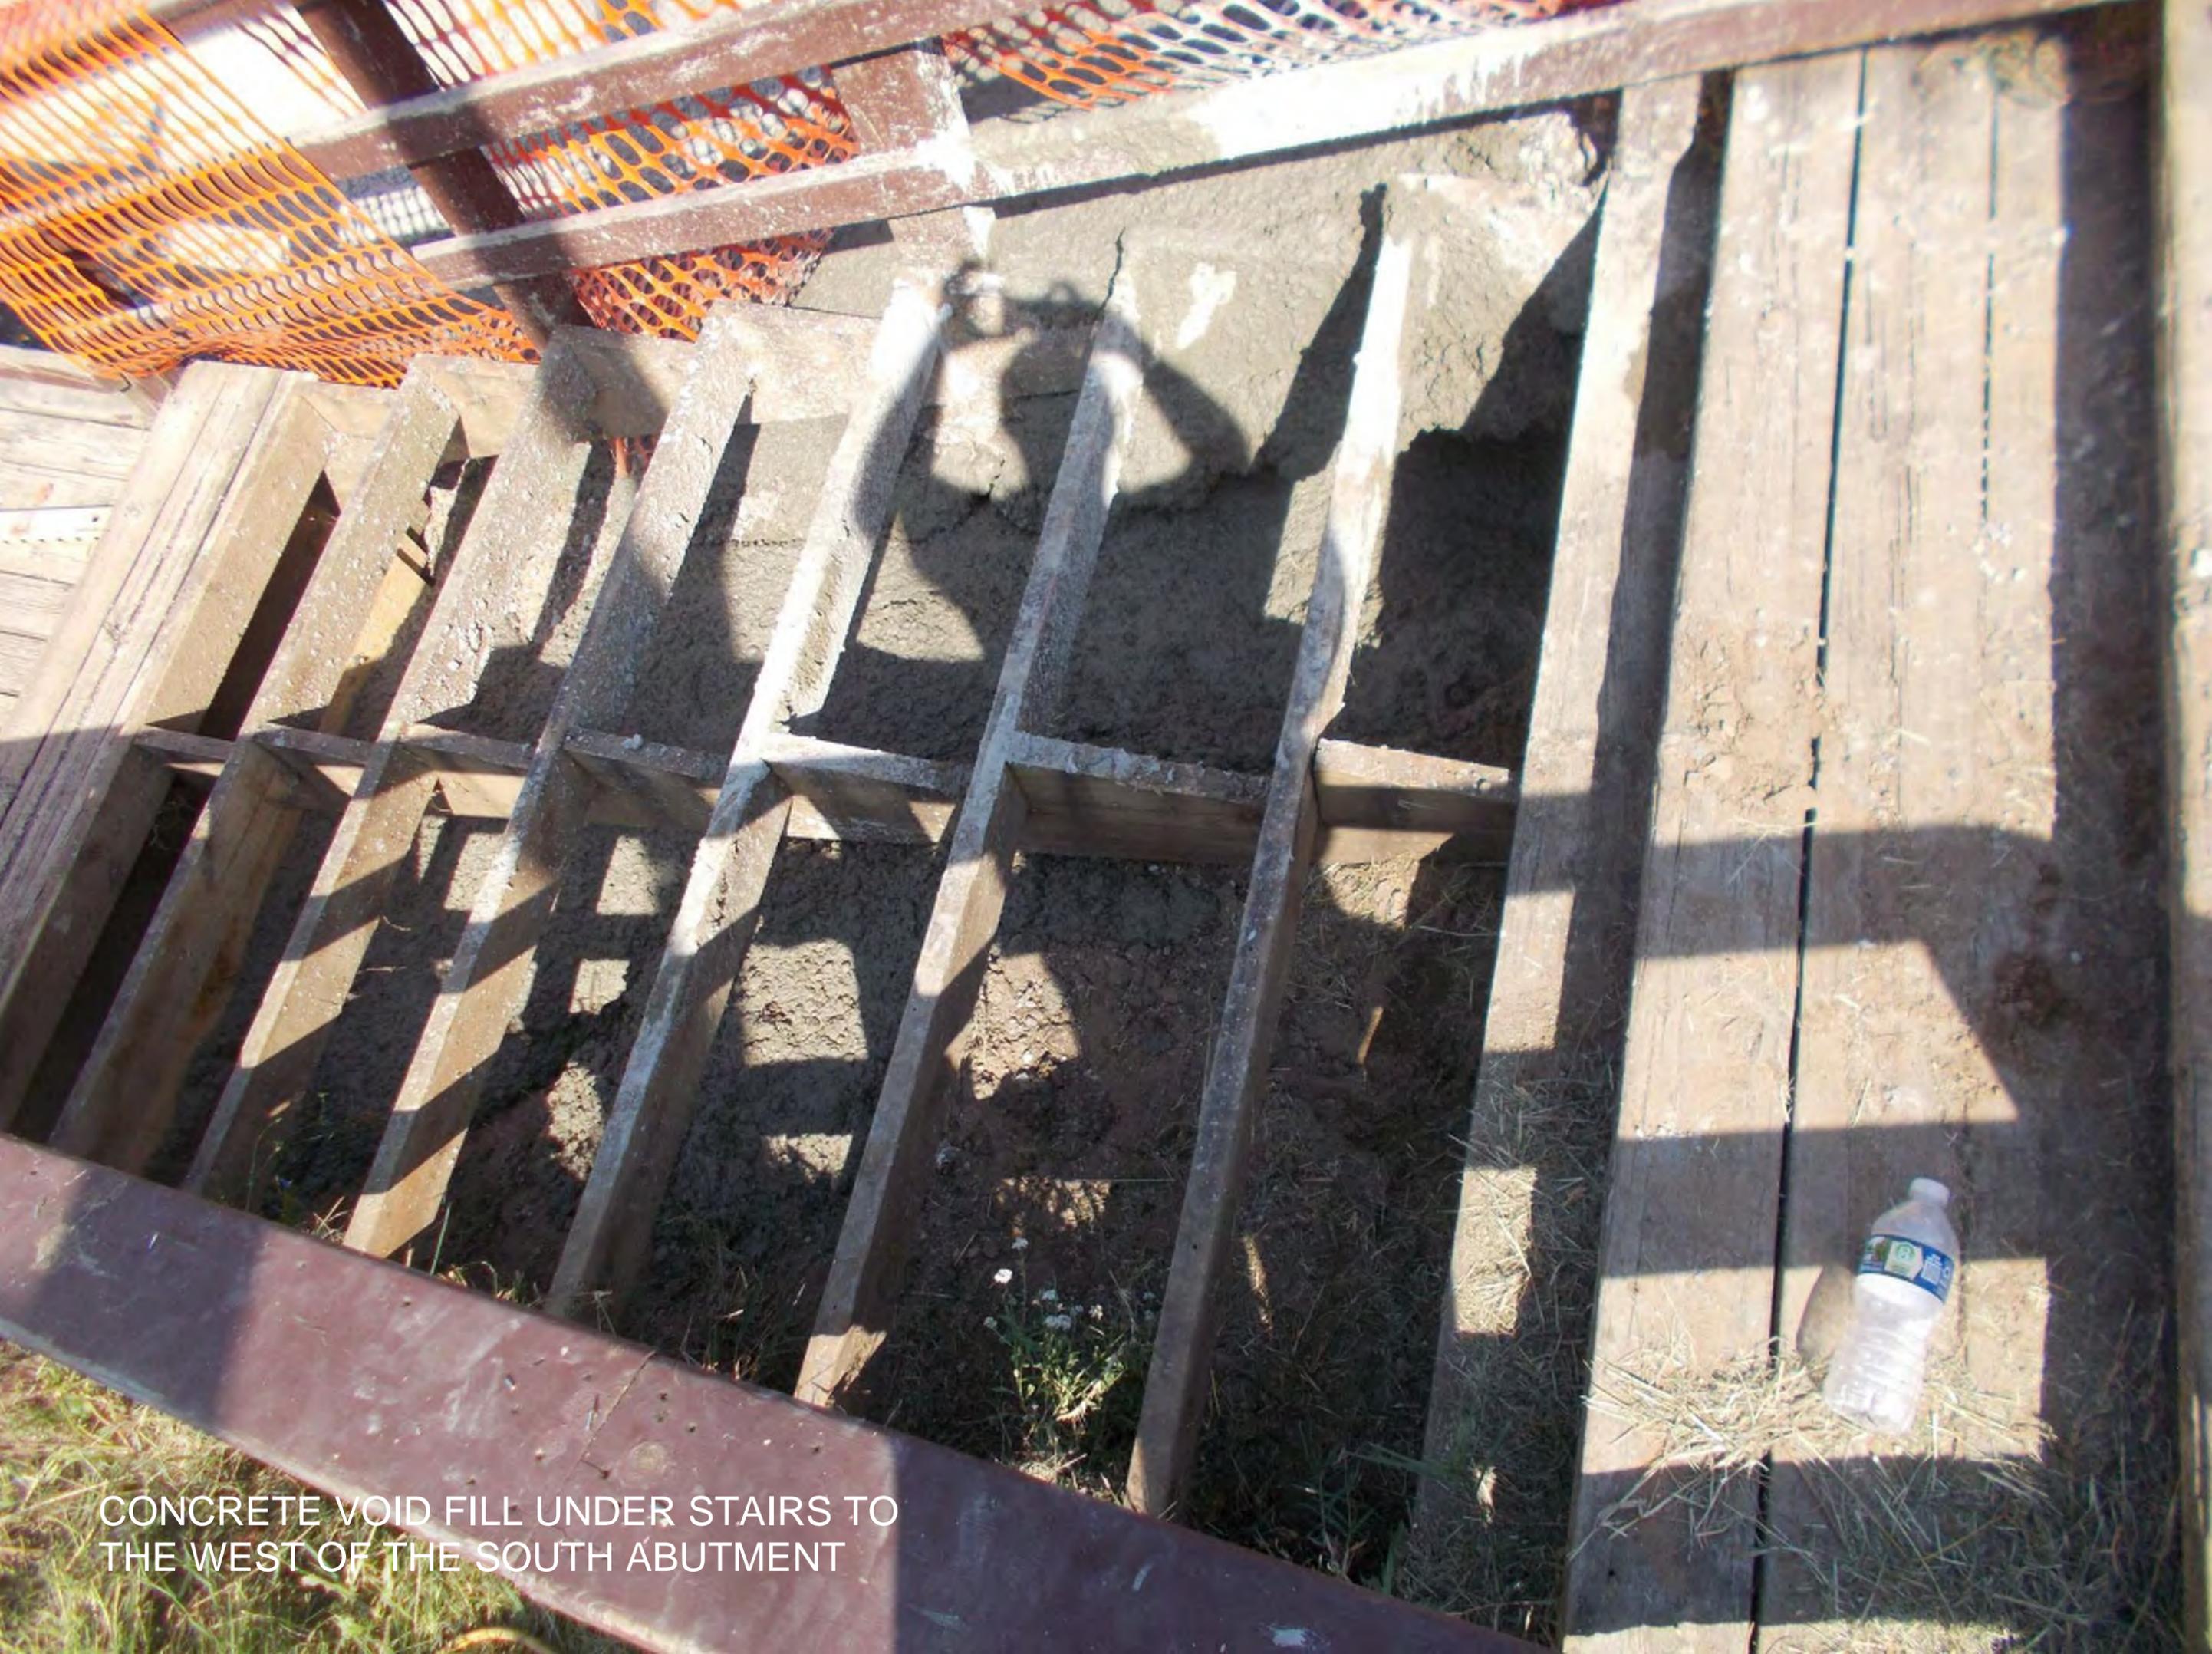
CONCRETE VOID FILL UNDER STAIRS TO
THE WEST OF THE SOUTH ABUTMENT

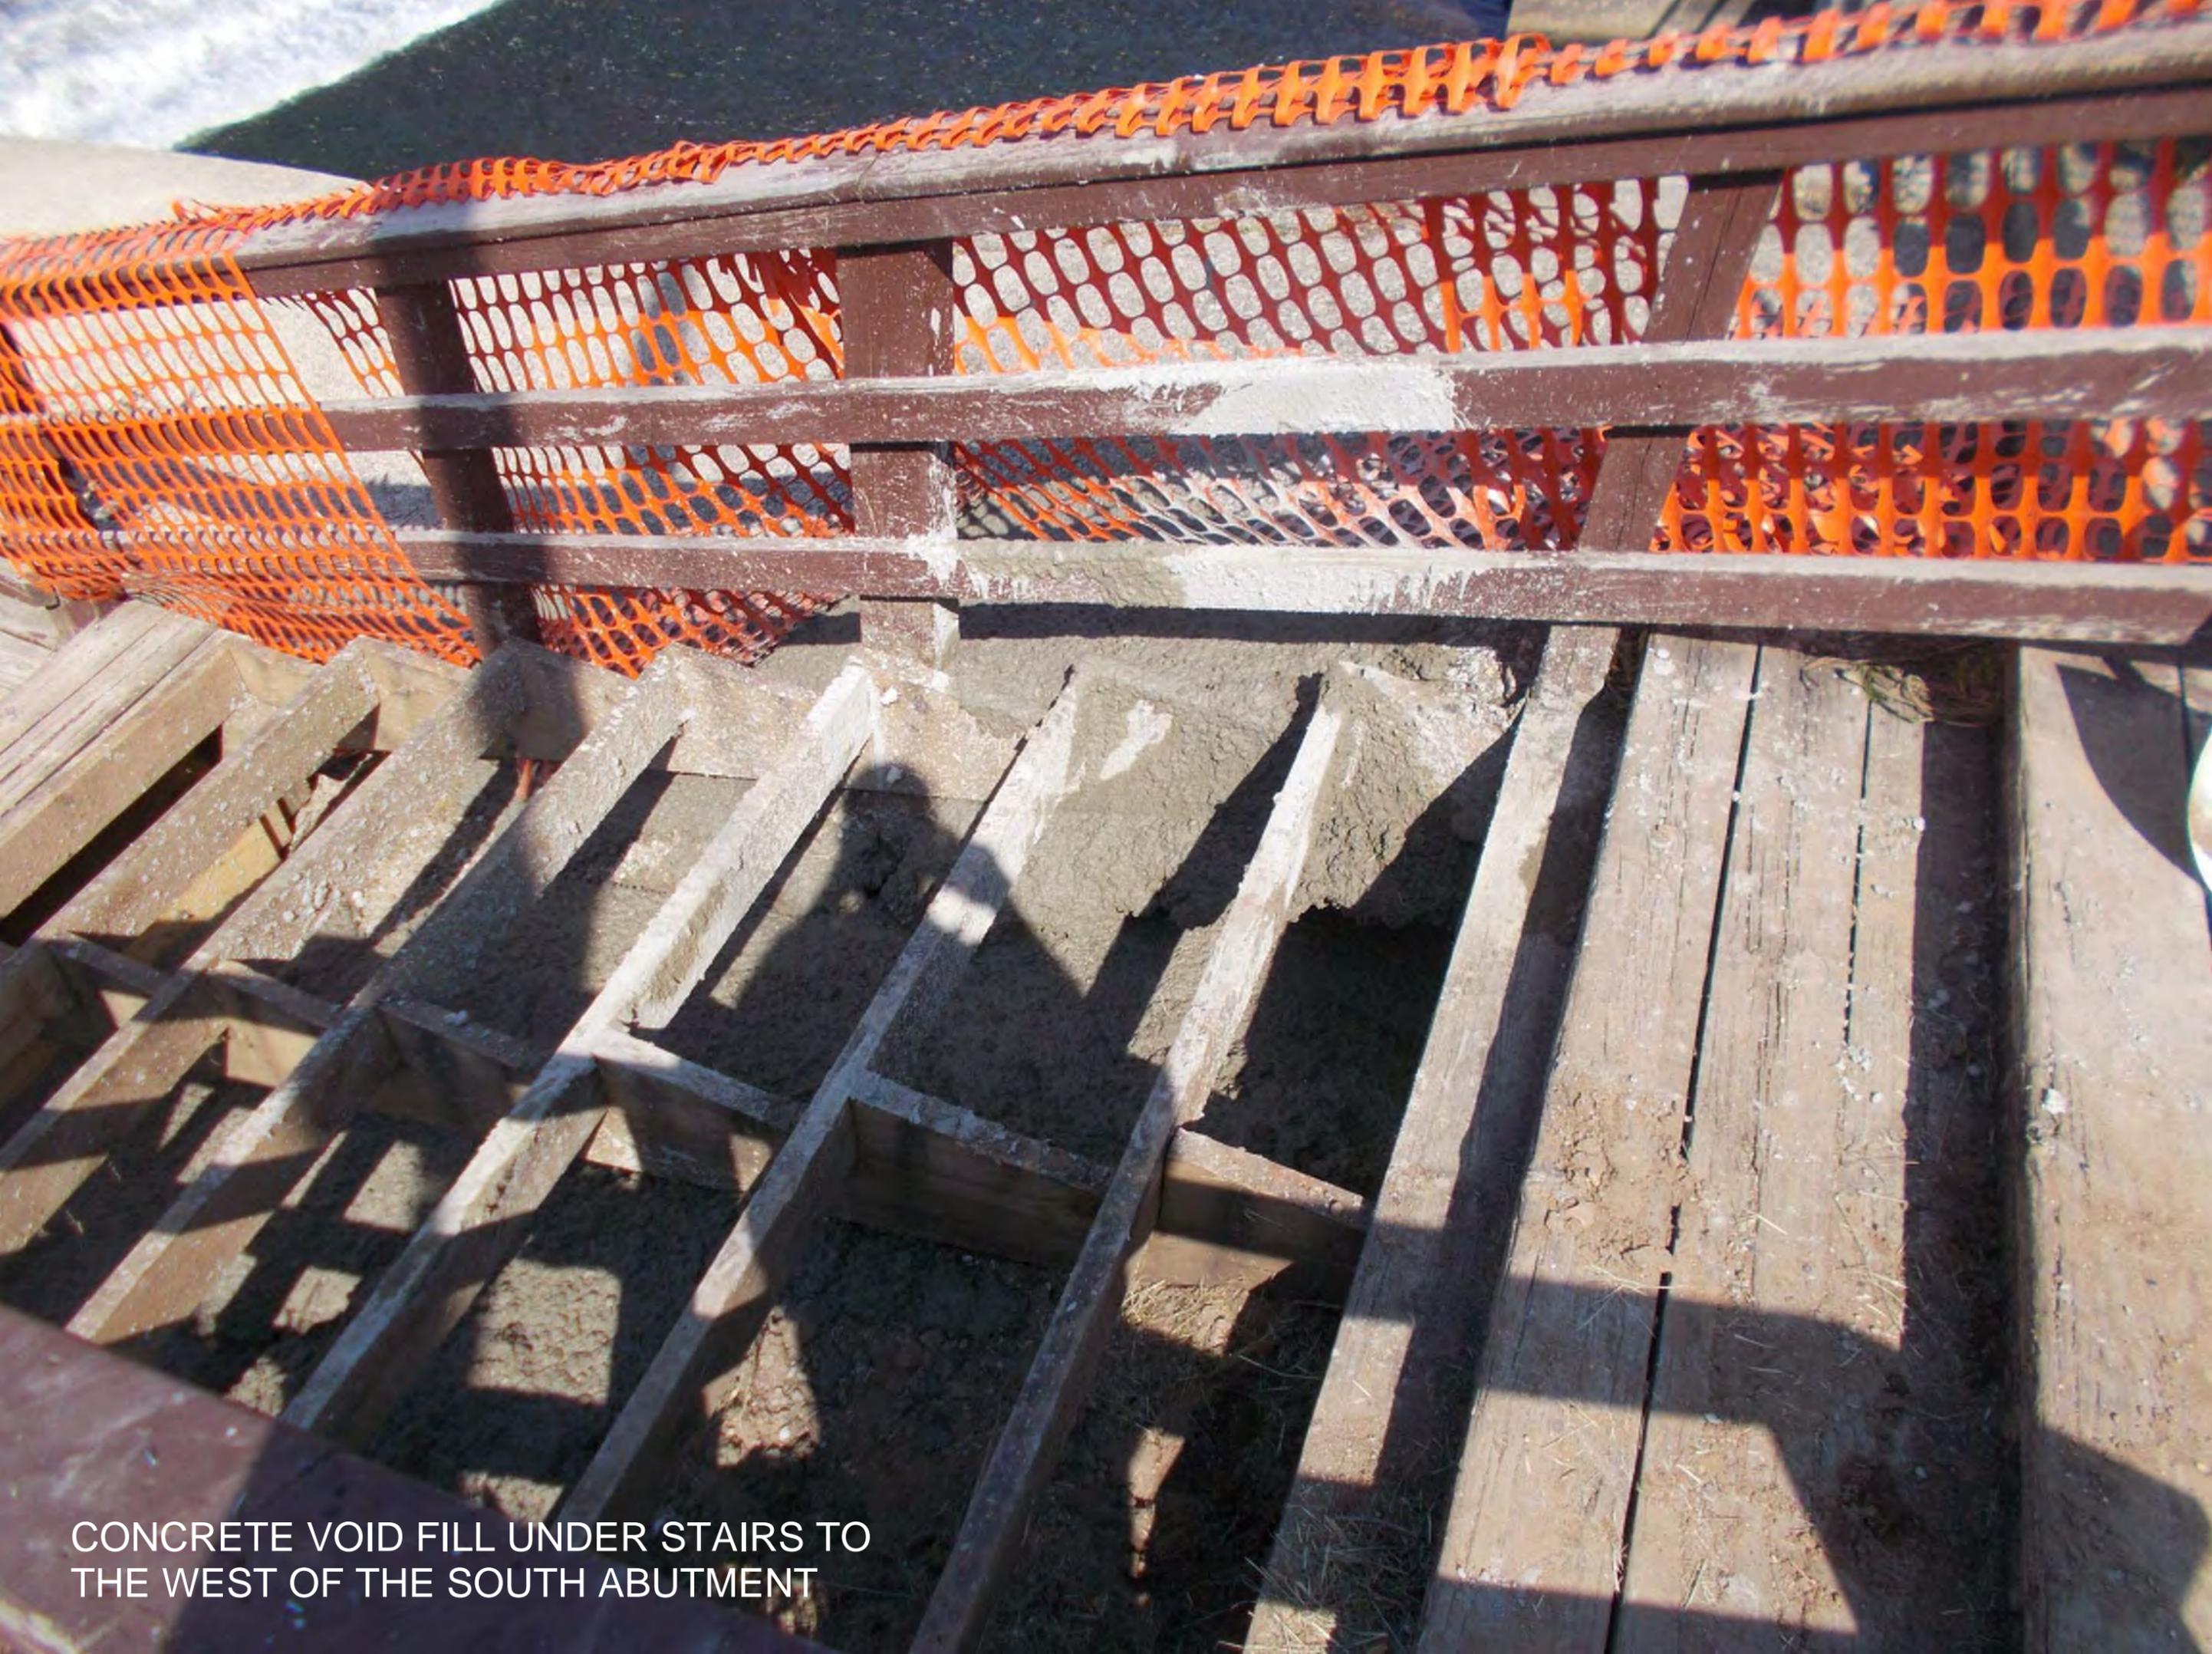
CONCRETE VOID FILL UNDER STAIRS TO
THE WEST OF THE SOUTH ABUTMENT

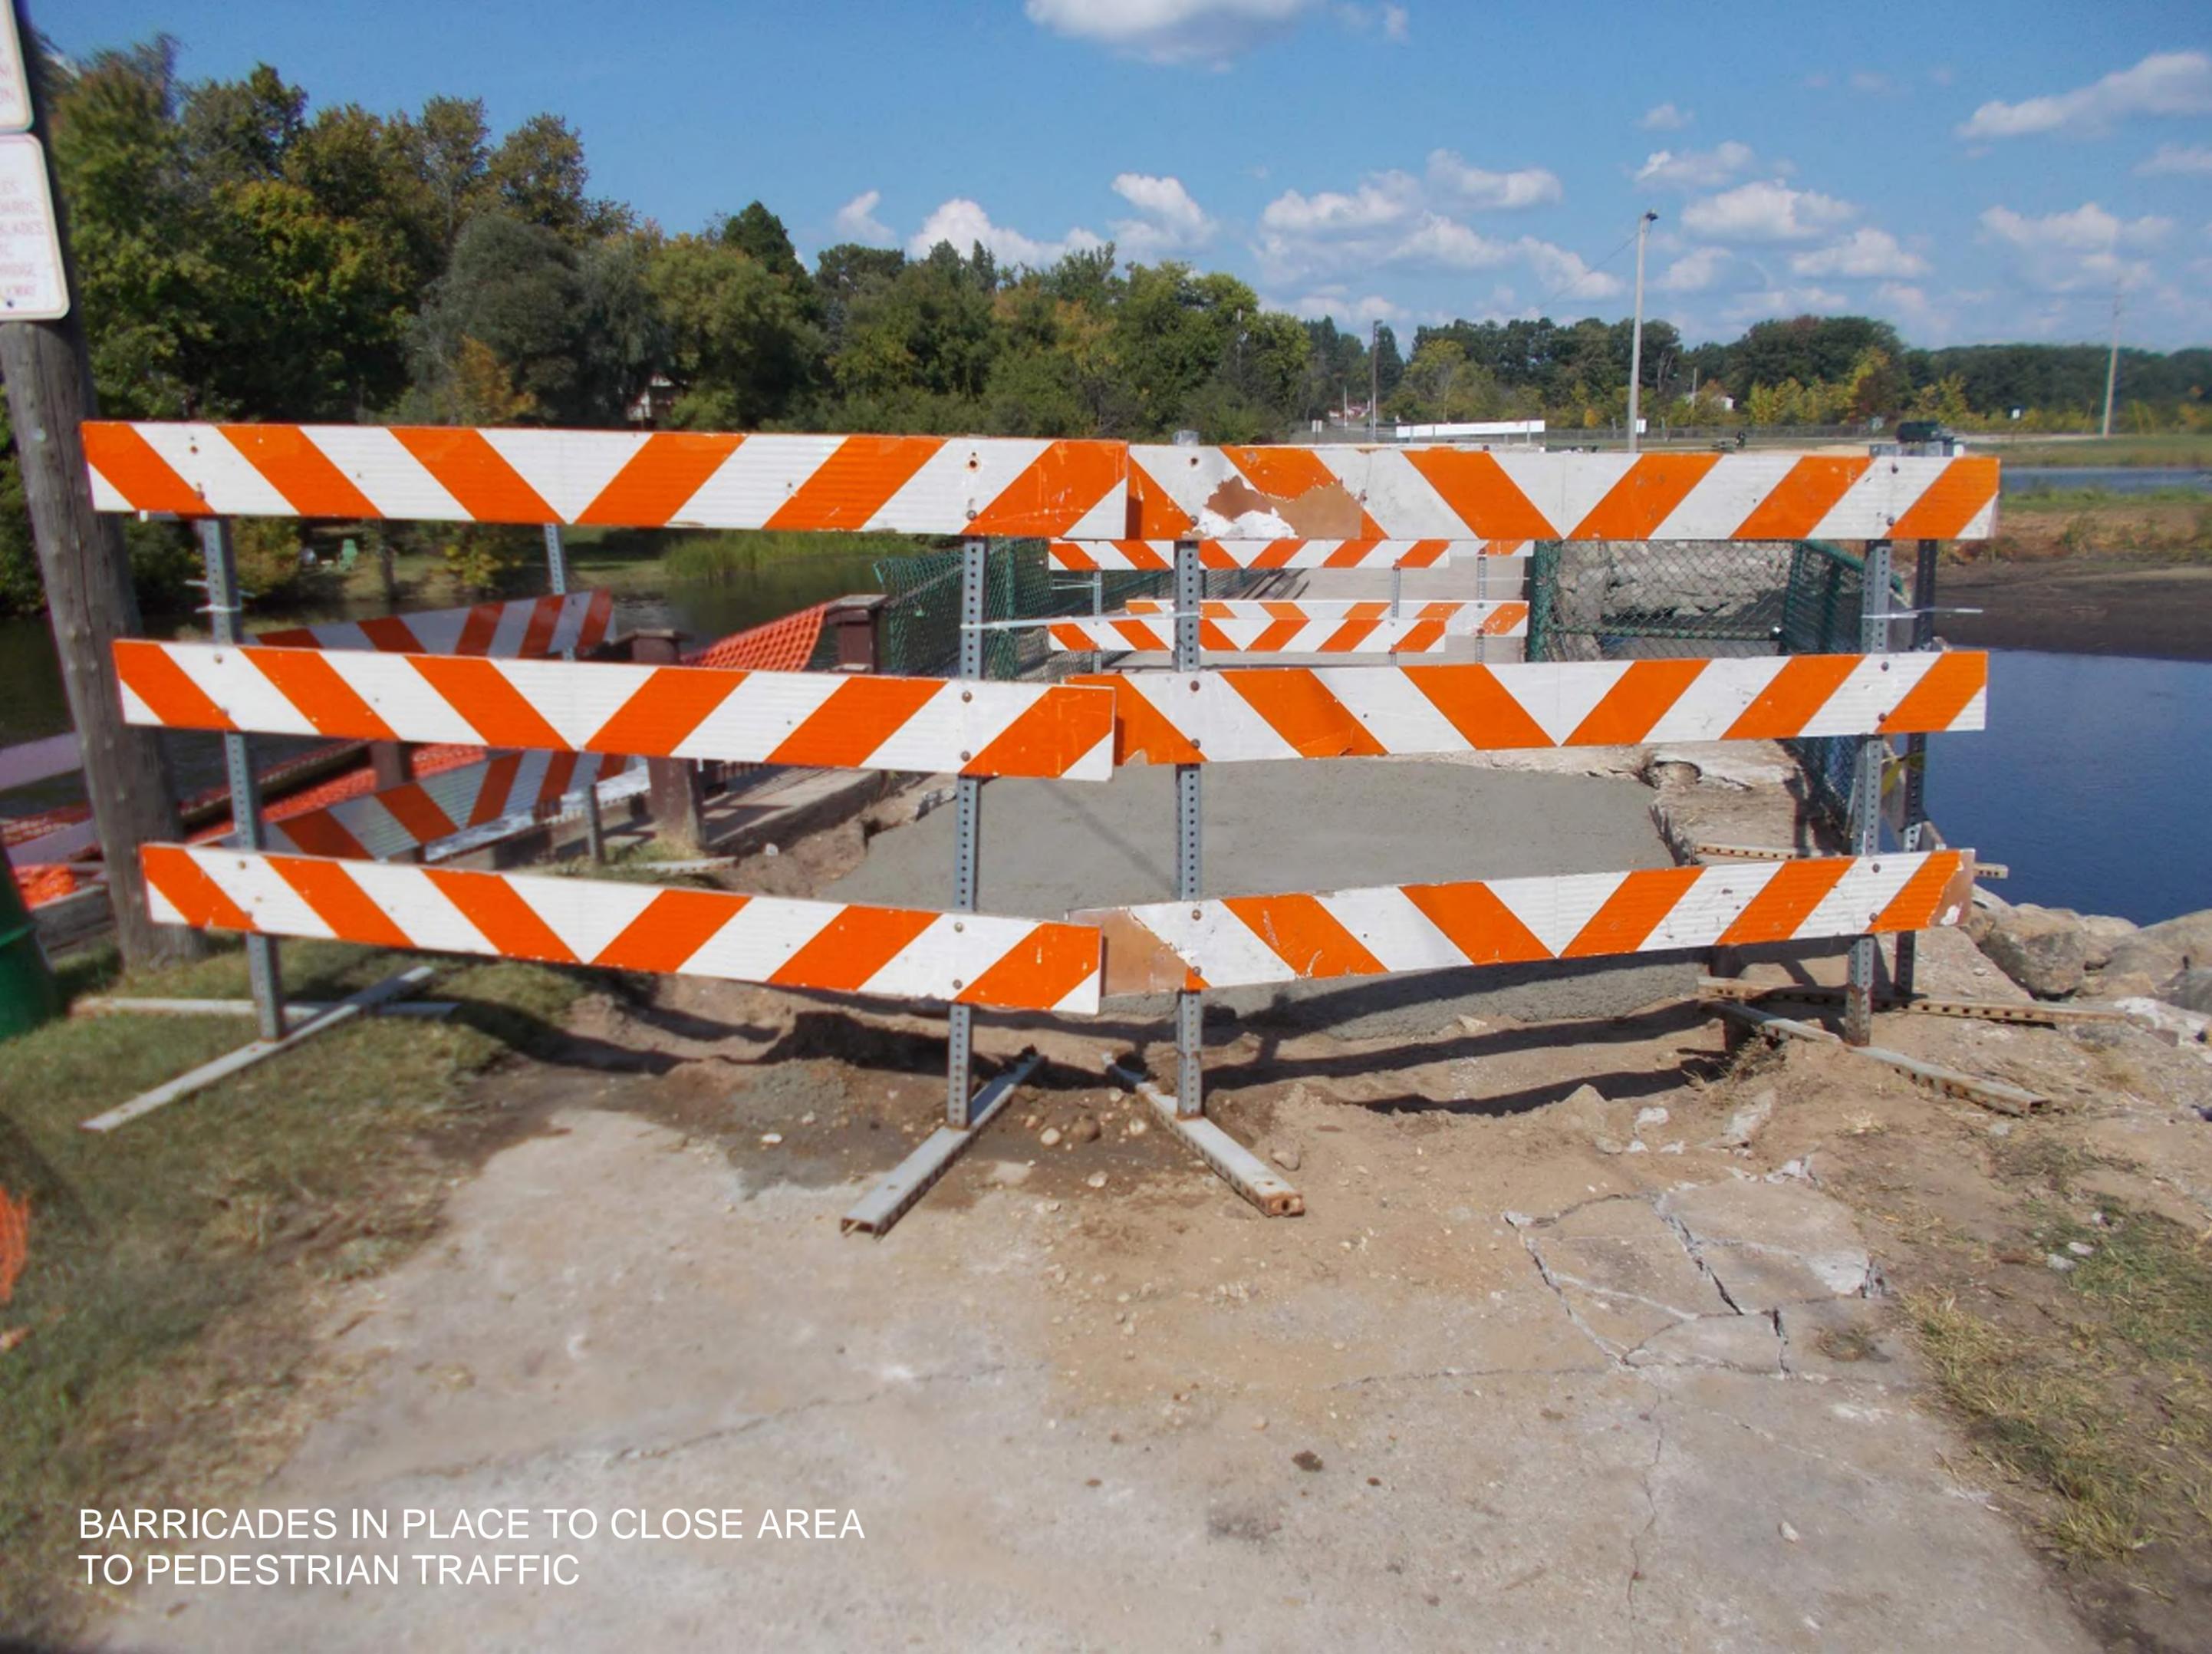
BARRICADES IN PLACE TO CLOSE AREA
TO PEDESTRIAN TRAFFIC

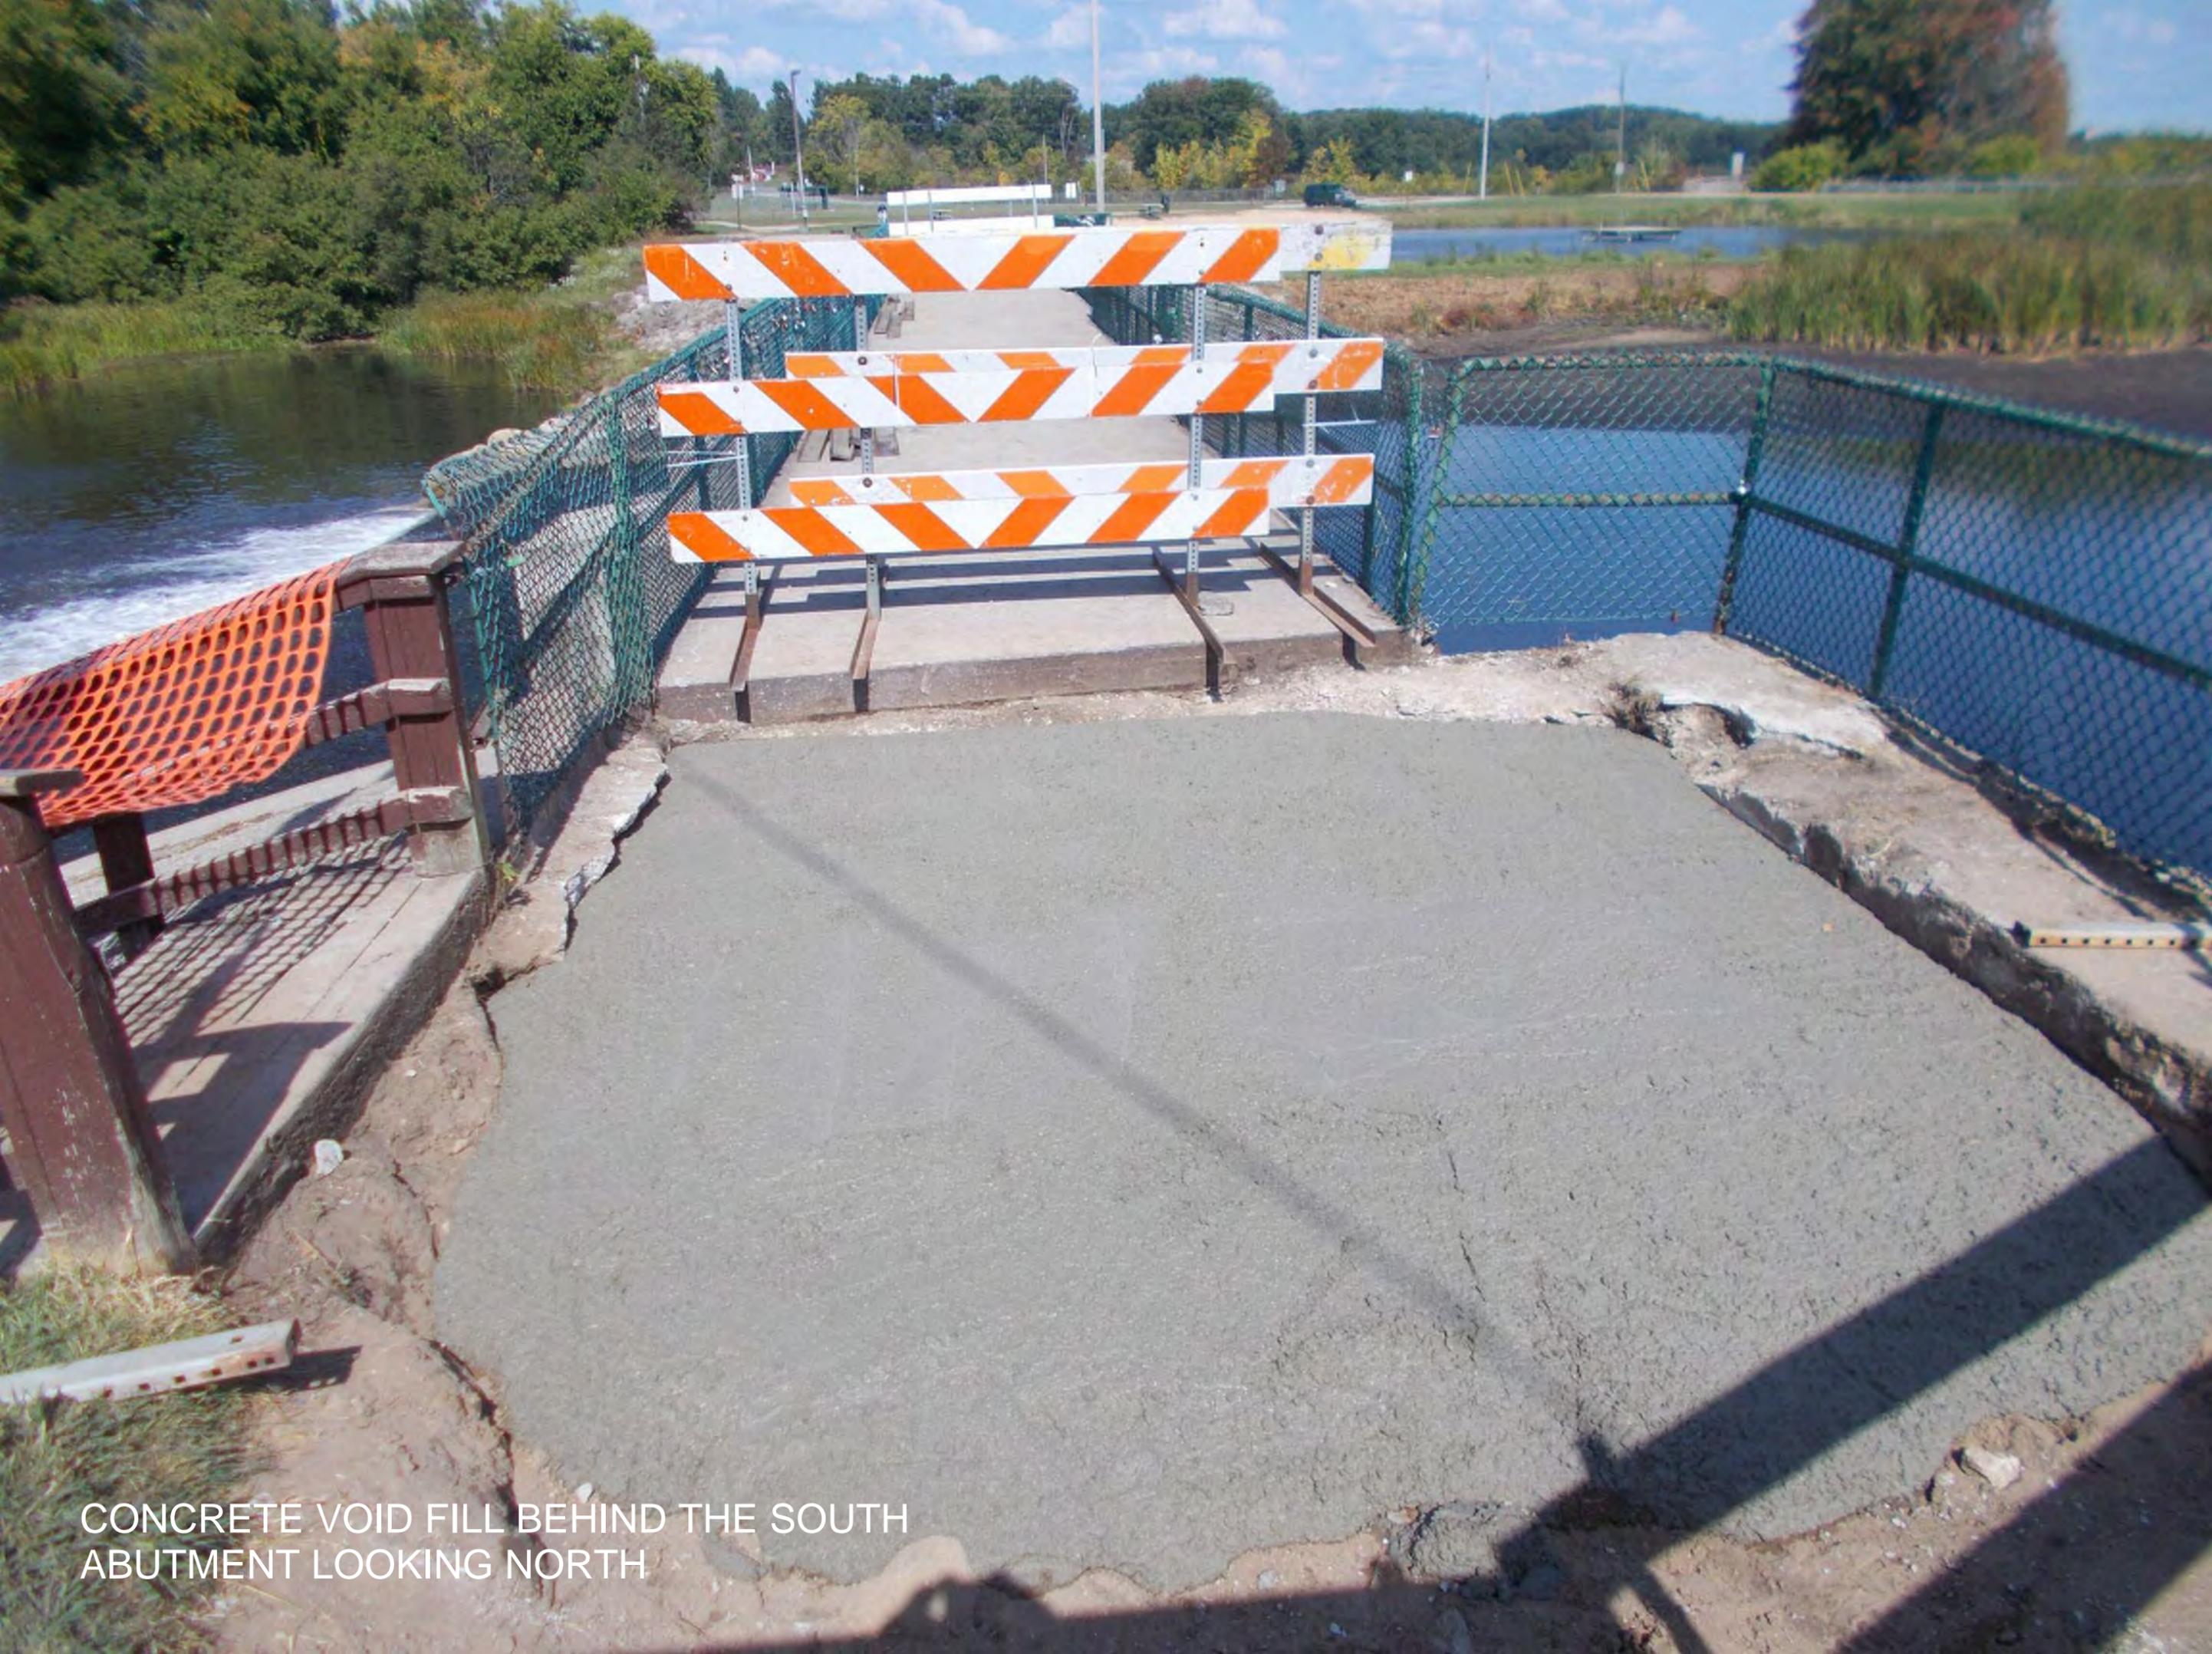
CONCRETE VOID FILL BEHIND THE SOUTH ABUTMENT LOOKING NORTH

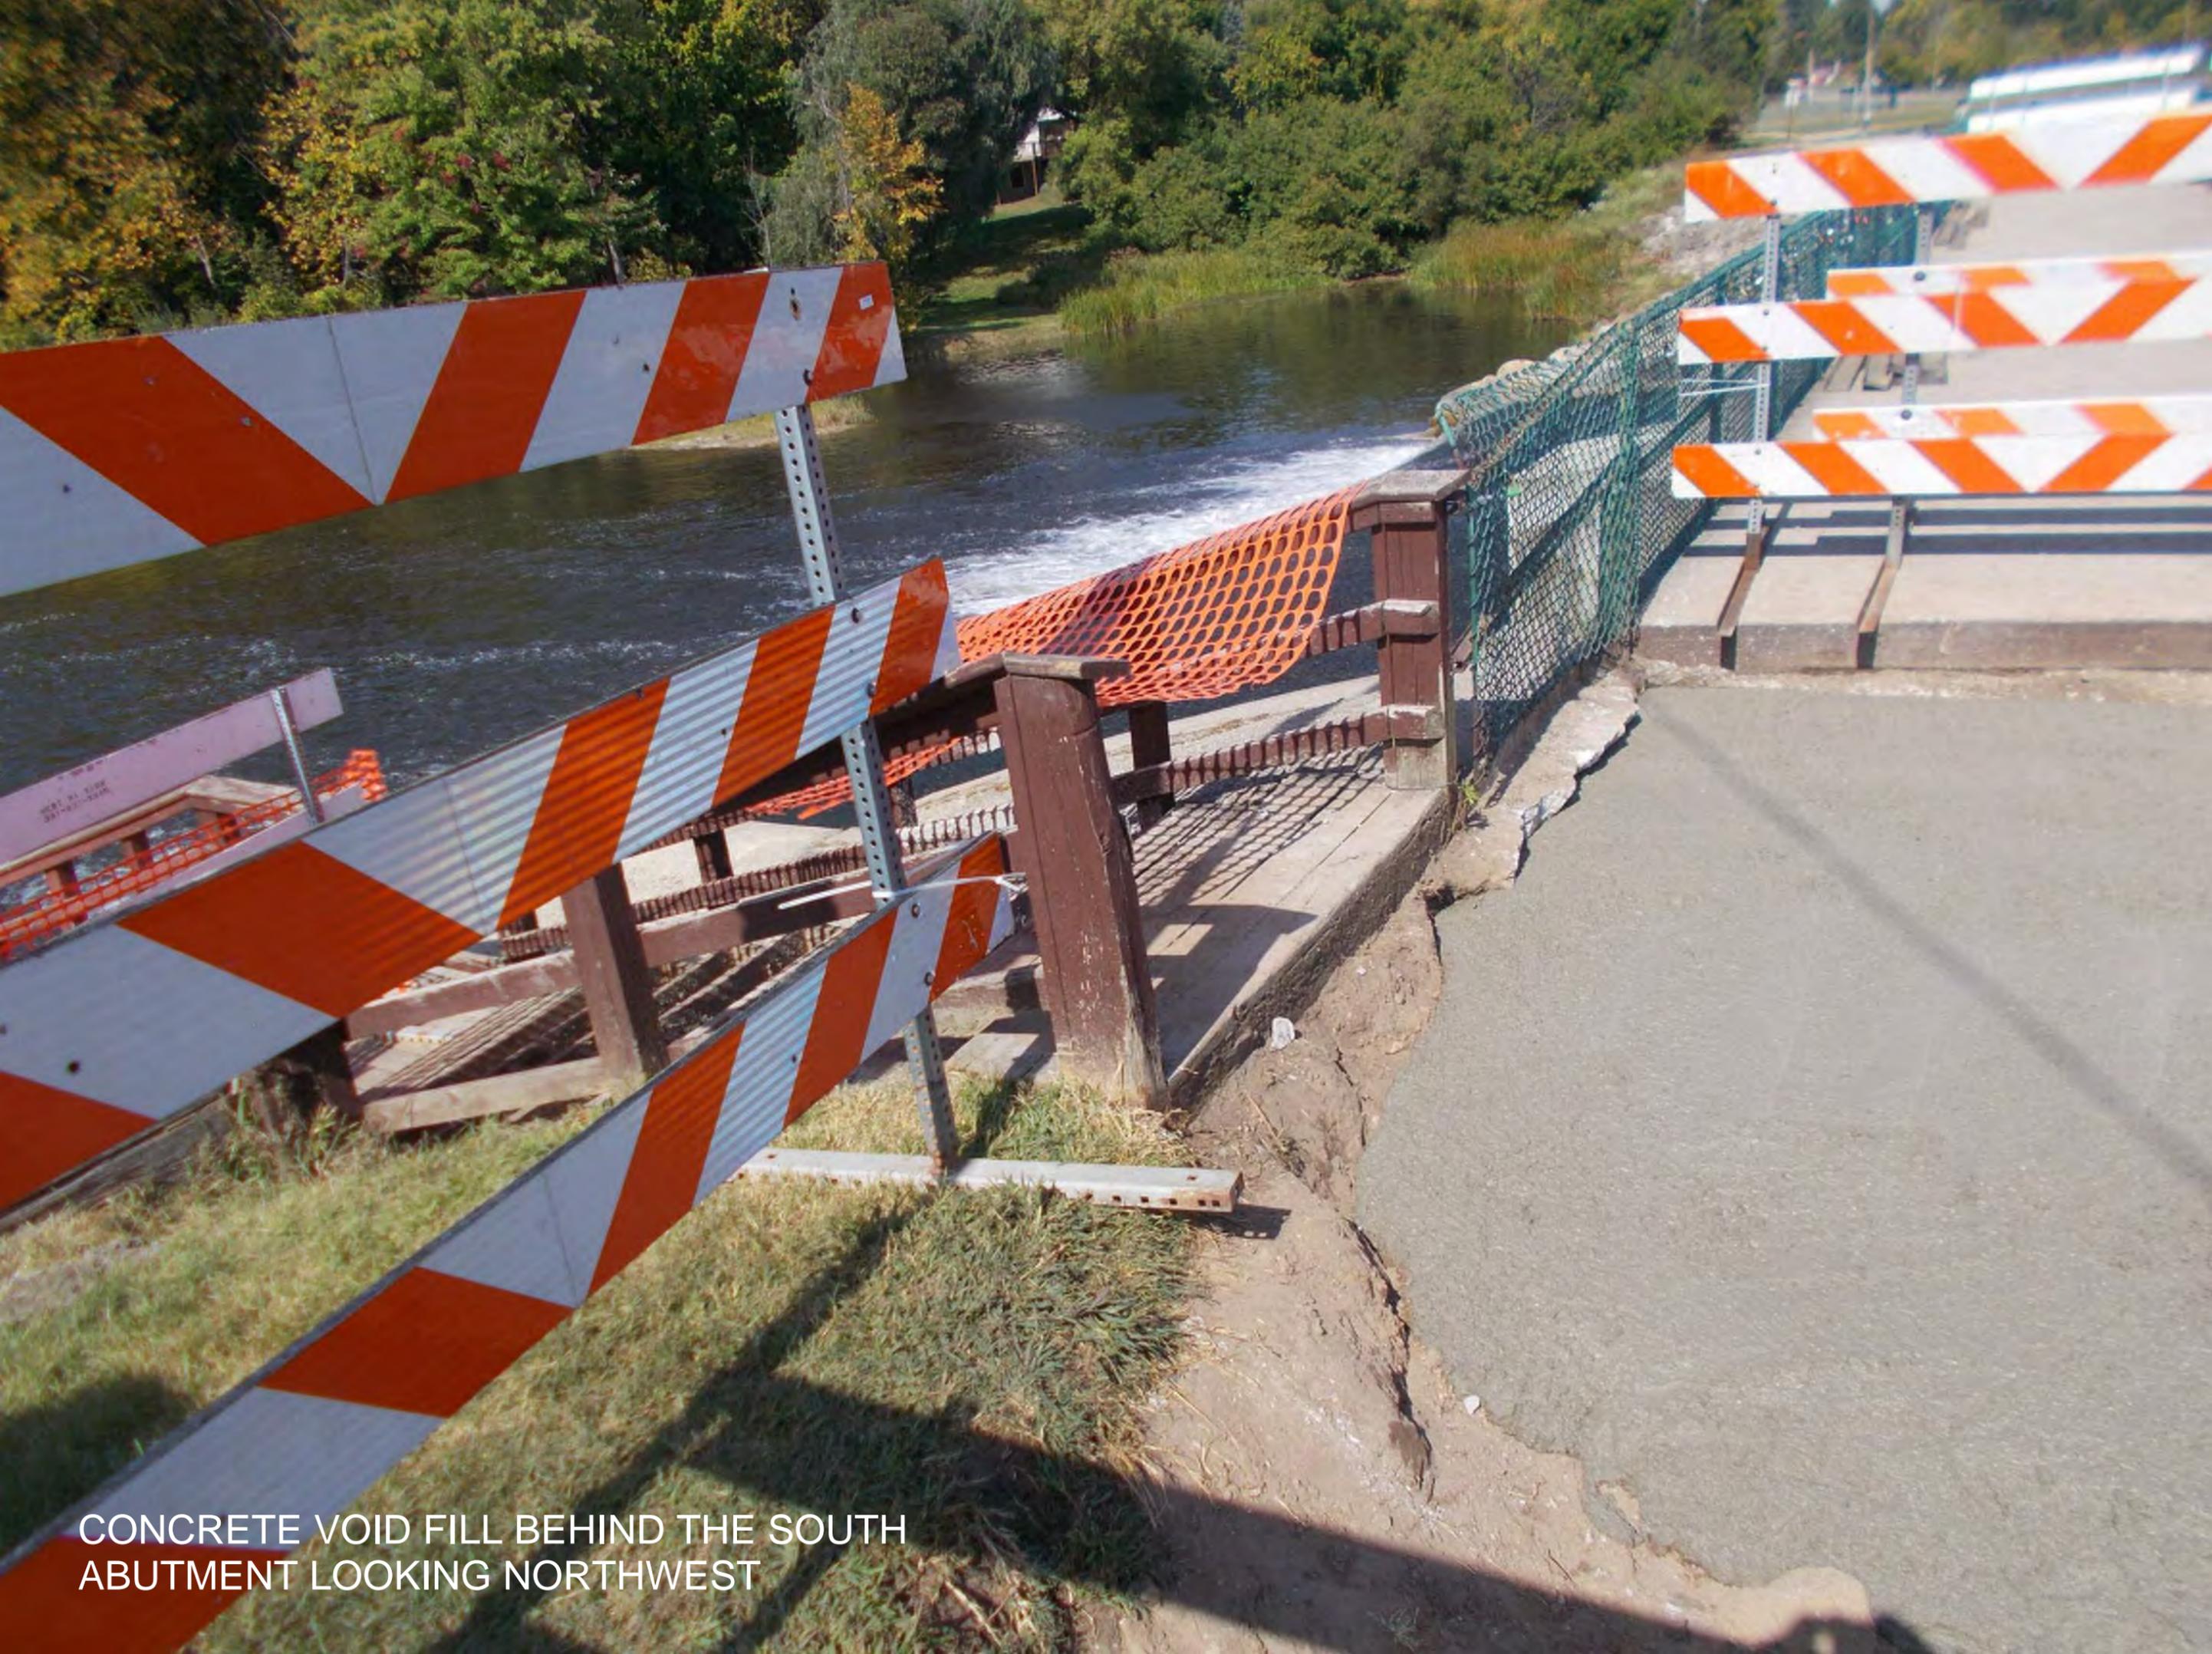
CONCRETE VOID FILL BEHIND THE SOUTH ABUTMENT LOOKING NORTHWEST

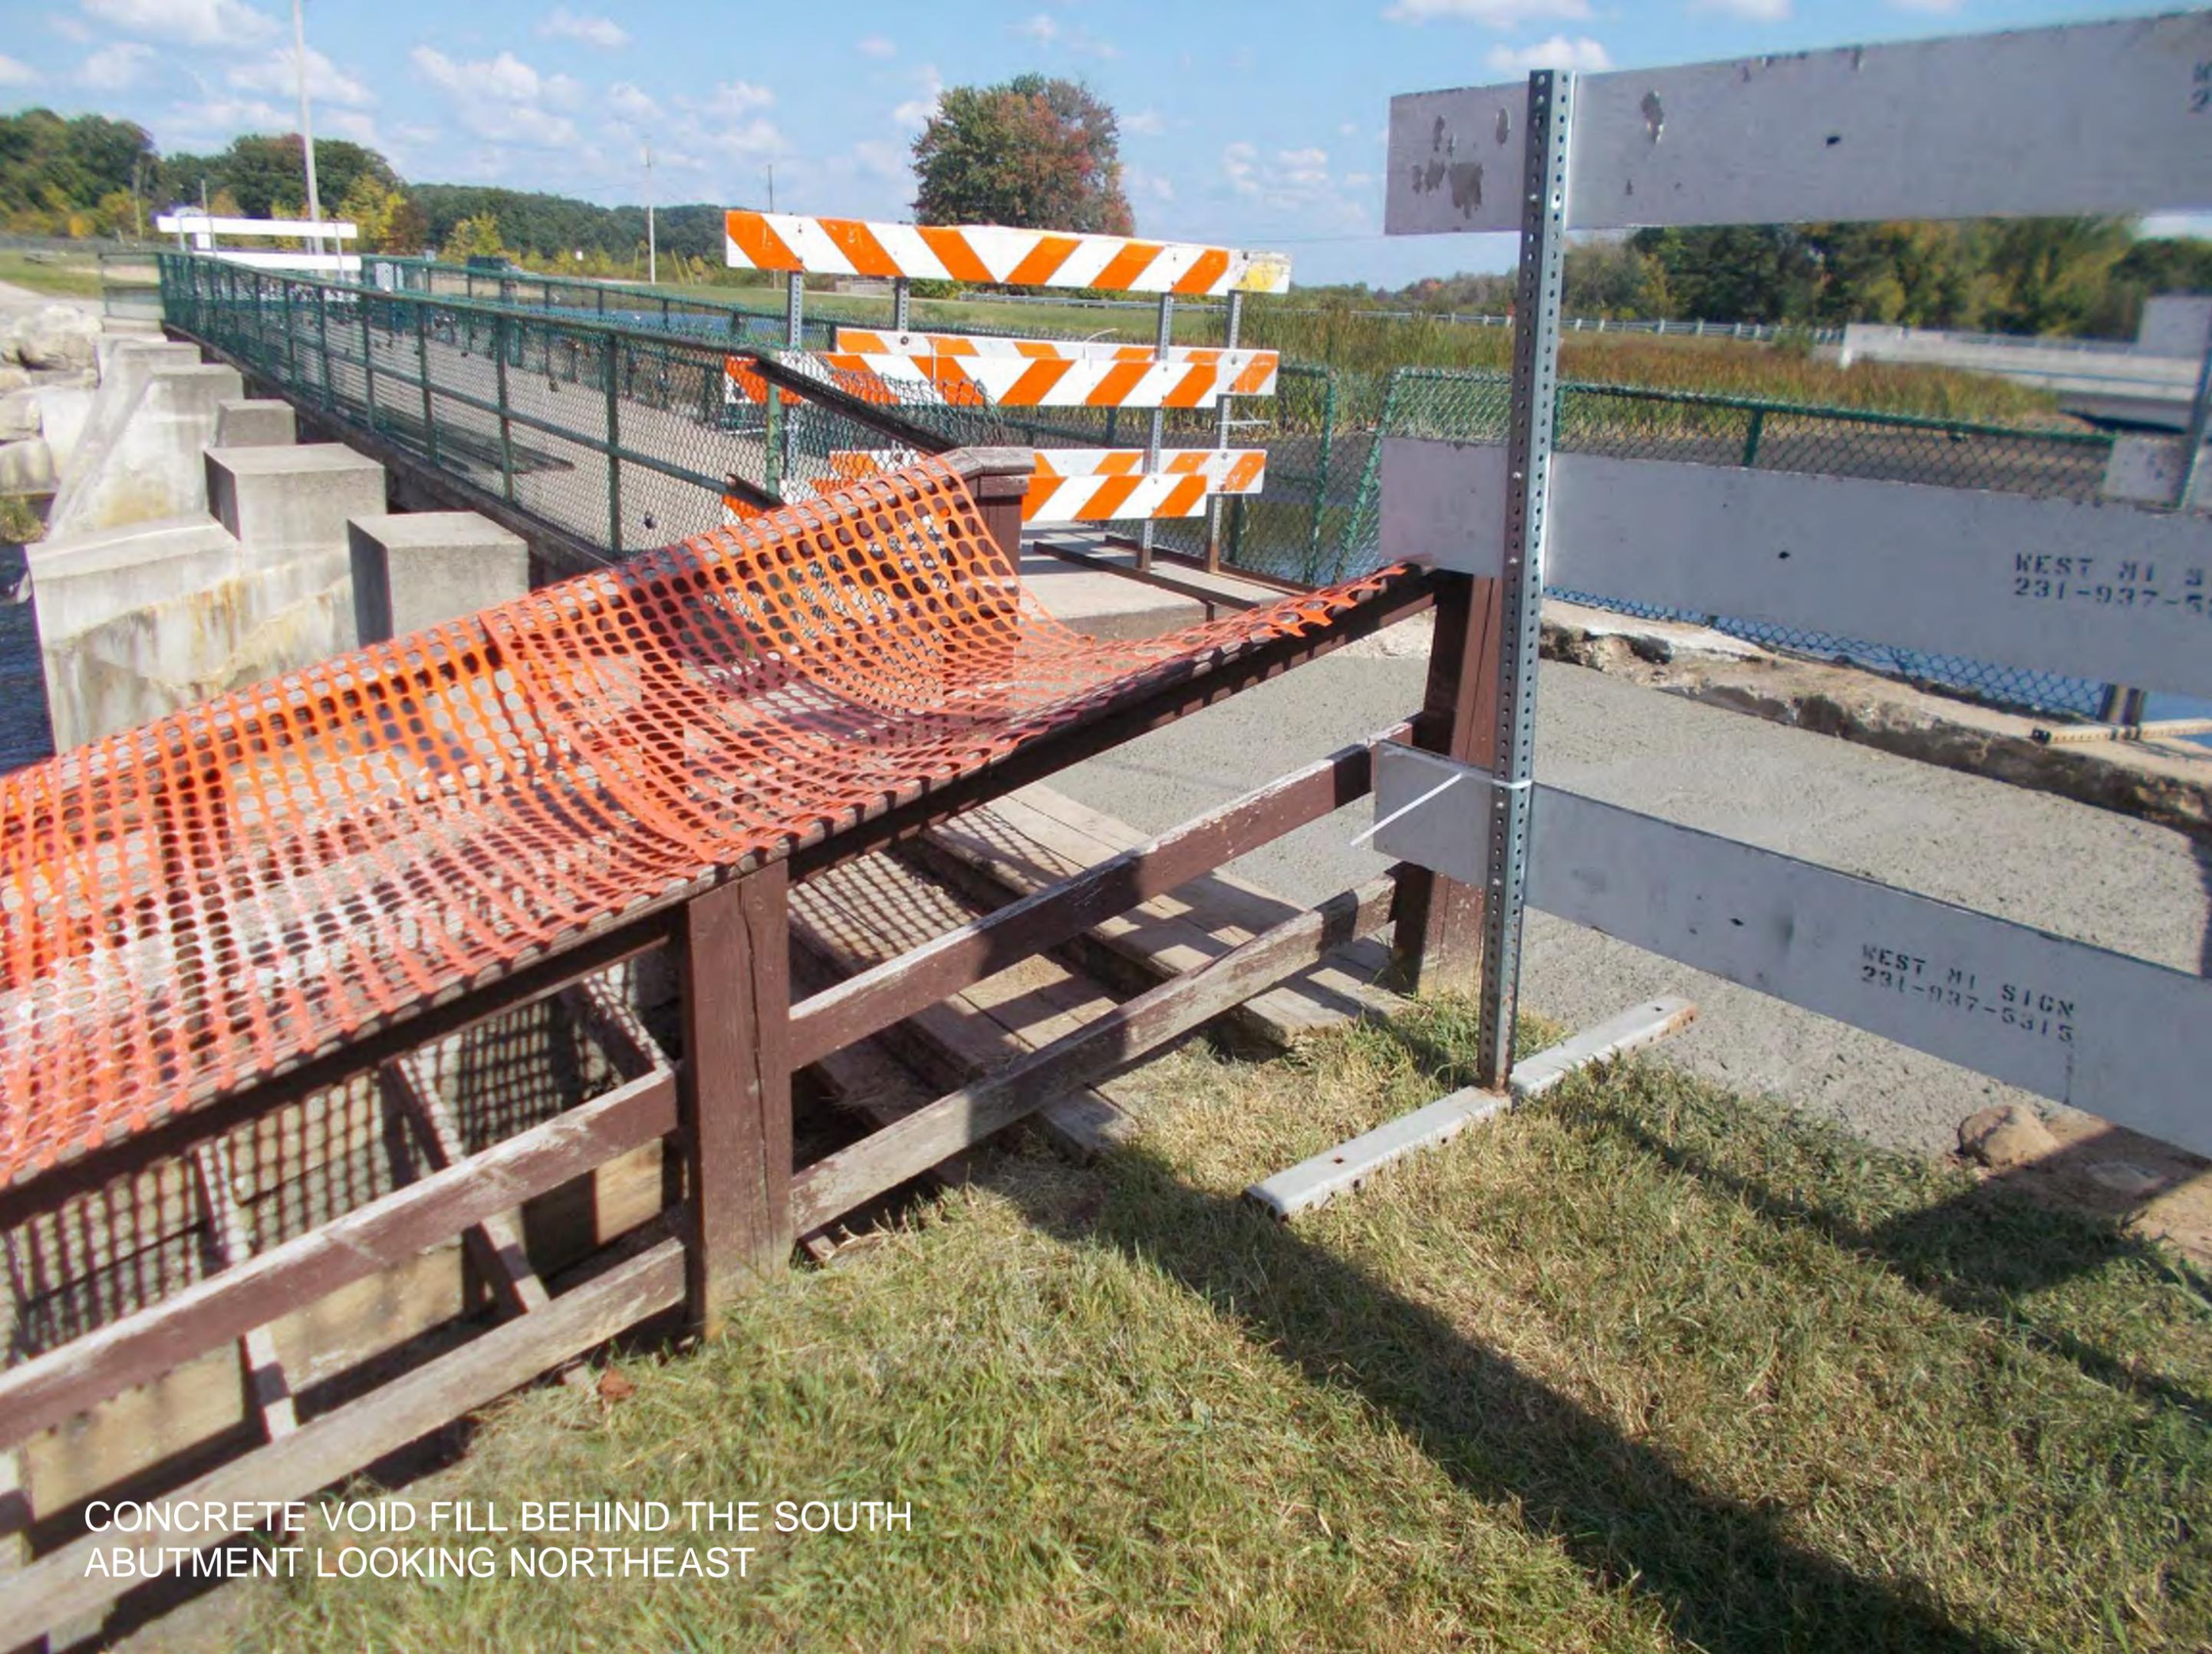
CONCRETE VOID FILL BEHIND THE SOUTH ABUTMENT LOOKING NORTHEAST
