Rehabilitation Alternatives Analysis - DRAFT

Hesperia Dam

Oceana County, Michigan
Dam I.D. No. 678

June 16, 2025
Project No. 2403886

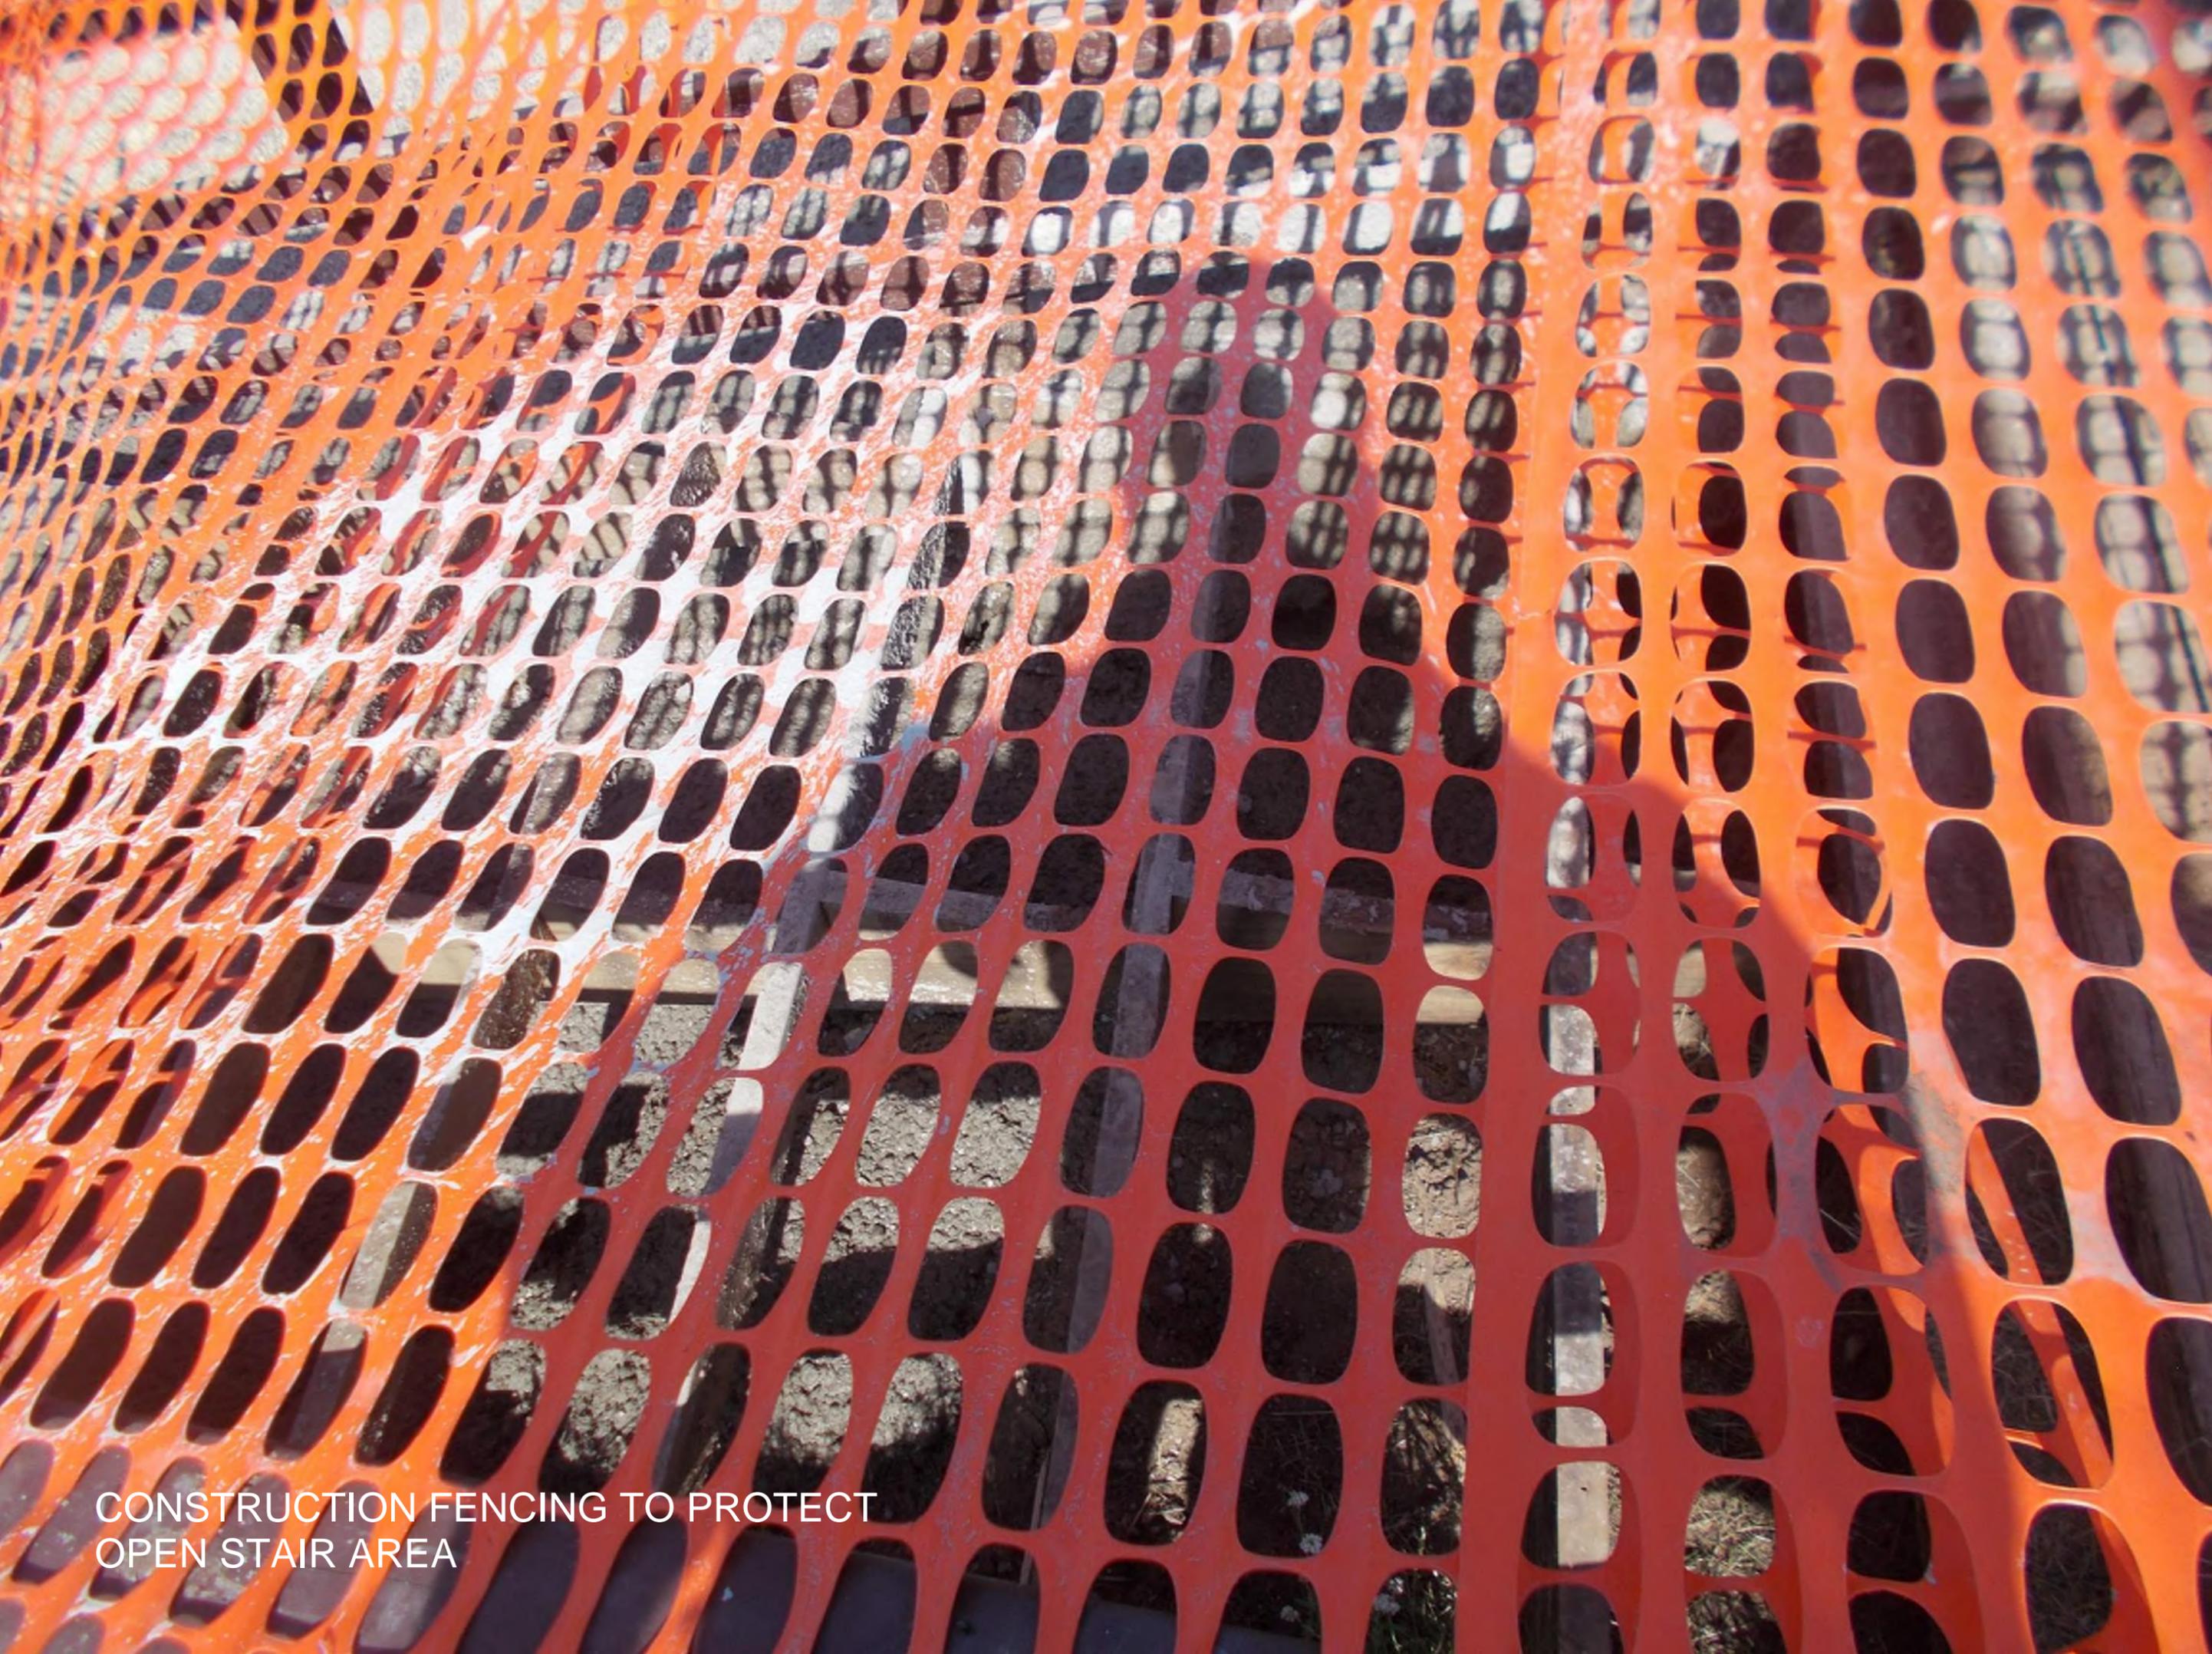
CONSTRUCTION FENCING TO PROTECT
OPEN STAIR AREA
